Airport Perimeter Security Projects for FY08-09

Buffalo Niagara International Airport (BUF)

*CCTV Enhancement/video analytics software and
SightLogix, SightSensors Perimeter Detection
System*

1. Report No. DHS/TSA—11-033		2. Government Accession No.		3. Recipient's Catalog No.	
4. Title and Subtitle Airport Perimeter Security (APS) Program – BUF – Operational Test and Evaluation Report				5. Report Date May 2011

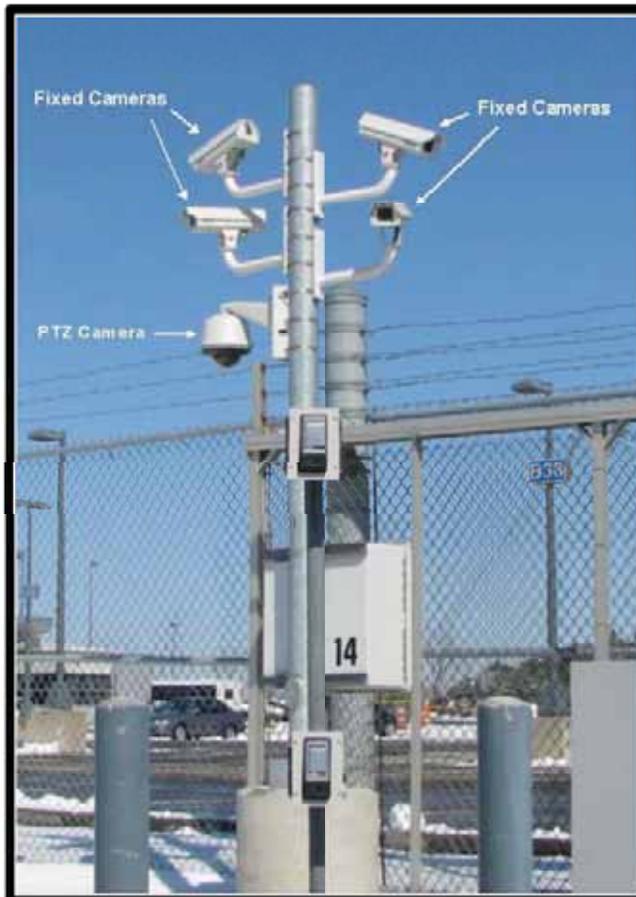
Figure 2. Installation Site 14: Four Fixed Cameras and One PTZ Camera

CCTV equipment was deployed throughout the outer perimeter region at sites that were selected by the Niagara Frontier Transportation Authority (NFTA). Figure 2 illustrates a typical installation. The fixed cameras provided coverage along the perimeter field, fence line, and nearby gate, and a PTZ camera was used for target tracking and alarm resolution.
