Airport Perimeter Security Projects for FY08-09

*Yuma Marine Corps Air Station/Yuma
International Airport (NYL)*

*Virtual Perimeter Monitoring System-Airport
(VPMS-A)*

<p>DHS/TSA 2600.02.01.10-016</p>	<h2>Virtual Perimeter Monitoring System-Airport (VPMS-A) NYL Operational Test and Evaluation Report</h2> <p>COPYRIGHT © 2010 National Safe Skies Alliance, Inc. ALL RIGHTS RESERVED</p>

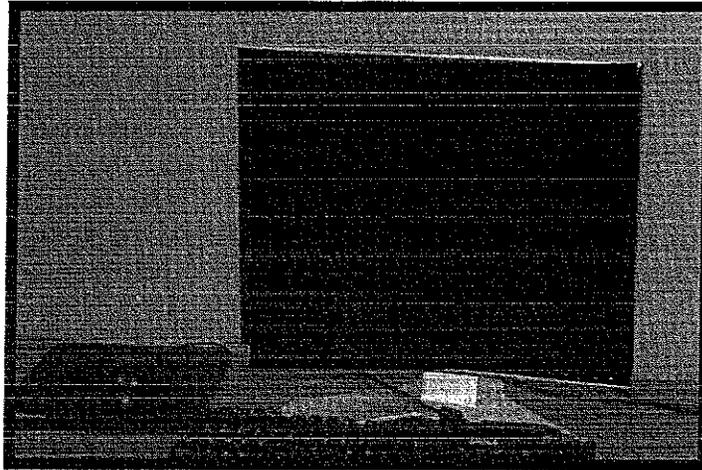
Figure 3. COP Operators Station Used by NYL Personnel

and set of peripheral devices drove the interaction between the end user and the surveillance network. This COP provided the end user with a means to view all of the integrated camera surveillance equipment, retrieve and display video archives, and review alarm alerts. Figure 3 shows the COP.
