Radiation Survey Inspection/Test Instruction

No. ITI 6-011 Dwg No: 3L01000, 3L01001
Date: 10/16/02

Date Survey Performed: **2/12/2009**

Tunnel Numbers: 6316 A/B

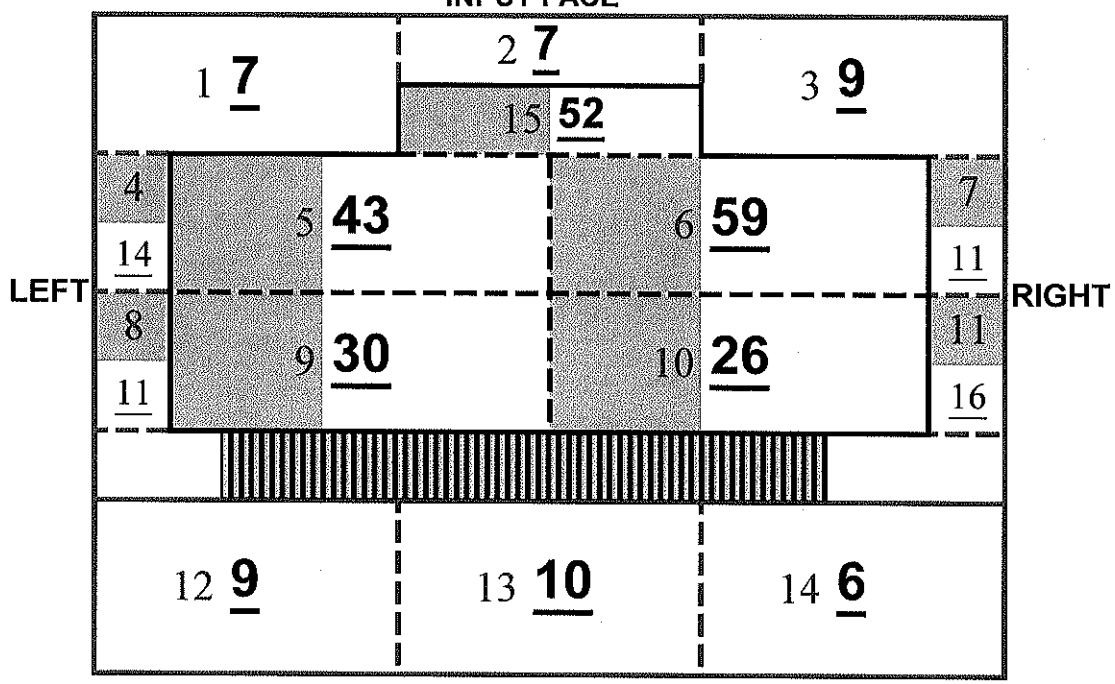
INPUT TUNNEL ROOF

1 **11**	2 **88**	3 **11**	4 **14**	5 **10**
6 **14**	7 **122**	8 **31**	9 **7**	10 **10**
11 **15**	12 **134**	13 **18**	14 **9**	15 **14**

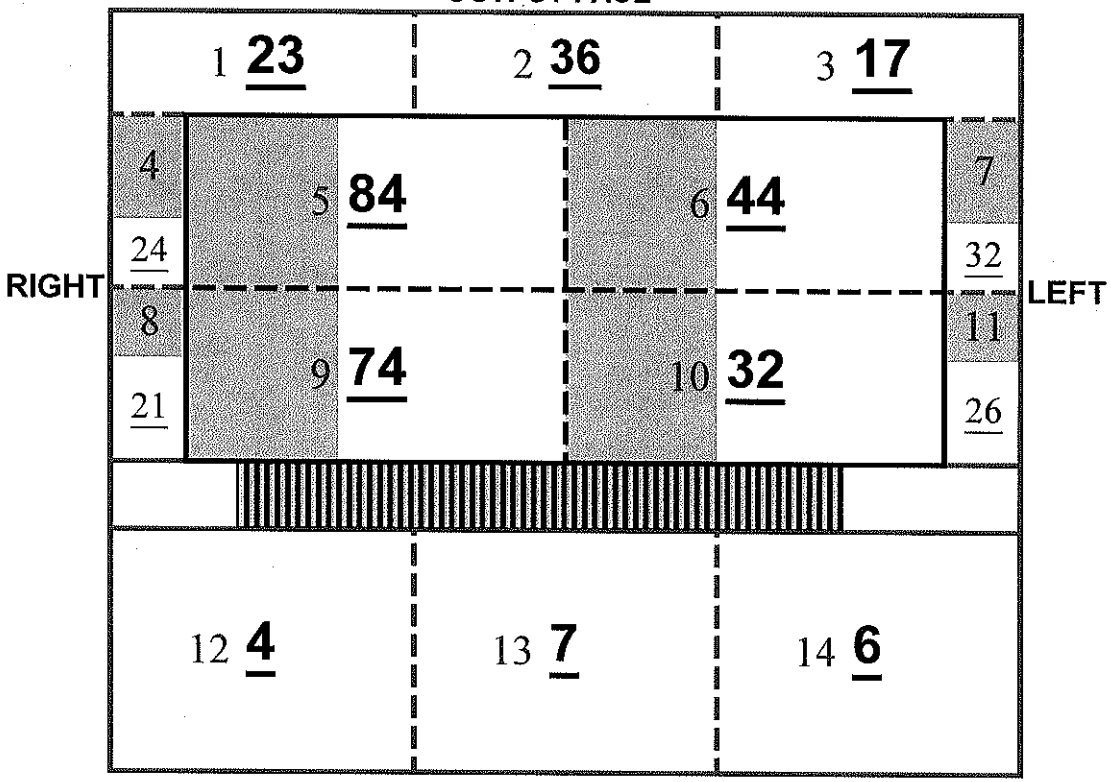
OUTPUT TUNNEL ROOF

1 **24**	2 **98**	3 **8**	4 **6**	5 **5**
6 **65**	7 **126**	8 **27**	9 **6**	10 **5**
11 **55**	12 **156**	13 **6**	14 **7**	15 **6**
