WO# 3158988

BAGGAGE/PARCEL CABINET X-RAY SYSTEM RADIATION LEAKAGE REPORT

1. Name of Facility: Los Angeles Int. Airport
2. Region: WEST
3. Street Address: 1 World Way
4. City: Los Angeles
5. State or Province Code: CA
6. Zip Code: 90045
7. Room No. or Other Physical Location of System: TERM 5 LN 2
8. Person Interviewed: [redacted]
9. Telephone Number: [redacted]
10. Fax Number: [redacted]

13. System Model No.: 620 DV
14. Single Source ☐ Dual Source ☒ Other ☐, Describe:
15. System Serial No.: 708172

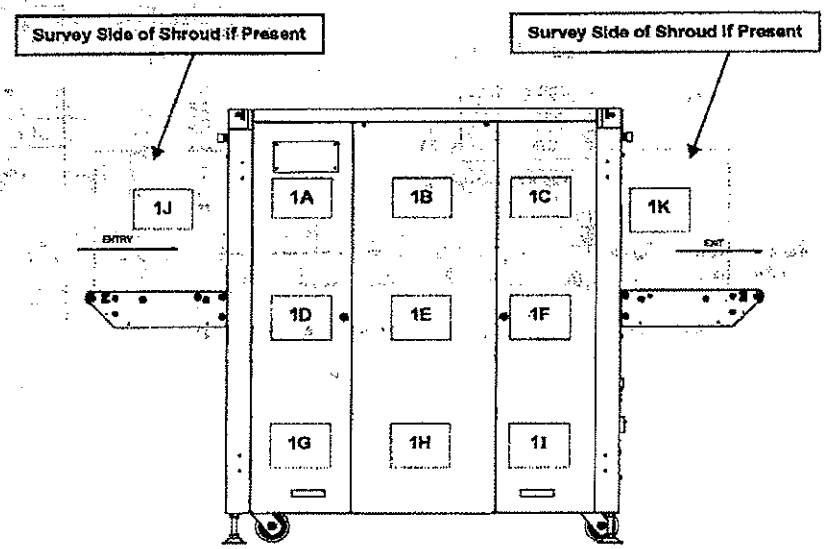
Operators Side

Location	Results NO Scatter Body	Results WITH Scatter Body
1A	14	7
1B	30	30
1C	16	26
1D	11	11
1E	24	40
1F	23	24
1G	7	7
1H	7	9
1I	3	9
1J	23	40
1K	22	36

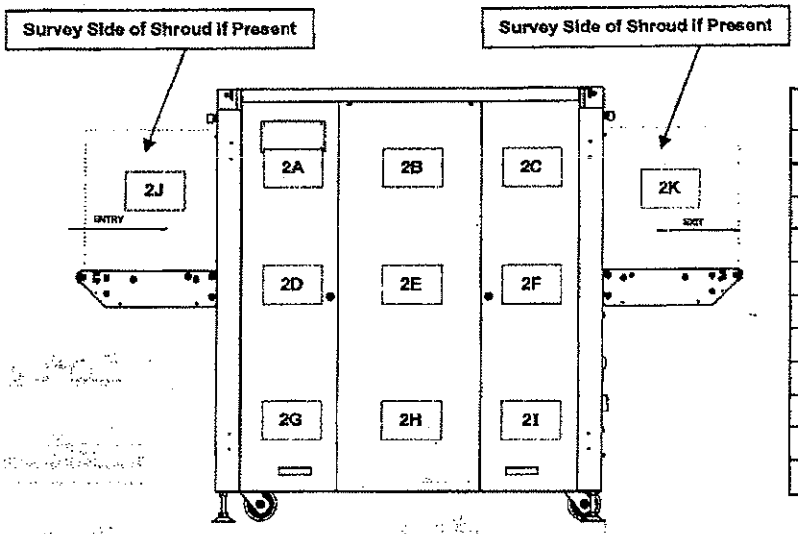
Non-Operators Side

Location	Results NO Scatter Body	Results WITH Scatter Body
2A	13	26
2B	10	32
2C	9	15
2D	7	17
2E	12	11
2F	9	19
2G	15	19
2H	14	15
2I	7	9
2J	166	119
2K	71	85

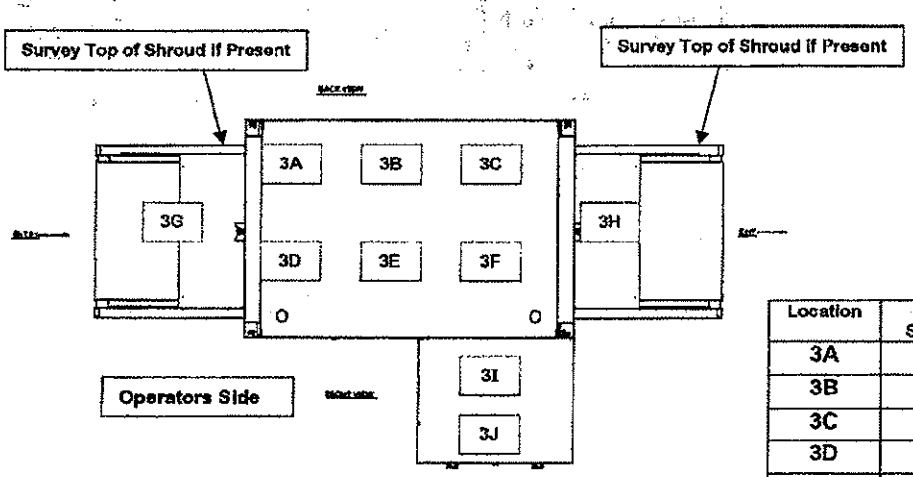
Top View

Location	Results NO Scatter Body	Results WITH Scatter Body
3A	3	14
3B	6	13
3C	8	15
3D	3	12
3E	7	13
3F	8	11
3G	7	43
3H	15	22
3I	16	17
3J	19	14

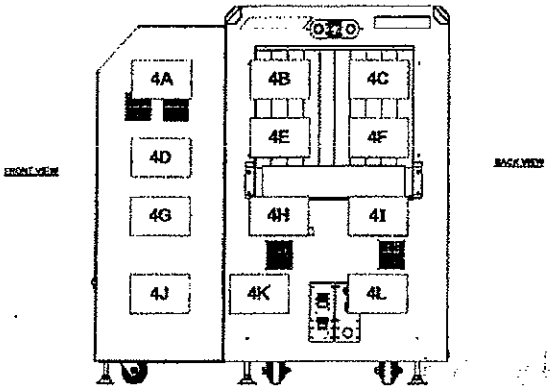
EXIT TUNNEL

Location	Results NO Scatter Body	Results WITH Scatter Body
4A	15	9
4B	30	41
4C	26	53
4D	11	19
4E	29	29
4F	29	39
4G	12	8
4H	15	41
4I	11	18
4J	10	15
4K	9	9
4L	21	16

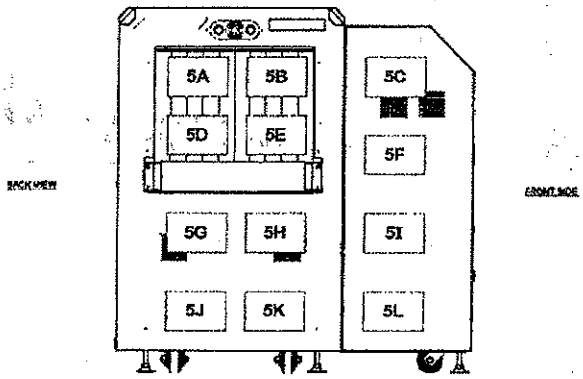
ENTRANCE TUNNEL

Location	Results NO Scatter Body	Results WITH Scatter Body
5A	37	51
5B	36	39
5C	25	34
5D	29	53
5E	43	63
5F	25	31
5G	11	11
5H	11	14
5I	19	16
5J	5	9
5K	7	11
5L	10	7
