Rapiscan systems	BAGGAGE/PARCEL CABINET X-RAY SYSTEM RADIATION LEAKAGE REPORT	FIELD SERVICE ENGINEERS	Form R-0588-3 9/9/09 45. RSI W.O.# 3321341 Deferred W.O.#

EQ: 57433
WO: 3321341
O.O.W. - Semi-Annual PM

Rapiscan systems	MODEL 620DV OR 500 SERIES EQUIVALENT RADIATION LEAKAGE SURVEY FORM	MODEL 620DV FSE SURVEY FORM	FORM FSE-R-0047-620DV-1

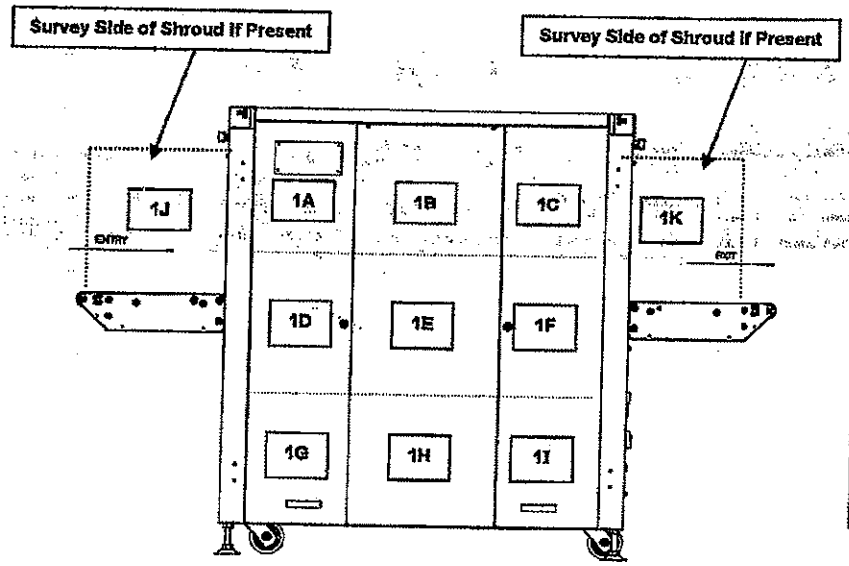
Operators Side

Location	Results NO Scatter Body	Results WITH Scatter Body
1A	18	21
1B	35	43
1C	20	22
1D	15	21
1E	30	36
1F	12	16
1G	8	10
1H	10	9
1I	17	23
1J	41	46
1K	62	65

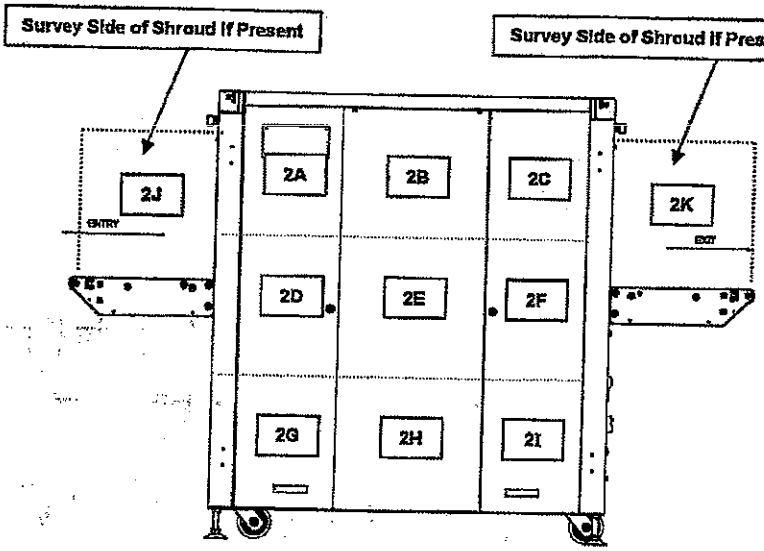
Non-Operators Side

Location	Results NO Scatter Body	Results WITH Scatter Body
2A	34	36
2B	23	27
2C	13	17
2D	17	21
2E	18	20
2F	23	25
2G	15	18
2H	19	21
2I	20	23
2J	87	90
2K	146	156

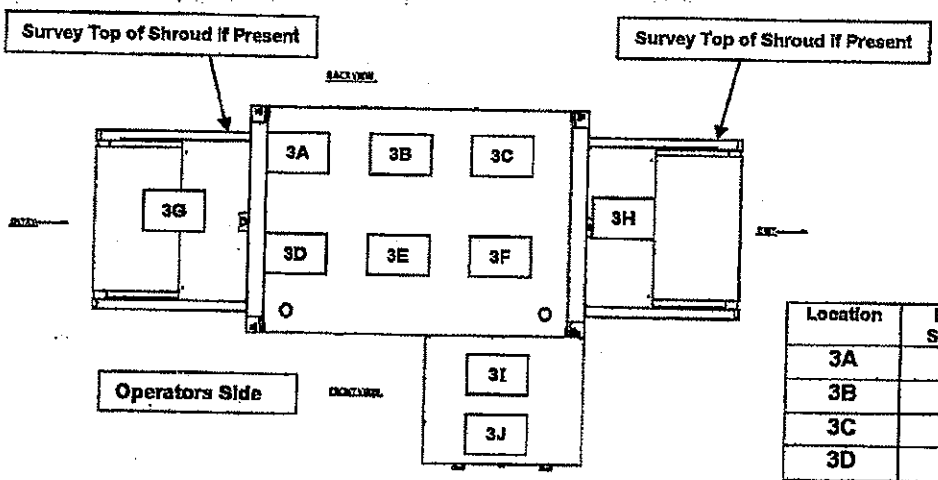
Top View

Location	Results NO Scatter Body	Results WITH Scatter Body
3A	3	6
3B	21	26
3C	18	20
3D	20	22
3E	26	30
3F	22	26
3G	35	37
3H	37	39
3I	28	32
3J	27	33

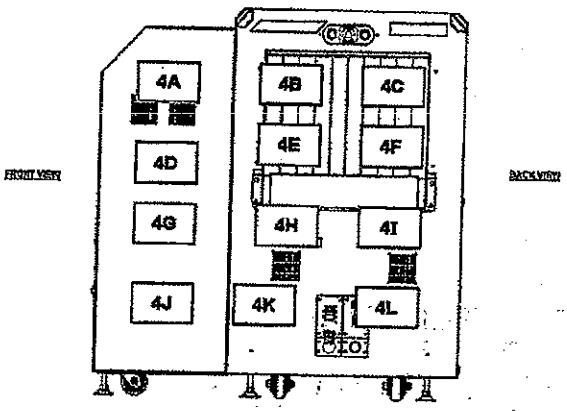
EXIT TUNNEL

Location	Results NO Scatter Body	Results WITH Scatter Body
4A	31	35
4B	54	56
4C	59	63
4D	15	18
4E	65	68
4F	60	62
4G	20	22
4H	49	52
4I	46	49
4J	14	16
4K	15	17
4L	23	25

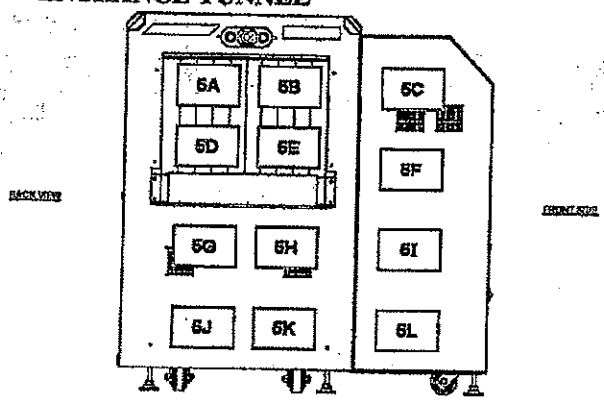
ENTRANCE TUNNEL

Location	Results NO Scatter Body	Results WITH Scatter Body
5A	45	47
5B	46	49
5C	54	57
5D	84	89
5E	52	54
5F	52	55
5G	15	17
5H	29	29
5I	12	15
5J	15	20
5K	10	12
5L	14	13
