Rapiscan systems	BAGGAGE/PARCEL CABINET X-RAY SYSTEM RADIATION LEAKAGE REPORT	FIELD SERVICE ENGINEERS	Form R-0588-3 9/9/09 45. RSI W.O.# ____ Deferred W.O.# ____

1. Name of Facility: LOS ANGELES INTERNATIONAL AIRPORT	2. Region: WEST	3. Street Address: 1 WORLD WAY	
4. City: LOS ANGELES		5. State or Province Code: CA	6. Zip Code: 90045

7. Room No. or Other Physical Location of System: TBIT South Checkpoint Lane #4	8. Person Interviewed: [redacted]	9. Telephone Number: [redacted]	10. Fax Number:

Rapiscan Systems	MODEL 620DV OR 500 SERIES EQUIVALENT RADIATION LEAKAGE SURVEY FORM	MODEL 620DV FSE SURVEY FORM	FORM FSE-R-0047-620DV-1

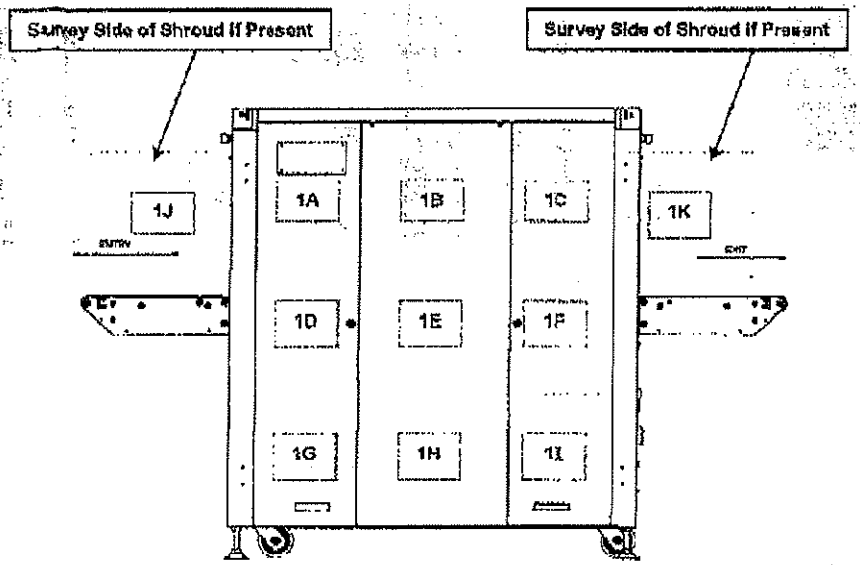
Operators Side

Location	Results NO Scatter Body	Results WITH Scatter Body
1A	7	9
1B	4	11
1C	5	9
1D	~~5~~ 6	8
1E	10	9
1F	7	7
1G	6	5
1H	3	8
1I	7	7
1J	90	93
1K	51	88

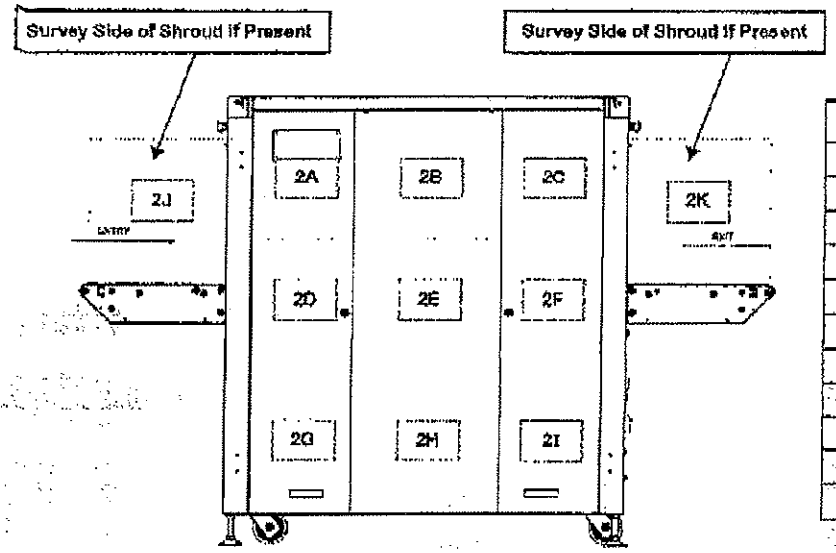
Non-Operators Side

Location	Results NO Scatter Body	Results WITH Scatter Body
2A	16	30
2B	2	6
2C	8	9
2D	14	7
2E	6	4
2F	3	3
2G	6	4
2H	8	6
2I	4	4
2J	33	65
2K	15	34

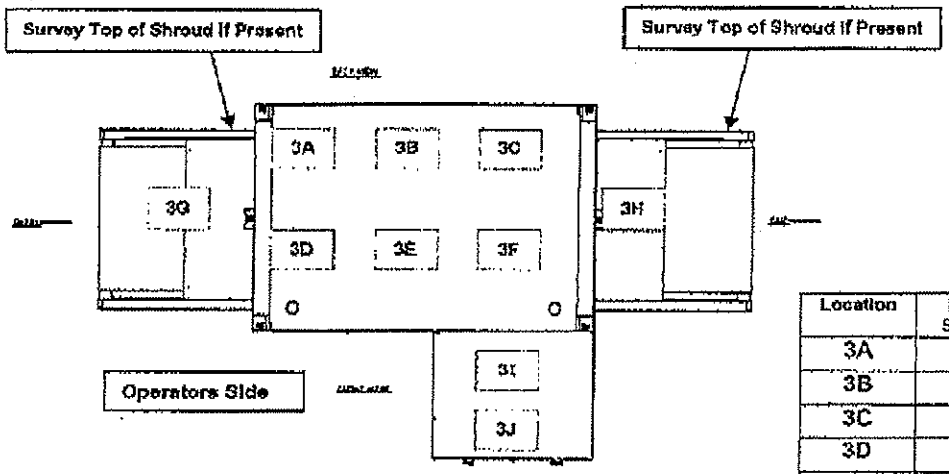
Top View

Location	Results NO Scatter Body	Results WITH Scatter Body
3A	8	5
3B	6	18
3C	7	9
3D	7	8
3E	2	3
3F	4	10
3G	58	92
3H	8	33
3I	8	44
3J	14	31

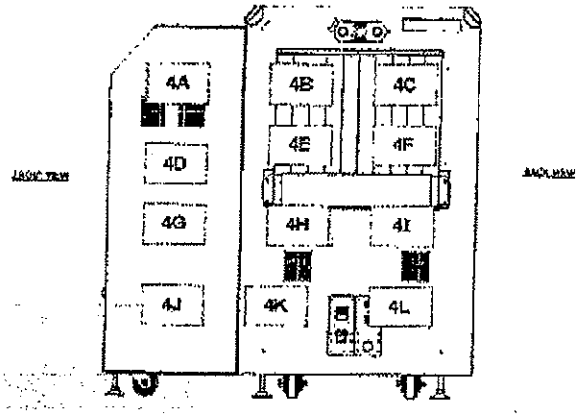
EXIT TUNNEL

Location	Results NO Scatter Body	Results WITH Scatter Body
4A	11	15
4B	17	31
4C	25	43
4D	8	9
4E	20	23
4F	42	30
4G	7	8
4H	12	9
4I	9	8
4J	5	5
4K	9	4
4L	6	5

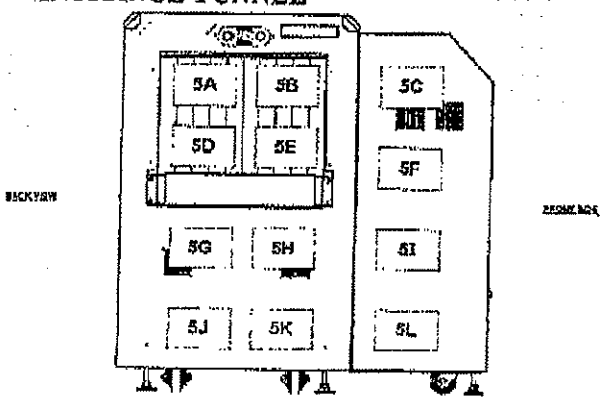
ENTRANCE TUNNEL

Location	Results NO Scatter Body	Results WITH Scatter Body
5A	38	44
5B	35	58
5C	31	44
5D	23	37
5E	22	47
5F	21	38
5G	10	9
5H	11	9
5I	11	9
5J	7	6
5K	7	7
5L	8	5
