Rapiscan Systems	BAGGAGE/PARCEL CABINET X-RAY SYSTEM RADIATION LEAKAGE REPORT	FIELD SERVICE ENGINEERS	Form R-0588-1 9/9/09 45. RSI W.O.# 3438383 Deferred W.O.#

1. Name of Facility: HARTSFIELD JACKSON	2. Region: EAST	3. Street Address: 6000 N. TERMINAL	
4. City: ATLANTA		5. State or Province Code: GA	6. Zip Code: 30320

7. Room No. or Other Physical Location of System: MAIN # 3	[redacted]	9. Telephone Number: [redacted]	10. Fax Number
11. Manufacture Information & Certification Label Present ☑ Yes - Pass ☐ No - Fail	12. Radiation Measuring Instrument: FSE Shall Attach Copy of Calibration Certificate to This Form Model: 451P Serial No. 676 Calibration Due Date: 8-2-2011		
Manufacturer: Rapiscan Systems Inc.	13. System Model No. 620DV	14. Single Source ☐ Dual Source ☐ Other ☐, Describe:	15. System Serial No. 708 3504

Rapiscan Systems	MODEL 620DV OR 600 SERIES EQUIVALENT RADIATION LEAKAGE SURVEY FORM	MODEL 620DV FSE SURVEY FORM	FORM FSE-R-0047-62)DV-1

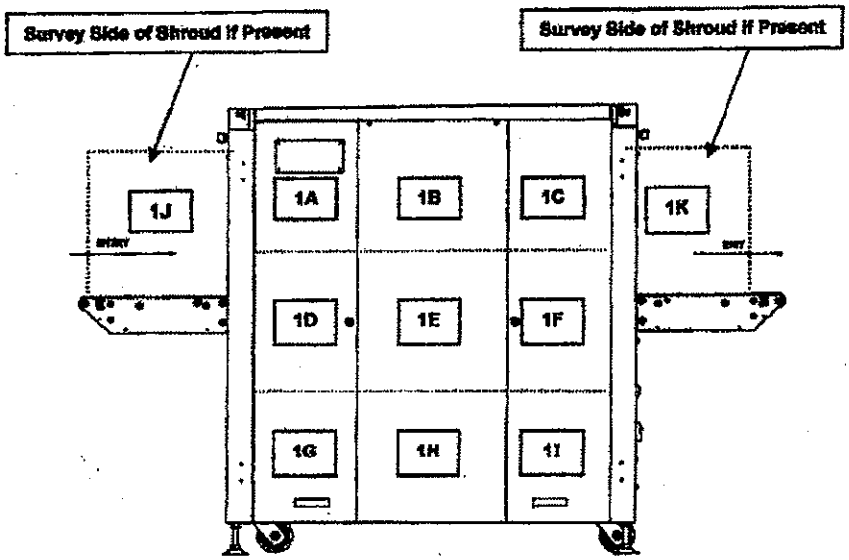
Operators Side

Location	Results NO Scatter Body	Results WITH Scatter Body
1A	20	26
1B	21	22
1C	21	30
1D	26	38
1E	28	15
1F	22	21
1G	14	7
1H	24	18
1I	15	20
1J	97	96
1K	52	44

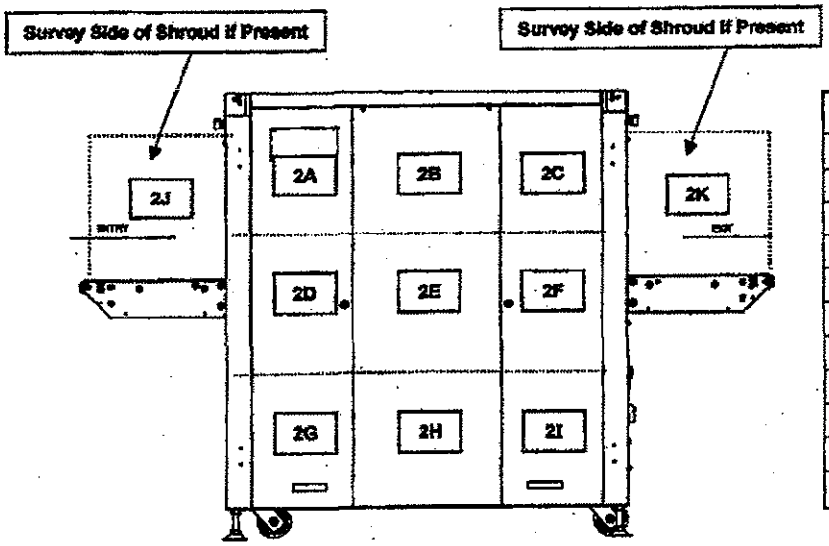
Non-Operators Side

Location	Results NO Scatter Body	Results WITH Scatte Body
2A	33	19
2B	44	15
2C	34	15
2D	23	19
2E	17	28
2F	21	41
2G	23	27
2H	16	15
2I	12	9
2J	9	56
2K	33	48

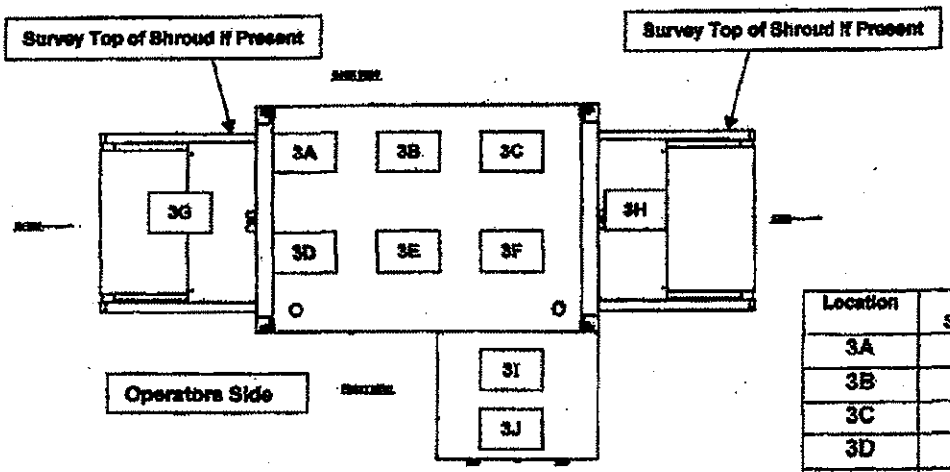
Top View

Location	Results NO Scatter Body	Results WITH Scatte Body
3A	57	55
3B	62	32
3C	47	14
3D	26	5
3E	12	6
3F	11	9
3G	14	57
3H	14	72
3I	29	21
3J	39	15

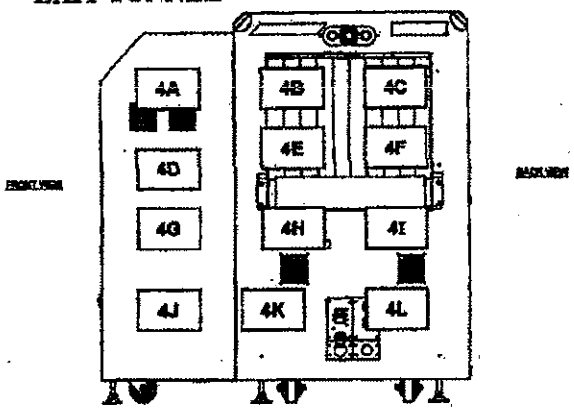
EXIT TUNNEL

Location	Results NO Scatter Body	Results WITH Scatter Body
4A	41	43
4B	29	45
4C	40	32
4D	47	49
4E	44	83
4F	30	15
4G	42	42
4H	46	38
4I	46	15
4J	39	27
4K	11	33
4L	57	12

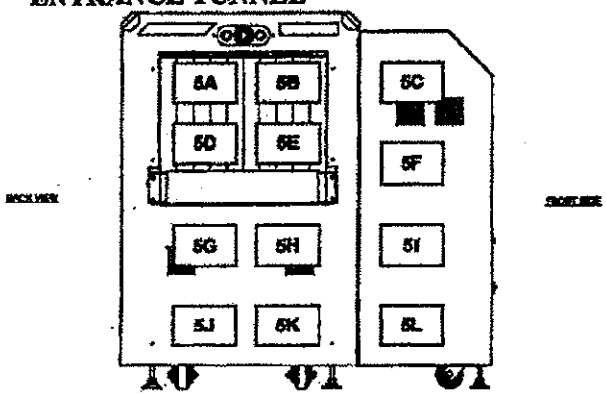
ENTRANCE TUNNEL

Location	Results NO Scatter Body	Results WITH Scatter Body
5A	7	61
5B	39	67
5C	62	34
5D	13	14
5E	25	57
5F	51	28
5G	30	6
5H	26	42
5I	26	22
5J	23	23
5K	21	28
5L	24	21
