Rapiscan Systems	BAGGAGE/PARCEL CABINET X-RAY SYSTEM RADIATION LEAKAGE REPORT	FIELD SERVICE ENGINEERS	Form R-0588-3 9/9/09 45. RSI W.O.# 3394182 Deferred W.O.#

1. Name of Facility: JFK INTERNATIONAL AIRPORT	2. Region: NEW YORK	3. Street Address: TERMINAL 7 C/P LN Y	
4. City: JAMAICA		5. State or Province Code: NY	6. Zip Code: 11430

Rapiscan systems	MODEL 620DV OR 500 SERIES EQUIVALENT RADIATION LEAKAGE SURVEY FORM	MODEL 620DV FSE SURVEY FORM	FORM FSE-R-0047-620DV-1

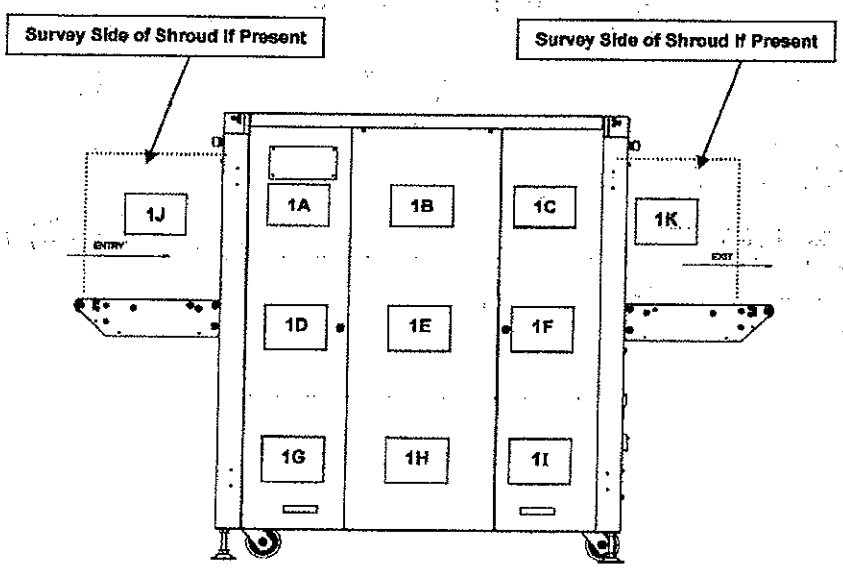
Operators Side

Location	Results NO Scatter Body	Results WITH Scatter Body
1A	6	8
1B	5	10
1C	3	12
1D	7	14
1E	8	22
1F	6	28
1G	4	8
1H	2	10
1I	3	9
1J	13	24
1K	16	18

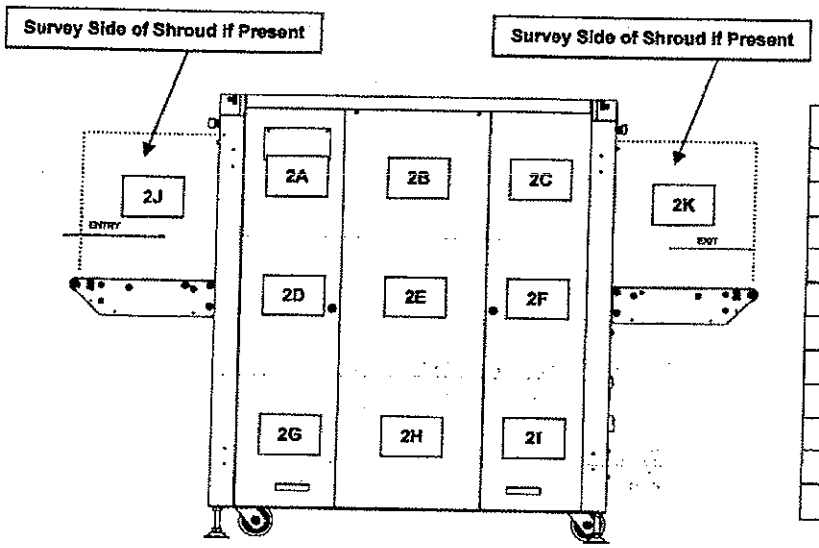
Non-Operators Side

Location	Results NO Scatter Body	Results WITH Scatter Body
2A	14	27
2B	16	26
2C	13	23
2D	19	19
2E	13	20
2F	15	18
2G	14	18
2H	13	16
2I	10	13
2J	11	16
2K	18	12

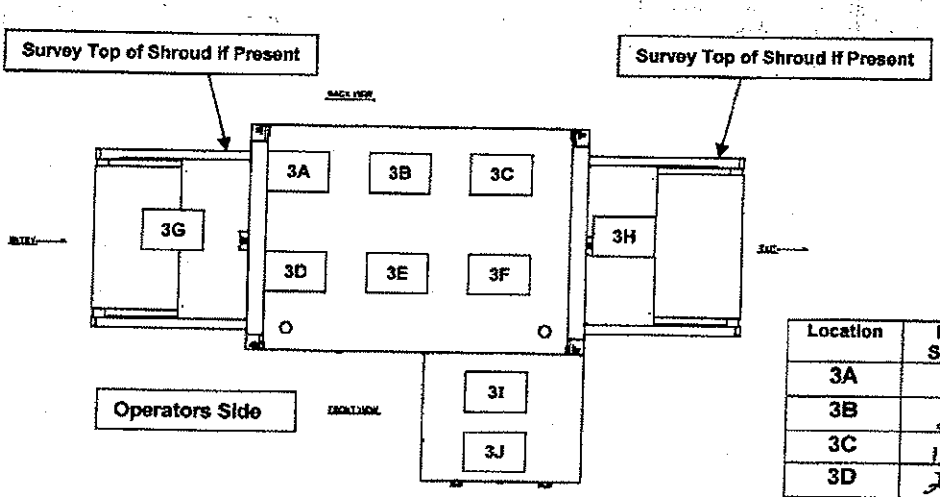
Top View

Location	Results NO Scatter Body	Results WITH Scatter Body
3A	18	21
3B	23	25
3C	17	14
3D	20	14
3E	16	18
3F	13	17
3G	20	29
3H	38	37
3I	39	36
3J	41	29

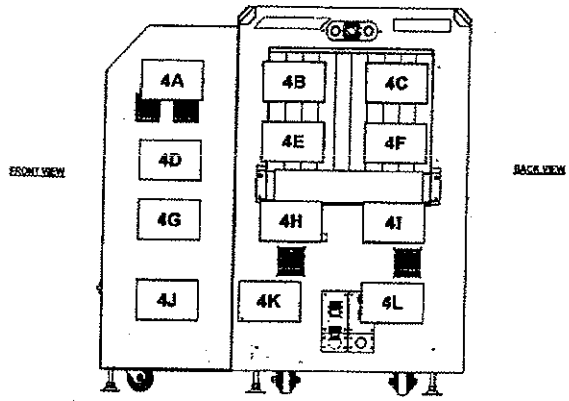
EXIT TUNNEL

Location	Results NO Scatter Body	Results WITH Scatter Body
4A	19	27
4B	33	63
4C	37	62
4D	23	28
4E	31	64
4F	35	93
4G	28	26
4H	19	15
4I	17	19
4J	22	15
4K	13	18
4L	8	10

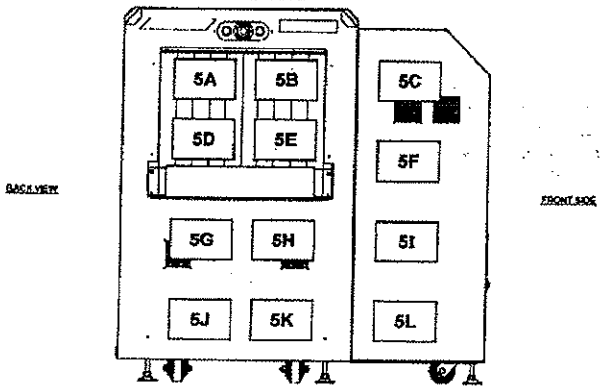
ENTRANCE TUNNEL

Location	Results NO Scatter Body	Results WITH Scatter Body
5A	30	78
5B	33	49
5C	18	9
5D	41	60
5E	35	68
5F	24	22
5G	21	23
5H	17	21
5I	6	14
5J	11	29
5K	18	18
5L	12	17
