Rapiscan systems	Secure 1000 Radiation Emission Measurement	FORM R-XXXX-DV

Re: Rapiscan AIT System Radiation Survey Reporting

R-0646-1 Addendum
(Documentation Errors)

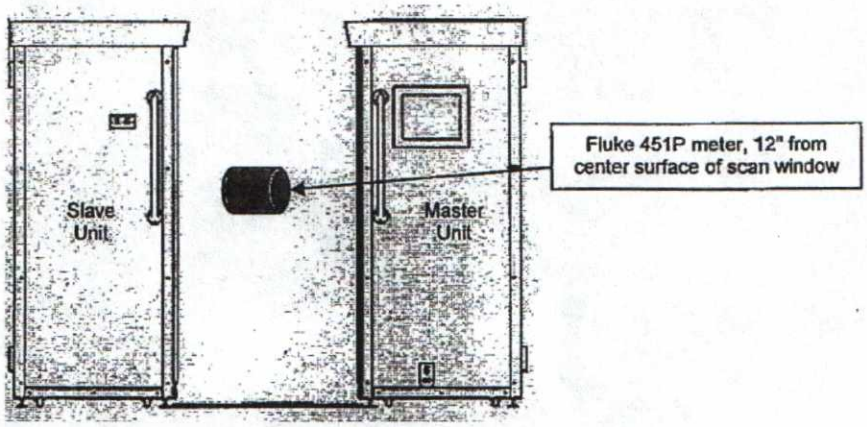
1. In Beam Dose Measurement: Survey Table. 1

Measurement Location	Measurement Height (in)	# of scan	Measured Exposure (µR) divide by 10	Fluke 451P Correction Factor[1]	Effective Dose Rem/R conversion factor (frontal)[2]	Effective Dose (µRem)
12"" from center of the scan window (Master Unit)	36	10	35 3.5	2.5	0.23	2.01
12"" from center of the scan window (Slave Unit)	36	10	38 3.8	2.5	0.23	2.18

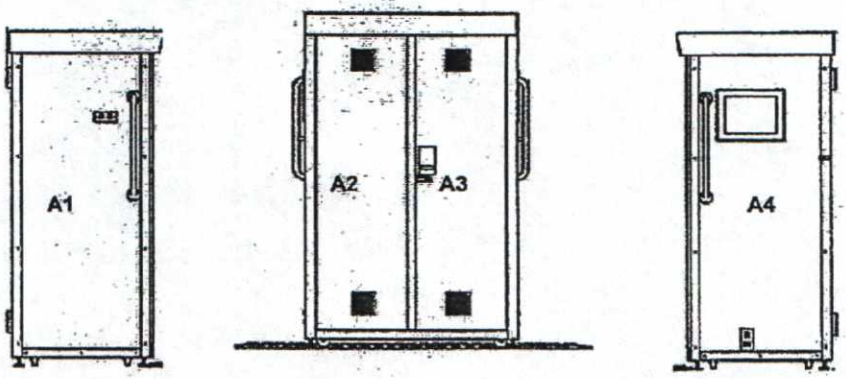
Master Unit

Measurement Location (center of the active unit external surface)	Measurement Height (in)	# of scan	Measured Exposure (µR)	Fluke 451P Correction Factor[1]	Rem/R conversion factor (dose equivalent)[3]	Dose Equivalent (H*10), (µRem)
A1	36	10	0	2.5	0.72	0
A2	36	10	0	2.5	0.72	0
A3	36	10	0	2.5	0.72	0
A4	36	10	0	2.5	0.72	0

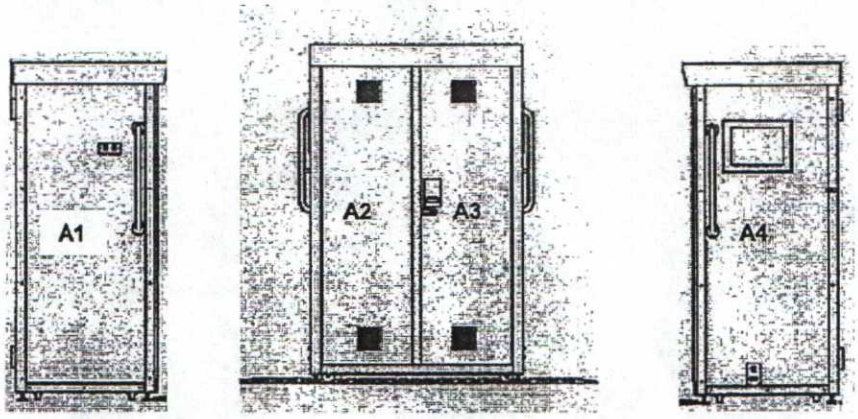
Slave Unit

Measurement Location (center of the active unit external surface)	Measurement Height (in)	# of scan	Measured Exposure (µR)	Fluke 451P Correction Factor[1]	Rem/R conversion factor (dose equivalent)[3]	Dose Equivalent (H*10), (µRem)
A1	36	10	0	2.5	0.72	0
A2	36	10	0	2.5	0.72	0
A3	36	10	0	2.5	0.72	0
A4	36	10	0	2.5	0.72	0

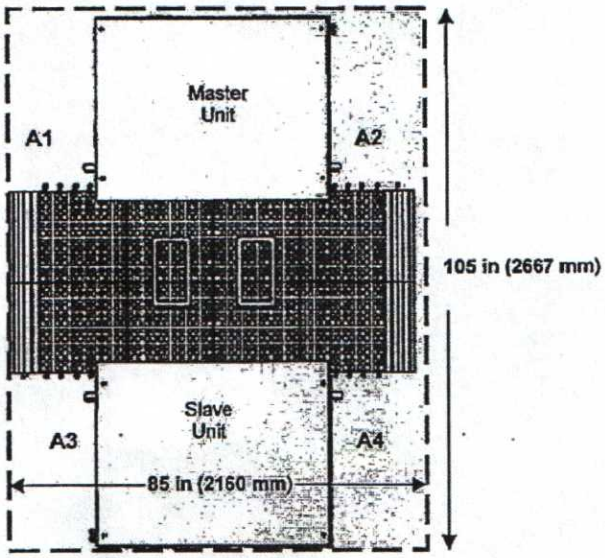
3. Inspection Zone Boundary Radiation Measurement: Survey Table. 3

Measurement Location	Measurement Height (in)	# of scan	Measured Exposure (µR)	Fluke 451P Correction Factor[1]	Rem/R conversion factor (dose equivalent)[3]	Dose Equivalent (H*10), (µRem)
A1 (12" from edge of the master unit scan window)	36	10	0	2.5	0.72	0
A2 (12" from edge of the master unit scan window)	36	10	0	2.5	0.72	0
A3 (12" from edge of the slave unit scan window)	36	10	0	2.5	0.72	0
A4 (12" from edge of the slave unit scan window)	36	10	0	2.5	0.72	0

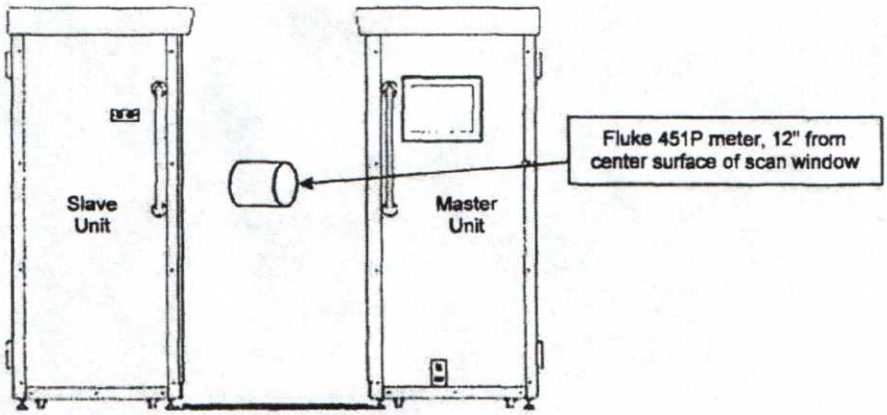
1. In Beam Dose Measurement: Survey Table. 1

Measurement Location	Measurement Height (in)	# of scan	Measured Exposure (µR) divide by 10	Fluke 451P Correction Factor[1]	Effective Dose Rem/R conversion factor (frontal)[2]	Effective Dose (µRem)
12"' from center of the scan window (Master Unit)	36	10	37	2.5	0.23	2.1275
12"' from center of the scan window (Slave Unit)	36	10	39	2.5	0.23	2.2425

4. TABLE 1: Incorrect presentation of data in Column 3 for Measured Exposure. Indicated values are 37uR and 39uR. Corrected values are 3.7uR and 3.9uR. The values were corrected by technician when calculating Effective Dose.

The service technician should attend refresher training.

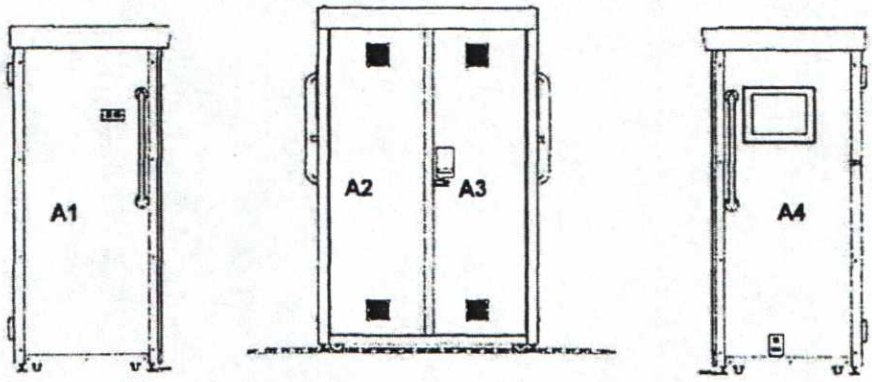
Master Unit

Measurement Location (center of the active unit external surface)	Measurement Height (in)	# of scan	Measured Exposure (µR)	Fluke 451P Correction Factor[1]	Rem/R conversion factor (dose equivalent)[3]	Dose Equivalent (H*10), (µRem)
A1	36	10	0	2.5	0.72	0
A2	36	10	0	2.5	0.72	0
A3	36	10	0	2.5	0.72	0
A4	36	10	0	2.5	0.72	0

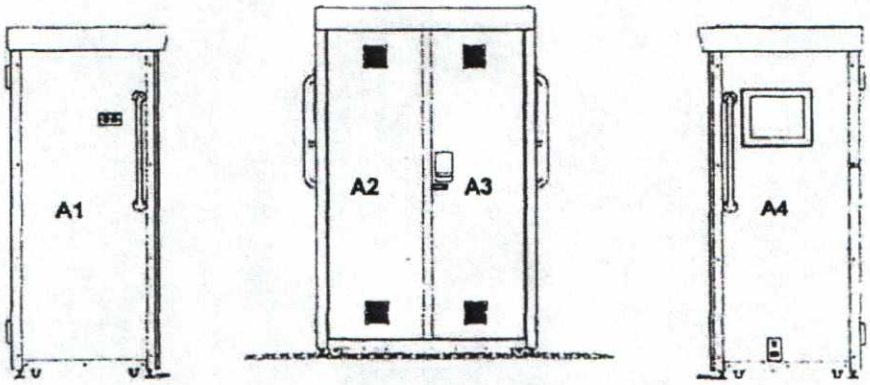
Slave Unit

Measurement Location (center of the active unit external surface)	Measurement Height (in)	# of scan	Measured Exposure (µR)	Fluke 451P Correction Factor[1]	Rem/R conversion factor (dose equivalent)[3]	Dose Equivalent (H*10), (µRem)
A1	36	10	0	2.5	0.72	0
A2	36	10	0	2.5	0.72	0
A3	36	10	0	2.5	0.72	0
A4	36	10	0	2.5	0.72	0

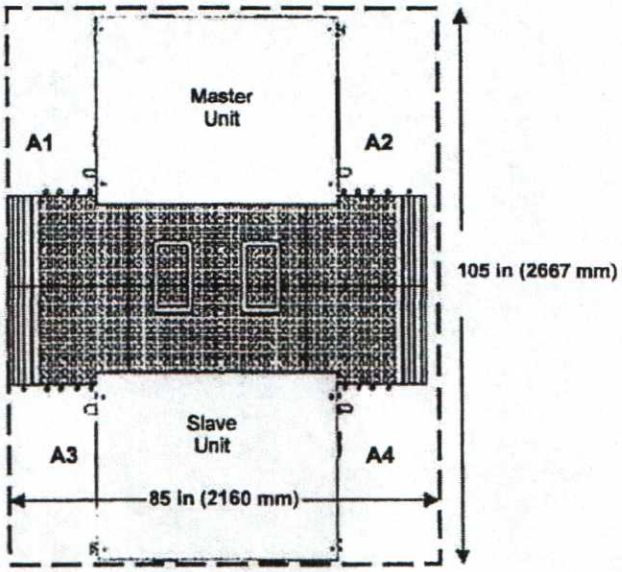
3. Inspection Zone Boundary Radiation Measurement: Survey Table. 3

Measurement Location	Measurement Height (in)	# of scan	Measured Exposure (µR)	Fluke 451P Correction Factor[1]	Rem/R conversion factor (dose equivalent)[3]	Dose Equivalent (H*10), (µRem)
A1 (12" from edge of the master unit scan window)	36	10	0	2.5	0.72	0
A2 (12" from edge of the master unit scan window)	36	10	0	2.5	0.72	0
A3 (12" from edge of the slave unit scan window)	36	10	0	2.5	0.72	0
A4 (12" from edge of the slave unit scan window)	36	10	0	2.5	0.72	0
