Rapiscan systems	Secure 1000 Radiation Emission Measurement	FORM R-XXXX-DV

Re: Rapiscan AIT System Radiation Survey Reporting

Rapiscan Systems	Secure 1000 Radiation Emission Measurement	FORM R-0646-1 (Single Pose)

R-0646-1 Addendum
(Documentation Errors)

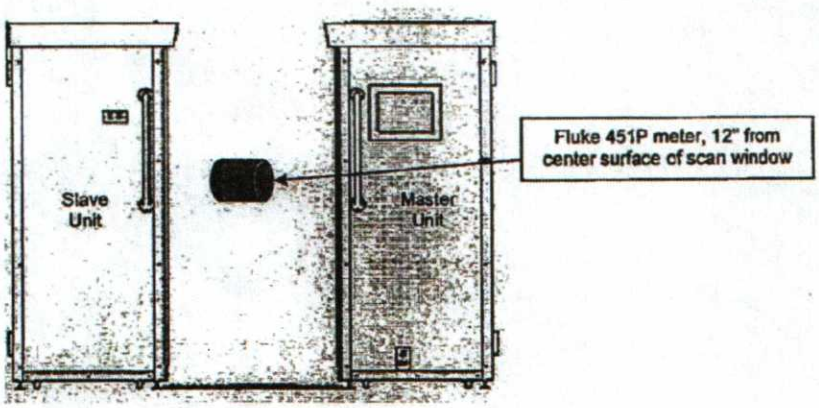
Measurement Location	Measurement Height (in)	# of scan	Measured Exposure (µR) divide by 10	Fluke 451P Correction Factor[1]	Effective Dose Rem/R conversion factor (frontal)[2]	Effective Dose (µRem)
12"' from center of the scan window (Master Unit)	36	10	28	2.5	0.23	2.18
12"' from center of the scan window (Slave Unit)	36	10	29	2.5	0.23	1.66

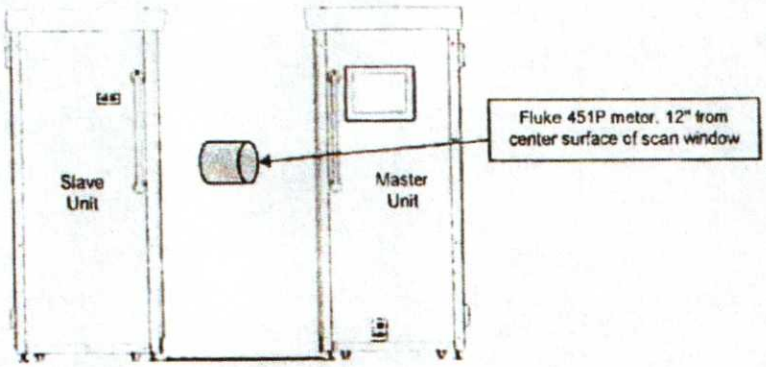
Side View

4. TABLE 1: Incorrect presentation of data in Column 3 for Measured Exposure. Indicated values are 31uR and 32uR. Corrected values are 3.1uR and 3.2uR. The values were corrected by technician when calculating Effective Dose.

The service technician should attend refresher training.
