Rapiscan Systems	Secure 1000 Radiation Emission Measurement	FORM R-XXXX-DV

Re: Rapiscan AIT System Radiation Survey Reporting

Rapiscan Systems	Secure 1000 Radiation Emission Measurement	FORM R-0646-1 (Single Pose)

R-0646-1 Addendum
(Documentation Errors)

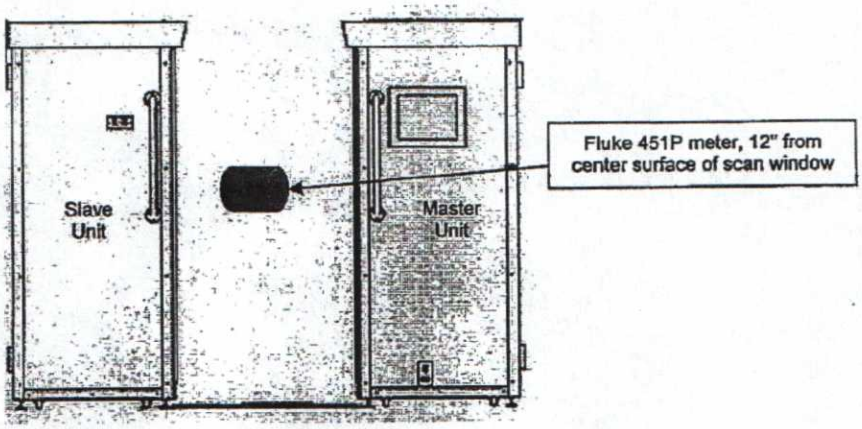
1. In Beam Dose Measurement: Survey Table. 1

Measurement Location	Measurement Height (in)	# of scan	Measured Exposure (µR) divide by 10	Fluke 451P Correction Factor[1]	Effective Dose Rem/R conversion factor (frontal)[2]	Effective Dose (µRem)
12"' from center of the scan window (Master Unit)	36	10	29 2.9	2.5	0.23	1.66
12"' from center of the scan window (Slave Unit)	36	10	38 3.8	2.5	0.23	2.185

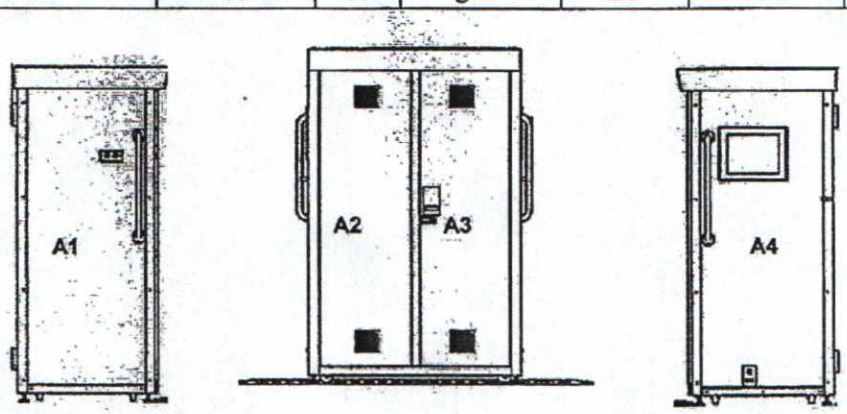
Master Unit

Measurement Location (center of the active unit external surface)	Measurement Height (in)	# of scan	Measured Exposure (µR)	Fluke 451P Correction Factor[1]	Rem/R conversion factor (dose equivalent)[3]	Dose Equivalent (H*10), (µRem)
A1	36	10	0	2.5	0.72	0
A2	36	10	0	2.5	0.72	0
A3	36	10	0	2.5	0.72	0
A4	36	10	0	2.5	0.72	0

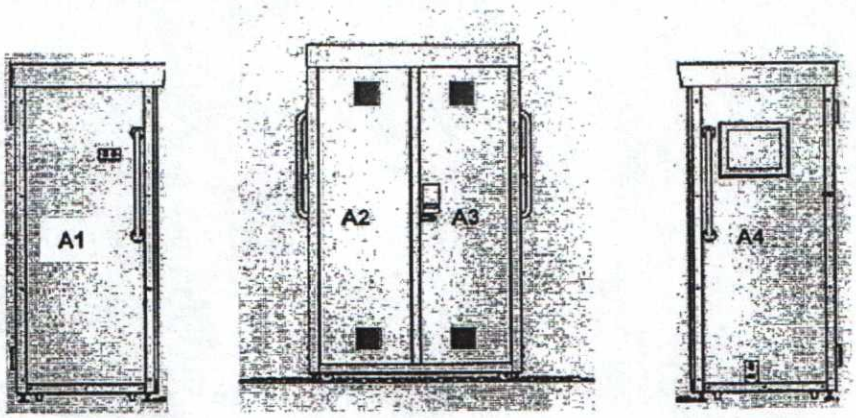
Slave Unit

Measurement Location (center of the active unit external surface)	Measurement Height (in)	# of scan	Measured Exposure (µR)	Fluke 451P Correction Factor[1]	Rem/R conversion factor (dose equivalent)[3]	Dose Equivalent (H*10), (µRem)
A1	36	10	0	2.5	0.72	0
A2	36	10	0	2.5	0.72	0
A3	36	10	0	2.5	0.72	0
A4	36	10	0	2.5	0.72	0

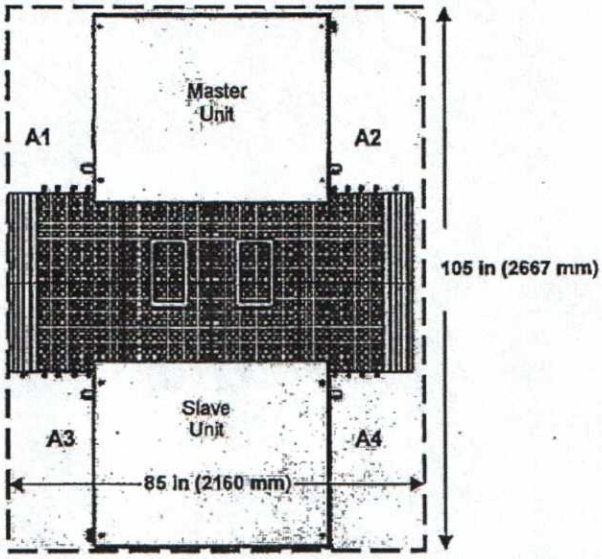
3. Inspection Zone Boundary Radiation Measurement: Survey Table. 3

Measurement Location	Measurement Height (in)	# of scan	Measured Exposure (µR)	Fluke 451P Correction Factor[1]	Rem/R conversion factor (dose equivalent)[3]	Dose Equivalent (H*10), (µRem)
A1 (12" from edge of the master unit scan window)	36	10	0	2.5	0.72	0
A2 (12" from edge of the master unit scan window)	36	10	1.0	2.5	0.72	.18
A3 (12" from edge of the slave unit scan window)	36	10	0	2.5	0.72	0
A4 (12" from edge of the slave unit scan window)	36	10	0	2.5	0.72	0

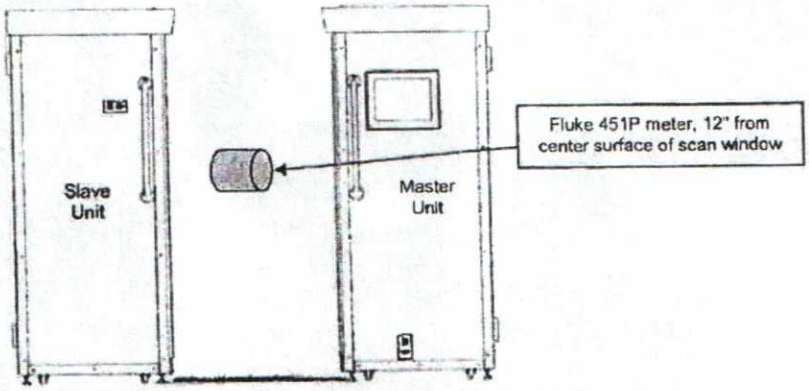
1. **In Beam Dose Measurement: Survey Table. 1**

Measurement Location	Measurement Height (in)	# of scan	Measured Exposure µR (µSv) divide by 10	Fluke 451P Correction Factor[1]	Effective Dose Rem/R conversion factor (frontal)[2]	Effective Dose µRem(µSv)
12'" from center of the scan window (Master Unit)	36	10	34	2.5	0.23	1.96
12'" from center of the scan window (Slave Unit)	36	10	31	2.5	0.23	1.78

1. Low value indicated for background radiation. Typical values range from 7uRem/hr to 13uRem/hr at sea level. Note: Low value has no adverse impact on calculations.
2. Technician indicated scan time as 7 seconds. Correct scan time is 3 seconds.
3. TABLE 1: Incorrect presentation of data in Column 3 for Measured Exposure. Indicated values are 34uR and 31uR. Corrected values are 3.4uR and 3.1uR. The values were corrected by technician when calculating Effective Dose.

The service technician should attend refresher training.

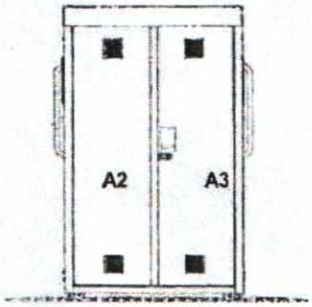
Master Unit (with monitor screen)

Measurement Location (center of the active unit external surface)	Measurement Height (in)	# of scan	Measured Exposure µR (µSv)	Fluke 451P Correction Factor[1]	Rem/R conversion factor (dose equivalent)[2]	Dose Equivalent (H*10), µRem(µSv)
A1	36	10	0	2.5	0.72	0
A2	36	10	0	2.5	0.72	0
A3	36	10	0	2.5	0.72	0
A4	36	10	1	2.5	0.72	0.18

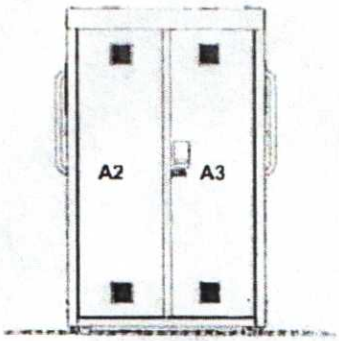
Slave Unit

Measurement Location (center of the active unit external surface)	Measurement Height (in)	# of scan	Measured Exposure µR (µSv)	Fluke 451P Correction Factor[1]	Rem/R conversion factor (dose equivalent)[2]	Dose Equivalent (H*10), µRem(µSv)
A1	36	10	0	2.5	0.72	0
A2	36	10	0	2.5	0.72	0
A3	36	10	1	2.5	0.72	0.18
A4	36	10	0	2.5	0.72	0

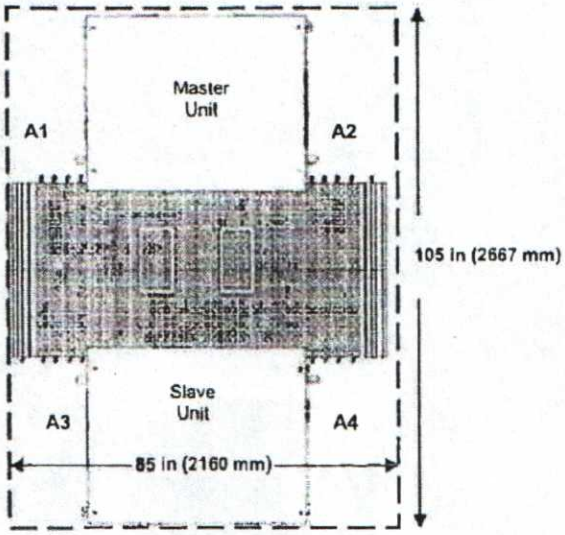
3. Inspection Zone Boundary Radiation Measurement: Survey Table. 3

Measurement Location	Measurement Height (in)	# of scan	Measured Exposure µR (µSv)	Fluke 451P Correction Factor[1]	Rem/R conversion factor (dose equivalent)[3]	Dose Equivalent (H*10), µRem(µSv)
A1 (12" from edge of the master unit scan window)	36	10	Ø	2.5	0.72	Ø
A2 (12" from edge of the master unit scan window)	36	10	1	2.5	0.72	0.18
A3 (12" from edge of the slave unit scan window)	36	10	Ø	2.5	0.72	Ø
A4 (12" from edge of the slave unit scan window)	36	10	1	2.5	0.72	0.18
