Rapiscan Systems	Secure 1000 Radiation Emission Measurement	FORM R-XXXX-DV

Re: Rapiscan AIT System Radiation Survey Reporting

Rapiscan systems	Secure 1000 Radiation Emission Measurement	FORM R-0646-1 (Single Pose)

R-0646-1 Addendum
(Documentation Errors)

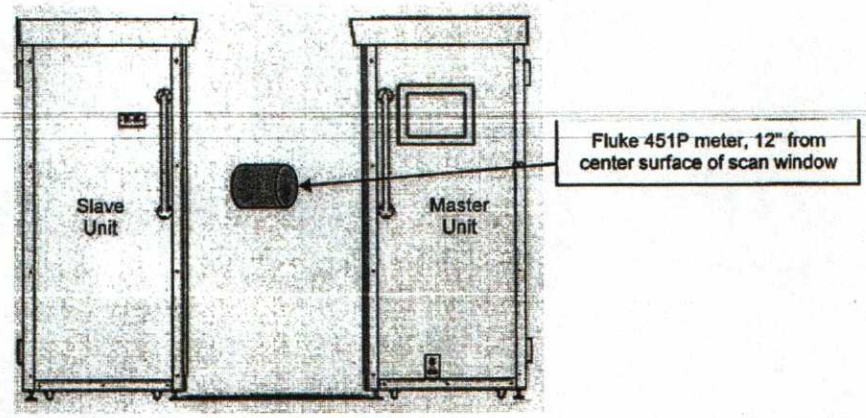
Measurement Location	Measurement Height (in)	# of scan	Measured Exposure (µR) divide by 10	Fluke 451P Correction Factor[1]	Effective Dose Rem/R conversion factor (frontal)[2]	Effective Dose (µRem)
12"' from center of the scan window (Master Unit)	36	10	~~20~~ 2.0	2.5	0.23	1.15
12"' from center of the scan window (Slave Unit)	36	10	~~22~~ 2.2	2.5	0.23	1.26

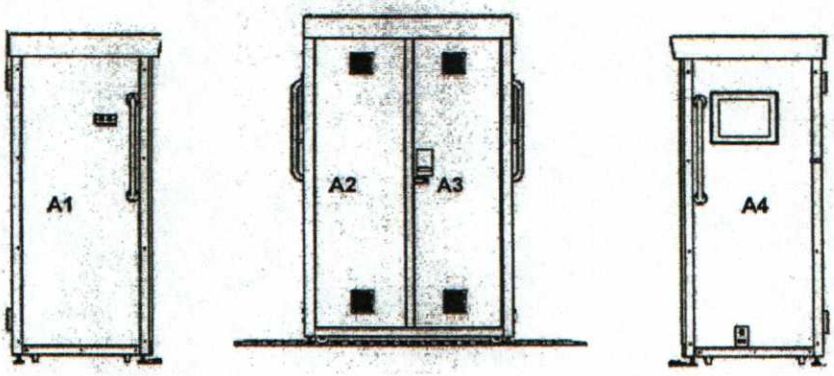
Master Unit

Measurement Location (center of the active unit external surface)	Measurement Height (in)	# of scan	Measured Exposure (µR)	Fluke 451P Correction Factor[1]	Rem/R conversion factor (dose equivalent)[3]	Dose Equivalent (H*10), (µRem)
A1	36	10	0	2.5	0.72	0
A2	36	10	0	2.5	0.72	0
A3	36	10	0	2.5	0.72	0
A4	36	10	0	2.5	0.72	0

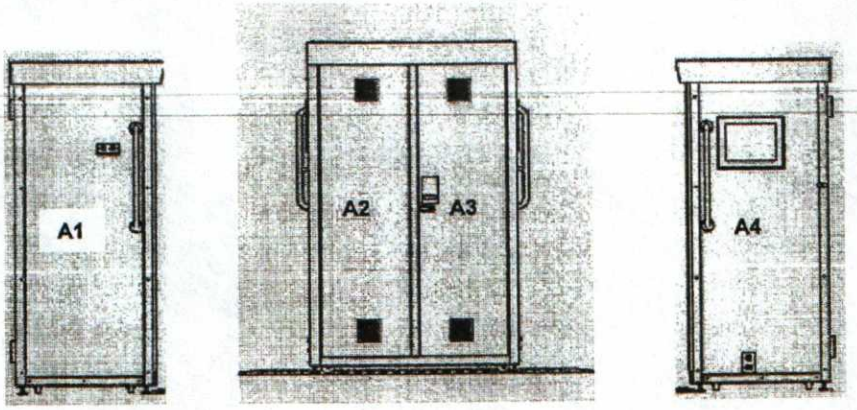
Slave Unit

Measurement Location (center of the active unit external surface)	Measurement Height (in)	# of scan	Measured Exposure (µR)	Fluke 451P Correction Factor[1]	Rem/R conversion factor (dose equivalent)[3]	Dose Equivalent (H*10), (µRem)
A1	36	10	0	2.5	0.72	0
A2	36	10	0	2.5	0.72	0
A3	36	10	0	2.5	0.72	0
A4	36	10	0	2.5	0.72	0

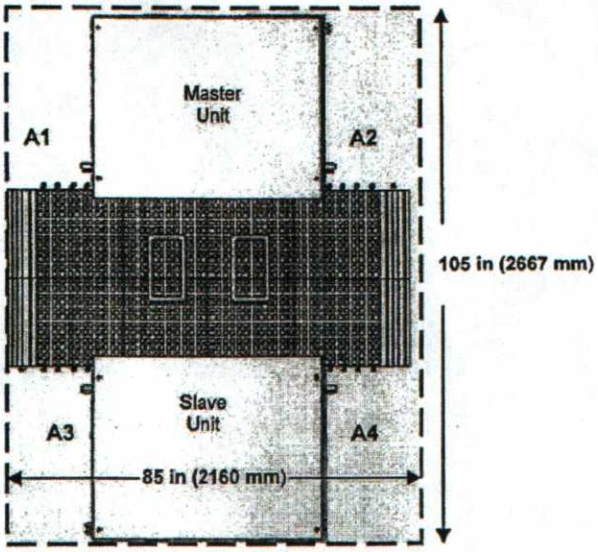
Measurement Location	Measurement Height (in)	# of scan	Measured Exposure (µR)	Fluke 451P Correction Factor[1]	Rem/R conversion factor (dose equivalent)[3]	Dose Equivalent (H*10), (µRem)
A1 (12" from edge of the master unit scan window)	36	10	0	2.5	0.72	0
A2 (12" from edge of the master unit scan window)	36	10	0	2.5	0.72	0
A3 (12" from edge of the slave unit scan window)	36	10	0	2.5	0.72	0
A4 (12" from edge of the slave unit scan window)	36	10	1.1	2.5	0.72	1.8

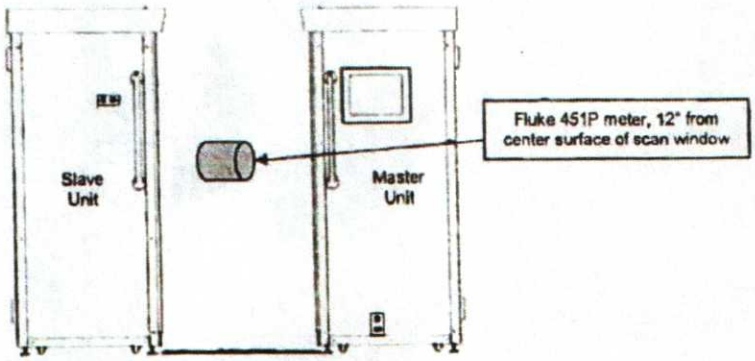
Measurement Location	Measurement Height (in)	# of scan	Measured Exposure µR (µSv) divide by 10	Fluke 451P Correction Factor[1]	Effective Dose Rem/R conversion factor (frontal)[2]	Effective Dose µRem(µSv)
12" from center of the scan window (Master Unit)	36	10	44	2.5	0.23	2.53
12" from center of the scan window (Slave Unit)	36	10	42	2.5	0.23	2.42

3. TABLE 1: Incorrect presentation of data in Column 3 for Measured Exposure. Indicated values are 44uR and 42uR. Corrected values are 4.4uR and 4.2uR. The values were corrected by technician when calculating Effective Dose.

The service technician should attend refresher training.

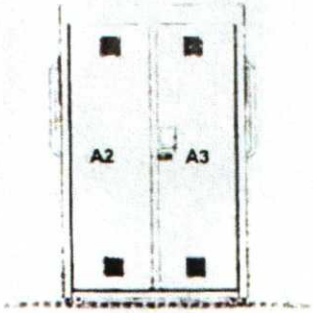
Left Side View

Measurement Location (center of the active unit external surface)	Measurement Height (in)	# of scan	Measured Exposure µR (µSv)	Fluke 451P Correction Factor[1]	Rem/R conversion factor (dose equivalent)[3]	Dose Equivalent (H*10), µRem(µSv)
A1	36	10	0	2.5	0.72	0
A2	36	10	0	2.5	0.72	0
A3	36	10	0	2.5	0.72	0
A4	36	10	0	2.5	0.72	0

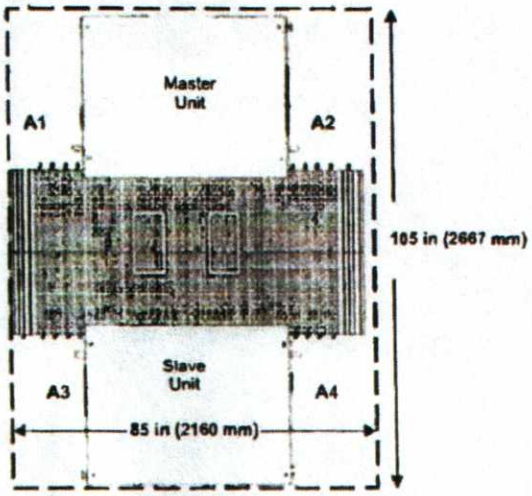
Top view

Measurement Location	Measurement Height (in)	# of scan	Measured Exposure µR (µSv)	Fluke 451P Correction Factor[1]	Rem/R conversion factor (dose equivalent)[2]	Dose Equivalent (H*10), µRem(µSv)
A1 (12" from edge of the master unit scan window)	36	10	0	2.5	0.72	0
A2 (12" from edge of the master unit scan window)	36	10	0	2.5	0.72	0
A3 (12" from edge of the slave unit scan window)	36	10	1	2.5	0.72	0.18
A4 (12" from edge of the slave unit scan window)	36	10	1	2.5	0.72	0.18
