Rapiscan Systems	Secure 1000 Radiation Emission Measurement	FORM R-XXXX-DV

Re: Rapiscan AIT System Radiation Survey Reporting

Rapiscan systems	Secure 1000 Radiation Emission Measurement	FORM R-0646-1 (Single Pose)

R-0646-1 Addendum
(Documentation Errors)

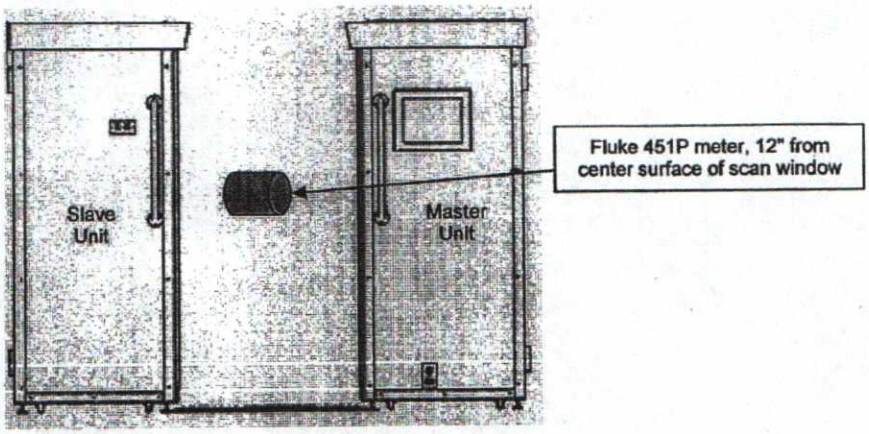
1. In Beam Dose Measurement: Survey Table. 1

Measurement Location	Measurement Height (in)	# of scan	Measured Exposure (µR) divide by 10	Fluke 451P Correction Factor[1]	Effective Dose Rem/R conversion factor (frontal)[2]	Effective Dose (µRem)
12"" from center of the scan window (Master Unit)	36	10	~~39~~ 3.9	2.5	0.23	2.24
12"" from center of the scan window (Slave Unit)	36	10	2.8	2.5	0.23	1.61

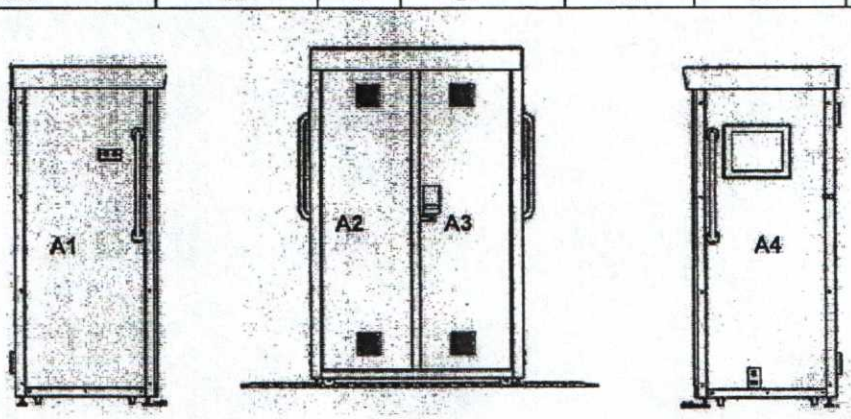
Master Unit

Measurement Location (center of the active unit external surface)	Measurement Height (in)	# of scan	Measured Exposure (µR)	Fluke 451P Correction Factor[1]	Rem/R conversion factor (dose equivalent)[3]	Dose Equivalent (H*10), (µRem)
A1	36	10	0 ~~1.2~~	2.5	0.72	0
A2	36	10	0	2.5	0.72	0
A3	36	10	0	2.5	0.72	0
A4	36	10	0	2.5	0.72	0

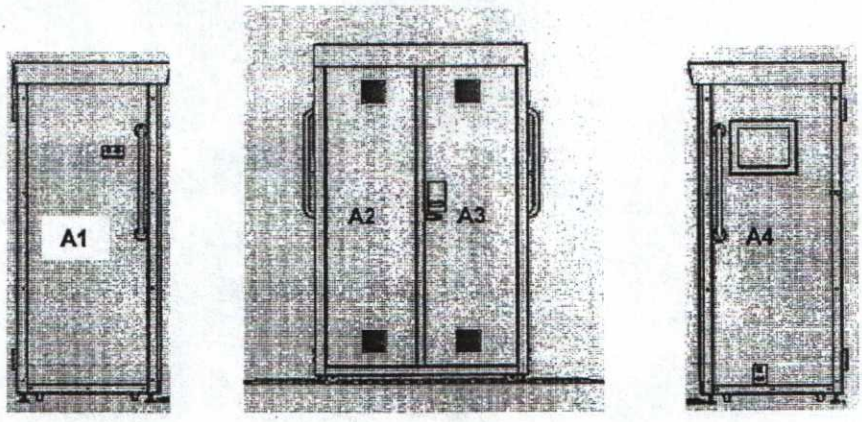
Slave Unit

Measurement Location (center of the active unit external surface)	Measurement Height (in)	# of scan	Measured Exposure (µR)	Fluke 451P Correction Factor[1]	Rem/R conversion factor (dose equivalent)[3]	Dose Equivalent (H*10), (µRem)
A1	36	10	1.0	2.5	0.72	~~0~~ 1.8
A2	36	10	0	2.5	0.72	0
A3	36	10	1.0	2.5	0.72	1.8
A4	36	10	0	2.5	0.72	0

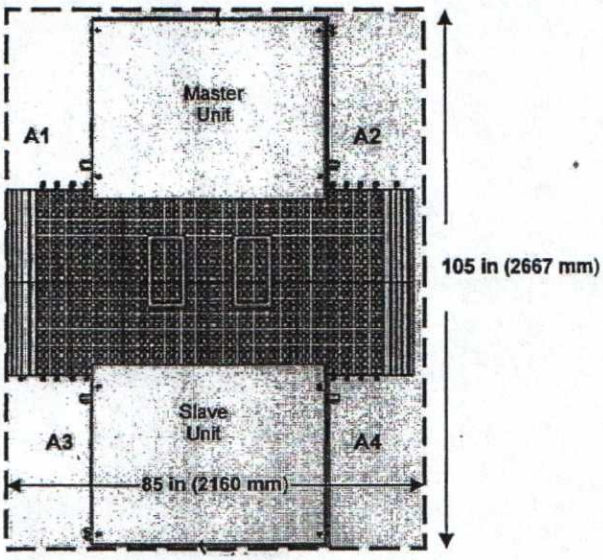
3. Inspection Zone Boundary Radiation Measurement: Survey Table. 3

Measurement Location	Measurement Height (in)	# of scan	Measured Exposure (µR)	Fluke 451P Correction Factor[1]	Rem/R conversion factor (dose equivalent)[3]	Dose Equivalent (H*10), (µRem)
A1 (12" from edge of the master unit scan window)	36	10	0	2.5	0.72	0
A2 (12" from edge of the master unit scan window)	36	10	0	2.5	0.72	0
A3 (12" from edge of the slave unit scan window)	36	10	0	2.5	0.72	0
A4 (12" from edge of the slave unit scan window)	36	10	0	2.5	0.72	0

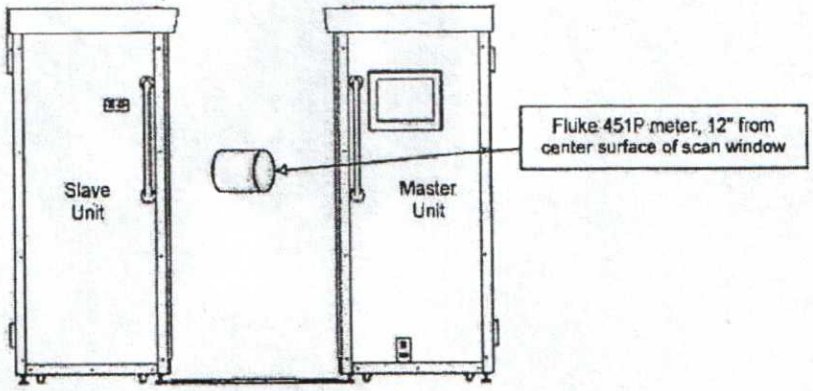
1. In Beam Dose Measurement: Survey Table. 1

Measurement Location	Measurement Height (in)	# of scan	Measured Exposure µR (µSv) divide by 10	Fluke 451P Correction Factor[1]	Effective Dose Rem/R conversion factor (frontal)[2]	Effective Dose µRem(µSv)
12"' from center of the scan window (Master Unit)	36	10	2.6	2.5	0.23	1.50
12"' from center of the scan window (Slave Unit)	36	10	2.2	2.5	0.23	1.27

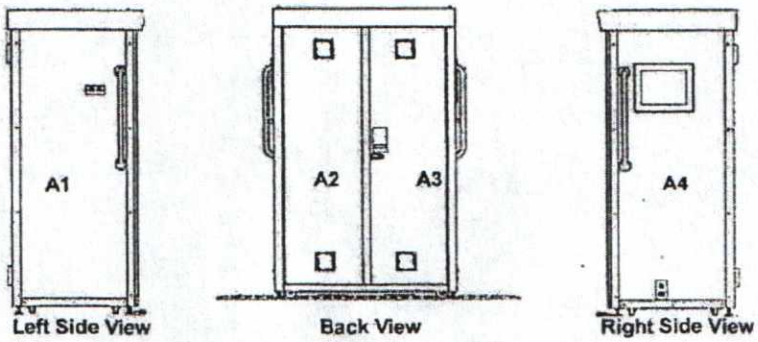
Master Unit (with monitor screen)

Measurement Location (center of the active unit external surface)	Measurement Height (in)	# of scan	Measured Exposure µR (µSv)	Fluke 451P Correction Factor[1]	Rem/R conversion factor (dose equivalent)[3]	Dose Equivalent (H*10), µRem(µSv)
A1	36	10	Ø	2.5	0.72	Ø
A2	36	10	Ø	2.5	0.72	Ø
A3	36	10	Ø	2.5	0.72	Ø
A4	36	10	Ø	2.5	0.72	Ø

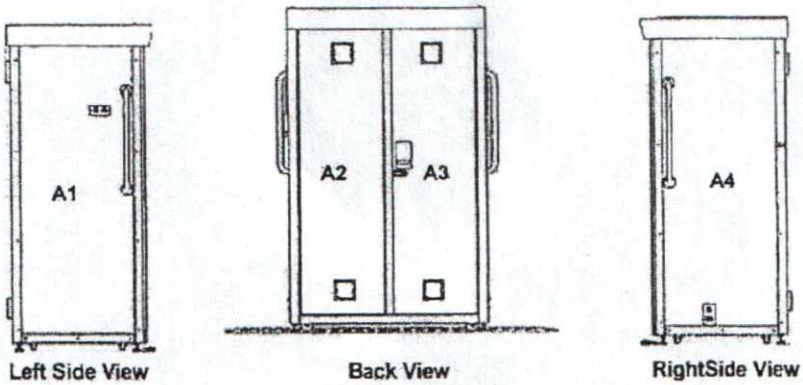
Slave Unit

Measurement Location (center of the active unit external surface)	Measurement Height (in)	# of scan	Measured Exposure µR (µSv)	Fluke 451P Correction Factor[1]	Rem/R conversion factor (dose equivalent)[3]	Dose Equivalent (H*10), µRem(µSv)
A1	36	10	Ø	2.5	0.72	Ø
A2	36	10	Ø	2.5	0.72	Ø
A3	36	10	Ø	2.5	0.72	Ø
A4	36	10	Ø	2.5	0.72	Ø

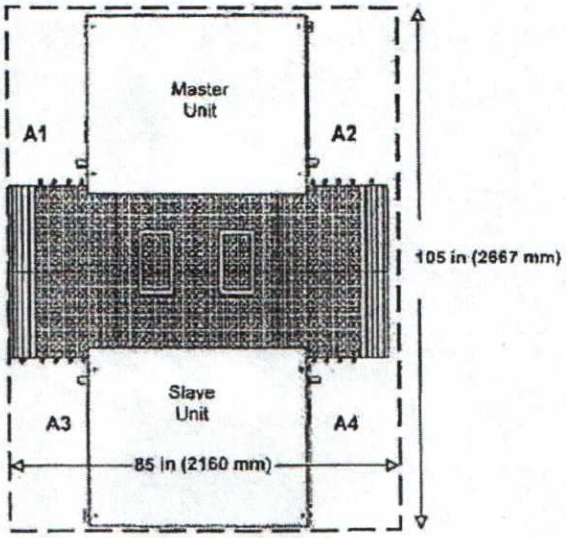
3. Inspection Zone Boundary Radiation Measurement: Survey Table. 3

Measurement Location	Measurement Height (in)	# of scan	Measured Exposure µR (µSv)	Fluke 451P Correction Factor[4]	Rem/R conversion factor (dose equivalent)[3]	Dose Equivalent (H*10), µRem(µSv)
A1 (12" from edge of the master unit scan window)	36	10	Ø	2.5	0.72	Ø
A2 (12" from edge of the master unit scan window)	36	10	Ø	2.5	0.72	Ø
A3 (12" from edge of the slave unit scan window)	36	10	Ø	2.5	0.72	Ø
A4 (12" from edge of the slave unit scan window)	36	10	Ø	2.5	0.72	Ø

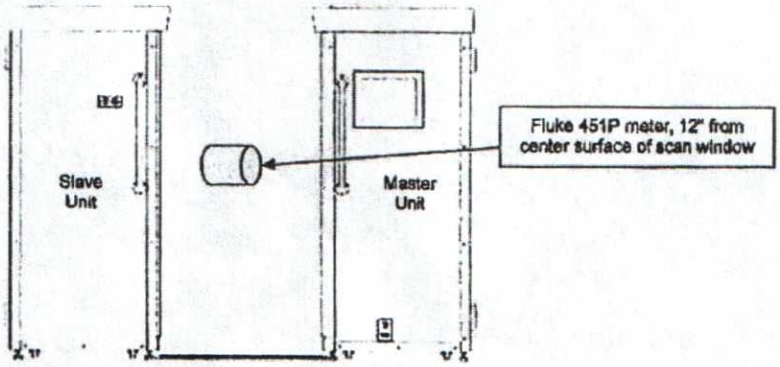
1. In Beam Dose Measurement: Survey Table. 1

Measurement Location	Measurement Height (in)	# of scan	Measured Exposure µR (µSv) divide by 10	Fluke 451P Correction Factor[1]	Effective Dose Rem/R conversion factor (frontal)[2]	Effective Dose µRem(µSv)
12" from center of the scan window (Master Unit)	36	10	1.4	2.5	0.23	.80
12" from center of the scan window (Slave Unit)	36	10	1.7	2.5	0.23	.97

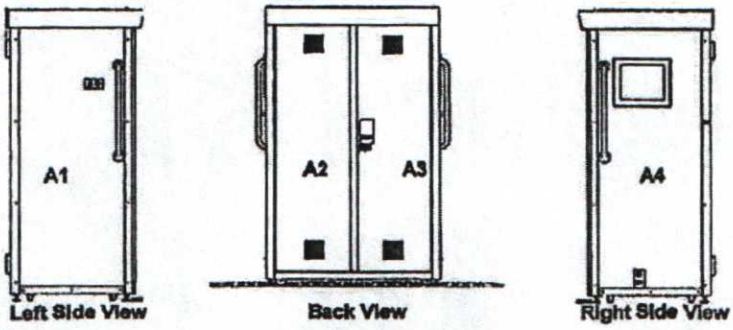
Master Unit (with monitor screen)

Measurement Location (center of the active unit external surface)	Measurement Height (in)	# of scan	Measured Exposure µR (µSv)	Fluke 451P Correction Factor[1]	Rem/R conversion factor (dose equivalent)[3]	Dose Equivalent (H*10), µRem(µSv)
A1	36	10	0	2.5	0.72	0
A2	36	10	0	2.5	0.72	0
A3	36	10	0	2.5	0.72	0
A4	36	10	0	2.5	0.72	0

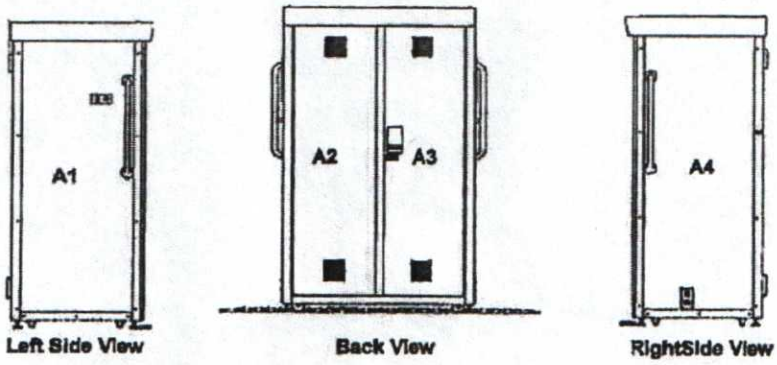
Slave Unit

Measurement Location (center of the active unit external surface)	Measurement Height (in)	# of scan	Measured Exposure µR (µSv)	Fluke 451P Correction Factor[1]	Rem/R conversion factor (dose equivalent)[3]	Dose Equivalent (H*10), µRem(µSv)
A1	36	10	0	2.5	0.72	0
A2	36	10	0	2.5	0.72	0
A3	36	10	0	2.5	0.72	0
A4	36	10	0	2.5	0.72	0

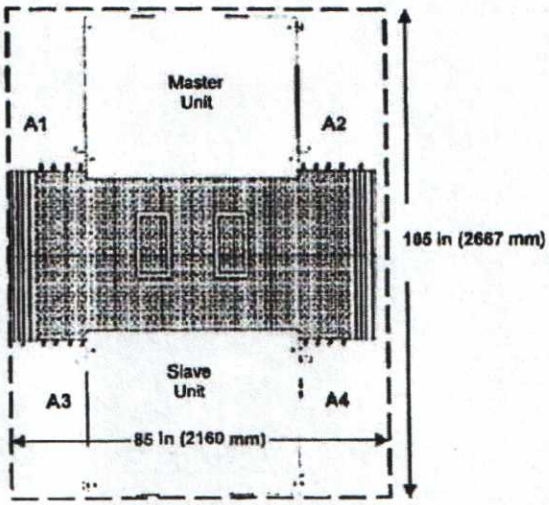
3. **Inspection Zone Boundary Radiation Measurement: Survey Table. 3**

Measurement Location	Measurement Height (in)	# of scan	Measured Exposure µR (µSv)	Fluke 451P Correction Factor[1]	Rem/R conversion factor (dose equivalent)[2]	Dose Equivalent (H*10), µRem(µSv)
A1 (12" from edge of the master unit scan window)	36	10	0	2.5	0.72	0
A2 (12" from edge of the master unit scan window)	36	10	0	2.5	0.72	0
A3 (12" from edge of the slave unit scan window)	36	10	0	2.5	0.72	0
A4 (12" from edge of the slave unit scan window)	36	10	0	2.5	0.72	0
