Rapiscan Systems	Secure 1000 Radiation Emission Measurement	FORM R-XXXX-DV

Re: Rapiscan AIT System Radiation Survey Reporting

R-0646-1 Addendum
(Documentation Errors)

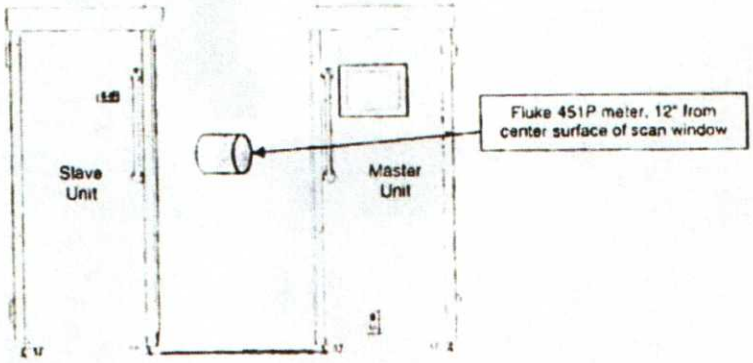
1. In Beam Dose Measurement: Survey Table. 1

Measurement Location	Measurement Height (in)	# of scan	Measured Exposure µR (µSv) divide by 10	Fluke 451P Correction Factor[1]	Effective Dose Rem/R conversion factor (frontal)[2]	Effective Dose µRem(µSv)
12" from center of the scan window (Master Unit)	36	10	36	2.5	0.23	2.07
12" from center of the scan window (Slave Unit)	36	10	24	2.5	0.23	1.38

3. TABLE 1: Incorrect presentation of data in Column 3 for Measured Exposure. Indicated values are 36uR and 24uR. Corrected values are 3.6uR and 2.4uR. The values were corrected by technician when calculating Effective Dose.

The service technician should attend refresher training.

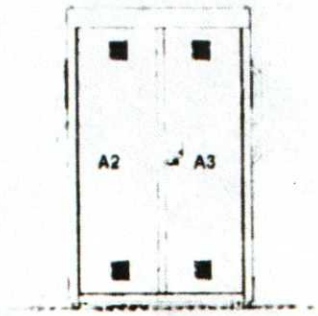
Slave Unit

Measurement Location (center of the active unit external surface)	Measurement Height (in)	# of scan	Measured Exposure µR (µSv)	Fluke 451P Correction Factor[1]	Rem/R conversion factor (dose equivalent)[3]	Dose Equivalent (H*10), µRem(µSv)
A1	36	10	1	2.5	0.72	6.48
A2	36	10	Ø	2.5	0.72	Ø
A3	36	10	Ø	2.5	0.72	Ø
A4	36	10	1	2.5	0.72	Ø

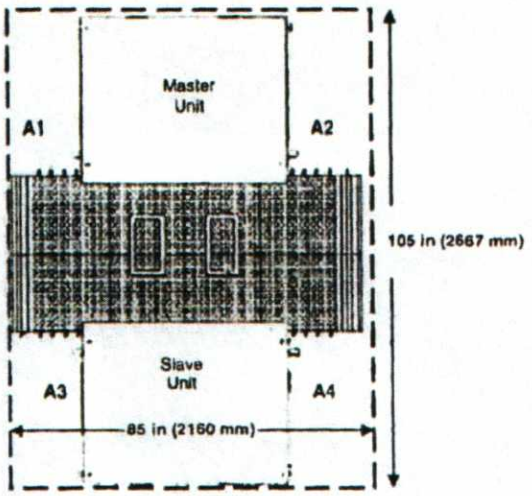
3. Inspection Zone Boundary Radiation Measurement: Survey Table. 3

Measurement Location	Measurement Height (in)	# of scan	Measured Exposure µR (µSv)	Fluke 451P Correction Factor[1]	Rem/R conversion factor (dose equivalent)[3]	Dose Equivalent (H*10), µRem(µSv)
A1 (12" from edge of the master unit scan window)	36	10	0	2.5	0.72	0
A2 (12" from edge of the master unit scan window)	36	10	1	2.5	0.72	0.18
A3 (12" from edge of the slave unit scan window)	36	10	1	2.5	0.72	0.18
A4 (12" from edge of the slave unit scan window)	36	10	0	2.5	0.72	0

4. TABLES 2 and 3: Incorrect presentation of data in Column 6 for Dose Equivalent. Indicated values are .18 uRem. The correct value should be 1.8 uRem.
