Rapiscan Systems	Secure 1000 Radiation Emission Measurement	FORM R-XXXX-DV

Re: Rapiscan AIT System Radiation Survey Reporting

Rapiscan systems	Secure 1000 Radiation Emission Measurement	FORM R-0646-1 (Single Pose)

R-0646-1 Addendum
(Documentation Errors)

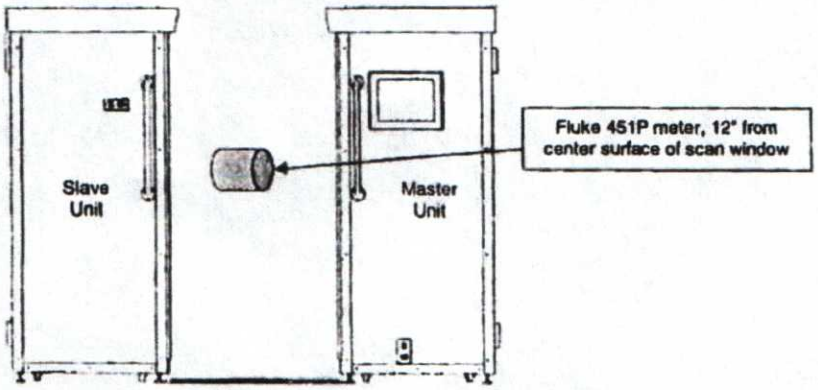
Measurement Location	Measurement Height (in)	# of scan	Measured Exposure µR (µSv) divide by 10	Fluke 451P Correction Factor[1]	Effective Dose Rem/R conversion factor (frontal)[2]	Effective Dose µRem(µSv)
12" from center of the scan window (Master Unit)	36	10	29	2.5	0.23	1.67
12" from center of the scan window (Slave Unit)	36	10	28	2.5	0.23	1.61

3. TABLE 1: Incorrect presentation of data in Column 3 for Measured Exposure. Indicated values are 29uR and 28uR. Corrected values are 2.9uR and 2.8uR. The values were corrected by technician when calculating Effective Dose.

The service technician should attend refresher training.

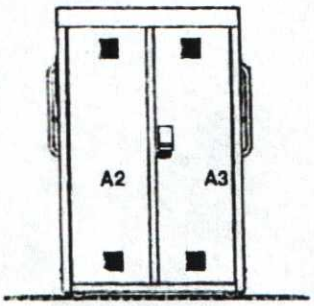
Master Unit (with monitor screen)

Measurement Location (center of the active unit external surface)	Measurement Height (in)	# of scan	Measured Exposure µR (µSv)	Fluke 451P Correction Factor[1]	Rem/R conversion factor (dose equivalent)[3]	Dose Equivalent (H*10), µRem(µSv)
A1	36	10	0	2.5	0.72	0
A2	36	10	0	2.5	0.72	0
A3	36	10	1	2.5	0.72	0.18
A4	36	10	0	2.5	0.72	0

4. TABLES 2 and 3: Incorrect presentation of data in Column 6 for Dose Equivalent. Indicated values are .18 uRem. The correct value should be 1.8 uRem.

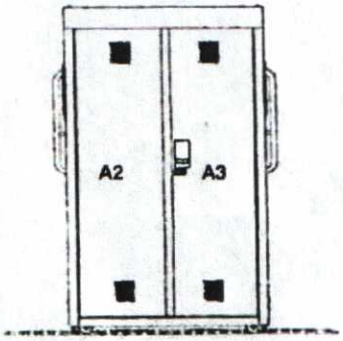
Slave Unit

Measurement Location (center of the active unit external surface)	Measurement Height (in)	# of scan	Measured Exposure µR (µSv)	Fluke 451P Correction Factor[1]	Rem/R conversion factor (dose equivalent)[3]	Dose Equivalent (H*10), µRem(µSv)
A1	36	10	0	2.5	0.72	0
A2	36	10	0	2.5	0.72	0
A3	36	10	1	2.5	0.72	0.18
A4	36	10	0	2.5	0.72	0

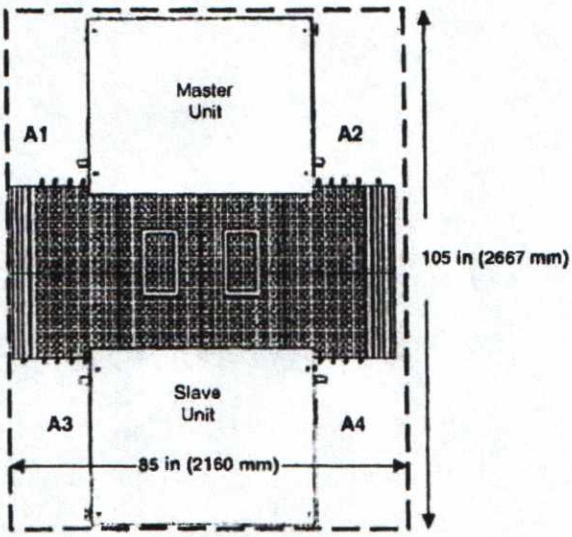
Top view

Measurement Location	Measurement Height (in)	# of scan	Measured Exposure µR (µSv)	Fluke 451P Correction Factor[1]	Rem/R conversion factor (dose equivalent)[3]	Dose Equivalent (H*10), µRem(µSv)
A1 (12" from edge of the master unit scan window)	36	10	1	2.5	0.72	0.18
A2 (12" from edge of the master unit scan window)	36	10	Ø	2.5	0.72	Ø
A3 (12" from edge of the slave unit scan window)	36	10	Ø	2.5	0.72	Ø
A4 (12" from edge of the slave unit scan window)	36	10	Ø	2.5	0.72	Ø
