Rapiscan systems	Secure 1000 Radiation Emission Measurement	FORM R-XXXX-DV

Re: Rapiscan AIT System Radiation Survey Reporting

Rapiscan Systems	Secure 1000 Radiation Emission Measurement	FORM R-0646-1 (Single Pose)

R-0646-1 Addendum
(Documentation Errors)

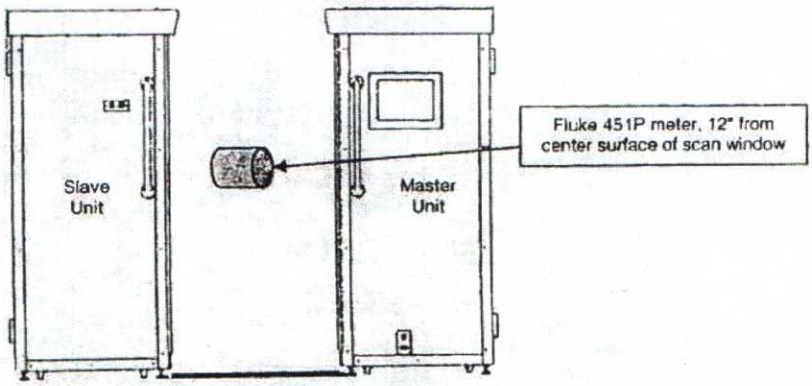
1. In Beam Dose Measurement: Survey Table. 1

3. TABLE 1: Incorrect presentation of data in Column 3 for Measured Exposure. Indicated values are 39uR and 38uR. Corrected values are 3.9uR and 3.8uR. The values were corrected by technician when calculating Effective Dose.

The service technician should attend refresher training.

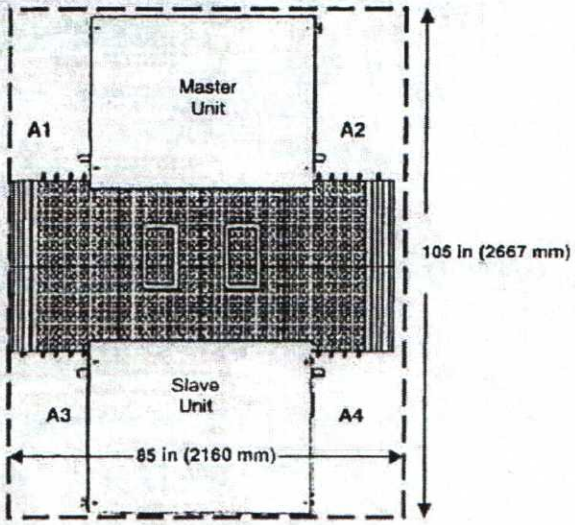
3. Inspection Zone Boundary Radiation Measurement: Survey Table. 3

4. TABLE 3: Incorrect presentation of data in Column 6 for Dose Equivalent. Indicated values are .18 uRem. The correct value should be 1.8 uRem.
