Rapiscan systems	Secure 1000 Radiation Emission Measurement	FORM R-XXXX-DV

Re: Rapiscan AIT System Radiation Survey Reporting

Rapiscan systems	Secure 1000 Radiation Emission Measurement	FORM R-0646-1 (Single Pose)

R-0646-1 Addendum
(Documentation Errors)

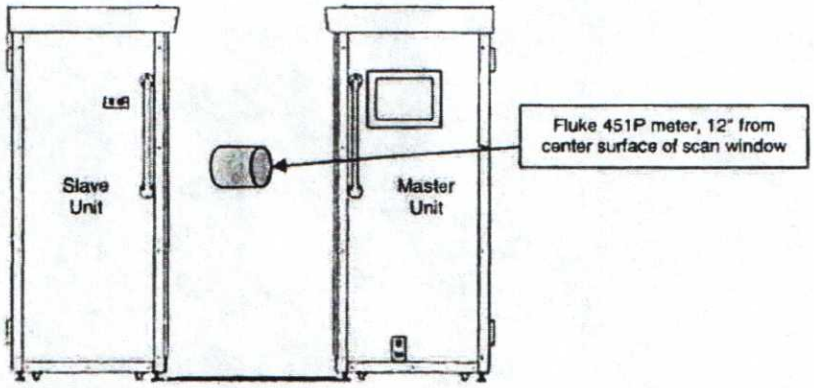
1. In Beam Dose Measurement: Survey Table. 1

3. TABLE 1: Incorrect presentation of data in Column 3 for Measured Exposure. Indicated values are 38uR and 36uR. Corrected values are 3.8uR and 3.6uR. The values were corrected by technician when calculating Effective Dose.

The service technician should attend refresher training.

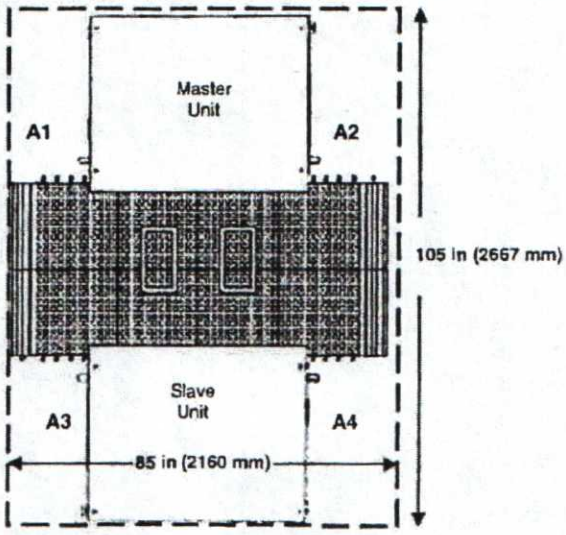
Top view

3. Inspection Zone Boundary Radiation Measurement: Survey Table. 3

4. TABLE 3: Incorrect presentation of data in Column 6 for Dose Equivalent. Indicated values are .18 uRem. The correct value should be 1.8 uRem.
