Rapiscan systems	Secure 1000 Radiation Emission Measurement	FORM R-XXXX-DV

Re: Rapiscan AIT System Radiation Survey Reporting

Secure 1000 Radiation Emission Measurement	FORM R-0646-1 (Single Pose)

R-0646-1 Addendum
(Documentation Errors)

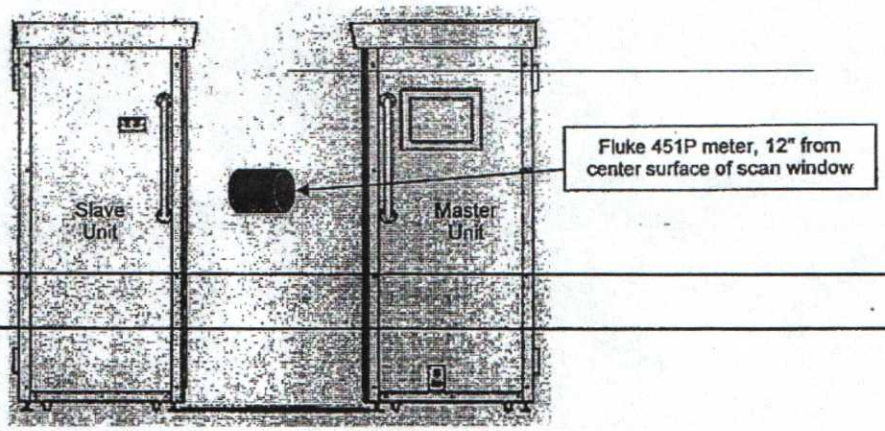
1. In Beam Dose Measurement: Survey Table. 1

Measurement Location	Measurement Height (in)	# of scan	Measured Exposure (µR) divide by 10	Fluke 451P Correction Factor[1]	Effective Dose Rem/R conversion factor (frontal)[2]	Effective Dose (µRem)
12" from center of the scan window (Master Unit)	36	10	3.9	2.5	0.23	2.24
12" from center of the scan window (Slave Unit)	36	10	3.6	2.5	0.23	2.07

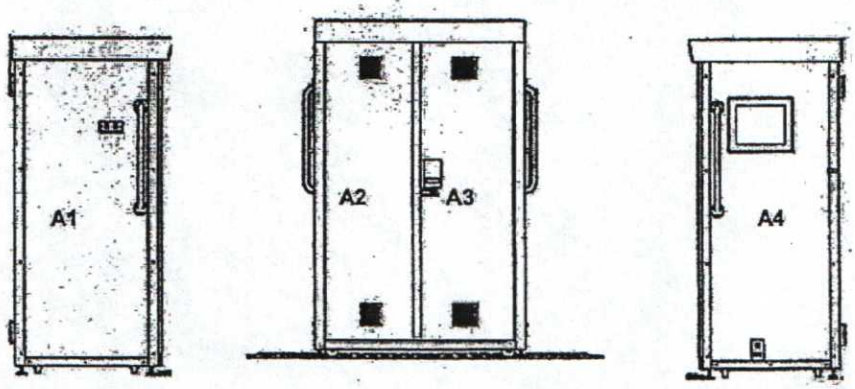
Master Unit

Measurement Location (center of the active unit external surface)	Measurement Height (in)	# of scan	Measured Exposure (µR)	Fluke 451P Correction Factor[1]	Rem/R conversion factor (dose equivalent)[3]	Dose Equivalent (H*10), (µRem)
A1	36	10	0	2.5	0.72	0
A2	36	10	0	2.5	0.72	0
A3	36	10	0	2.5	0.72	0
A4	36	10	0	2.5	0.72	0

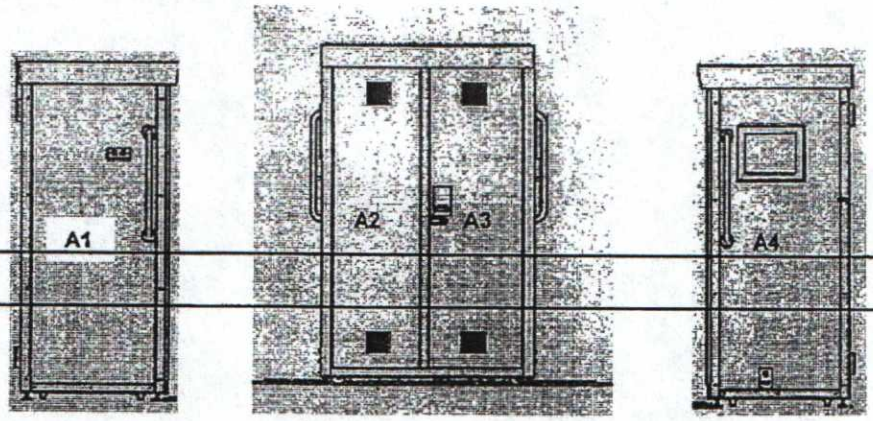
Slave Unit

Measurement Location (center of the active unit external surface)	Measurement Height (in)	# of scan	Measured Exposure (µR)	Fluke 451P Correction Factor[1]	Rem/R conversion factor (dose equivalent)[3]	Dose Equivalent (H*10), (µRem)
A1	36	10	0	2.5	0.72	0
A2	36	10	0	2.5	0.72	0
A3	36	10	0	2.5	0.72	0
A4	36	10	0	2.5	0.72	0

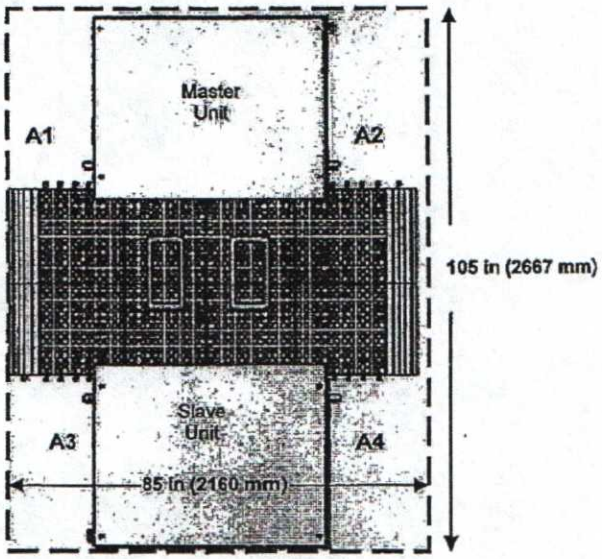
3. Inspection Zone Boundary Radiation Measurement: Survey Table. 3

Measurement Location	Measurement Height (in)	# of scan	Measured Exposure (µR)	Fluke 451P Correction Factor[1]	Rem/R conversion factor (dose equivalent)[3]	Dose Equivalent (H*10), (µRem)
A1 (12" from edge of the master unit scan window)	36	10	0	2.5	0.72	0
A2 (12" from edge of the master unit scan window)	36	10	.1	2.5	0.72	.18
A3 (12" from edge of the slave unit scan window)	36	10	.1	2.5	0.72	.18
A4 (12" from edge of the slave unit scan window)	36	10	0	2.5	0.72	0

1. TABLE 3: Incorrect presentation of data in Column 3 for Measured Exposure. Indicated value is .1 uRem. The correct value should be 1 uRem.

2. TABLE 3: Incorrect presentation of data in Column 6 for Dose Equivalent. Indicated value is .18 uRem. The correct value should be 1.8 uRem.

The service technician should attend refresher training.
