Rapiscan Systems	Secure 1000 Radiation Emission Measurement	FORM R-XXXX-DV

Re: Rapiscan AIT System Radiation Survey Reporting

R-0646-1 Addendum
(Documentation Errors)

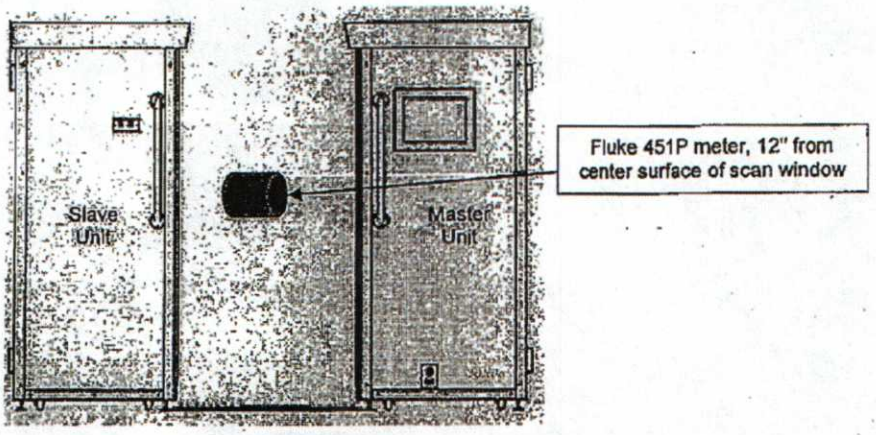
1. In Beam Dose Measurement: Survey Table. 1

Measurement Location	Measurement Height (in)	# of scan	Measured Exposure (µR) divide by 10	Fluke 451P Correction Factor[1]	Effective Dose Rem/R conversion factor (frontal)[2]	Effective Dose (µRem)
12"' from center of the scan window (Master Unit)	36	10	2.0	2.5	0.23	1.15
12"' from center of the scan window (Slave Unit)	36	10	2.0	2.5	0.23	1.15

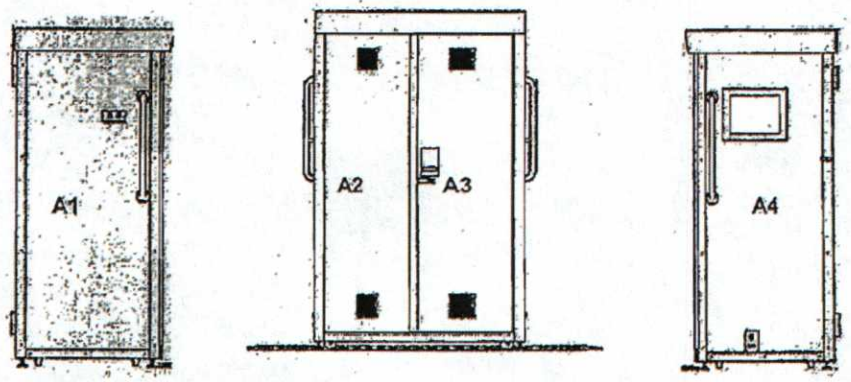
Master Unit

Measurement Location (center of the active unit external surface)	Measurement Height (in)	# of scan	Measured Exposure (µR)	Fluke 451P Correction Factor[1]	Rem/R conversion factor (dose equivalent)[3]	Dose Equivalent (H*10), (µRem)
A1	36	10	0	2.5	0.72	0
A2	36	10	0	2.5	0.72	0
A3	36	10	0	2.5	0.72	0
A4	36	10	0	2.5	0.72	0

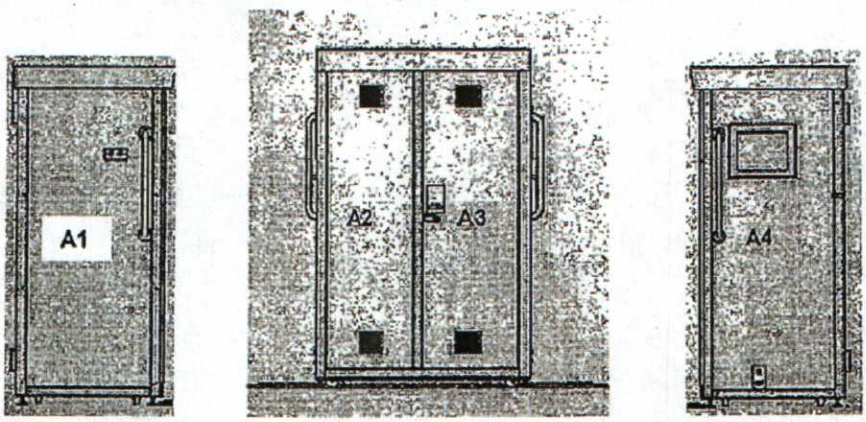
Slave Unit

Measurement Location (center of the active unit external surface)	Measurement Height (in)	# of scan	Measured Exposure (µR)	Fluke 451P Correction Factor[1]	Rem/R conversion factor (dose equivalent)[3]	Dose Equivalent (H*10), (µRem)
A1	36	10	0	2.5	0.72	0
A2	36	10	0	2.5	0.72	0
A3	36	10	0	2.5	0.72	0
A4	36	10	0	2.5	0.72	0

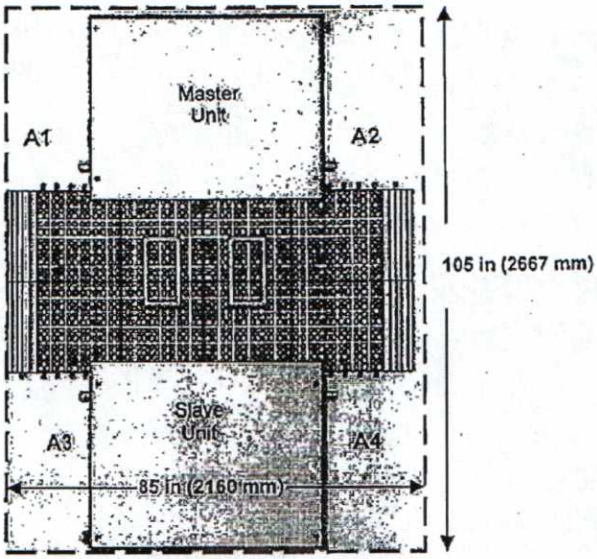
3. Inspection Zone Boundary Radiation Measurement: Survey Table. 3

Measurement Location	Measurement Height (in)	# of scan	Measured Exposure (µR)	Fluke 451P Correction Factor[1]	Rem/R conversion factor (dose equivalent)[3]	Dose Equivalent (H*10), (µRem)
A1 (12" from edge of the master unit scan window)	36	10	.1	2.5	0.72	.18
A2 (12" from edge of the master unit scan window)	36	10	0	2.5	0.72	0
A3 (12" from edge of the slave unit scan window)	36	10	0	2.5	0.72	0
A4 (12" from edge of the slave unit scan window)	36	10	0	2.5	0.72	0

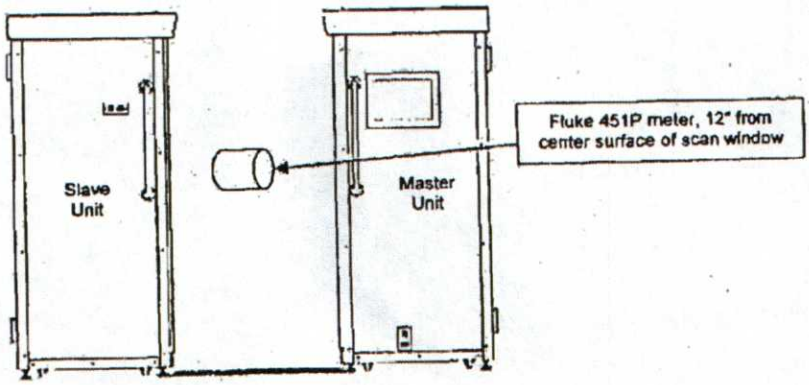
Side View

Measurement Location	Measurement Height (in)	# of scan	Measured Exposure µR (µSv) divide by 10	Fluke 451P Correction Factor[1]	Effective Dose Rem/R conversion factor (frontal)[2]	Effective Dose µRem(µSv)
12" from center of the scan window (Master Unit)	36	10	1.6	2.5	0.23	0.92
12" from center of the scan window (Slave Unit)	36	10	1.7	2.5	0.23	0.97

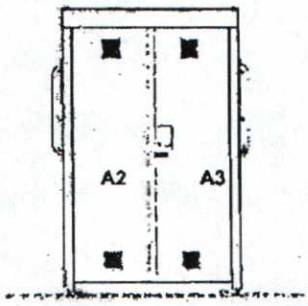
Master Unit (with monitor screen)

1. TABLE 2: Incorrect presentation of data in Column 3 for Measured Exposure. Indicated value is .1 uRem. The correct value should be 1 uRem.

2. TABLE 2: Incorrect presentation of data in Column 6 for Dose Equivalent. Indicated value is .18 uRem. The correct value should be 1.8 uRem.

The service technician should attend refresher training.

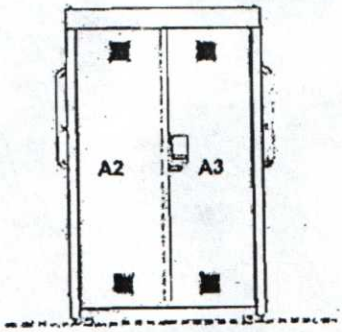
Left Side View

Measurement Location (center of the active unit external surface)	Measurement Height (in)	# of scan	Measured Exposure µR (µSv)	Fluke 451P Correction Factor[1]	Rem/R conversion factor (dose equivalent)[3]	Dose Equivalent (H*10), µRem(µSv)
A1	36	10	Ø	2.5	0.72	Ø
A2	36	10	Ø	2.5	0.72	Ø
A3	36	10	Ø	2.5	0.72	Ø
A4	36	10	Ø	2.5	0.72	Ø

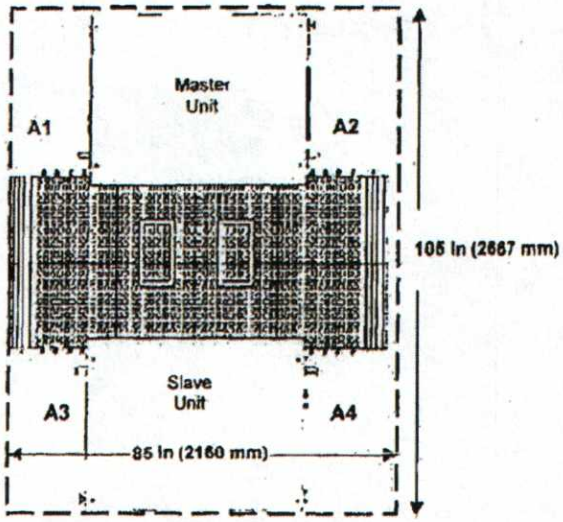
Top view

Measurement Location	Measurement Height (in)	# of scan	Measured Exposure µR (µSv)	Fluke 451P Correction Factor[1]	Rem/R conversion factor (dose equivalent)[3]	Dose Equivalent (H*10), µRem(µSv)
A1 (12" from edge of the master unit scan window)	36	10	Ø	2.5	0.72	Ø
A2 (12" from edge of the master unit scan window)	36	10	Ø	2.5	0.72	Ø
A3 (12" from edge of the slave unit scan window)	36	10	Ø	2.5	0.72	Ø
A4 (12" from edge of the slave unit scan window)	36	10	Ø	2.5	0.72	Ø
