Rapiscan Systems	Secure 1000 Radiation Emission Measurement	FORM R-XXXX-DV

Re: Rapiscan AIT System Radiation Survey Reporting

Rapiscan Systems	Secure 1000 Radiation Emission Measurement	FORM R-0646-1 (Single Pose)

R-0646-1 Addendum
(Documentation Errors)

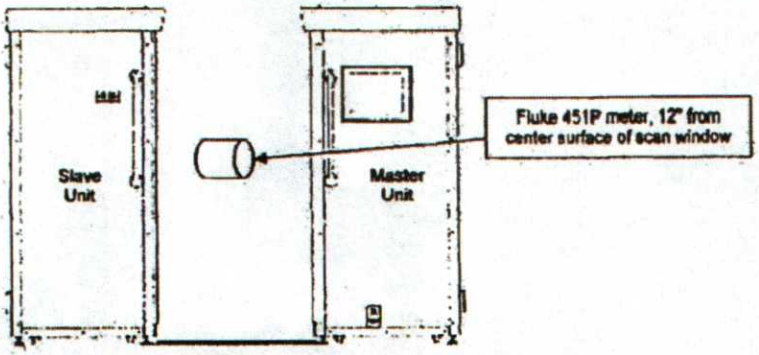
Measurement Location	Measurement Height (in)	# of scan	Measured Exposure µR (µSv) divide by 10	Fluke 451P Correction Factor[1]	Effective Dose Rem/R conversion factor (frontal)[2]	Effective Dose µRem(µSv)
12" from center of the scan window (Master Unit)	36	10	1.7	2.5	0.23	0.86
12" from center of the scan window (Slave Unit)	36	10	1.5	2.5	0.23	0.97

1. TABLE 1: Incorrect presentation of data in Column 6 for Effective Dose. Indicated values of .86 uRem and .97 uRem. are transposed.

The service technician should attend refresher training.

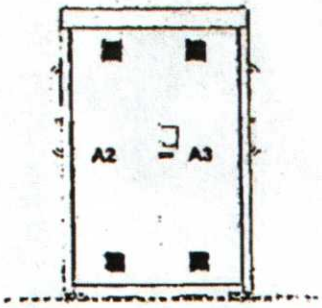
Slave Unit

Measurement Location (center of the active unit external surface)	Measurement Height (in)	# of scan	Measured Exposure µR (µSv)	Fluke 451P Correction Factor[1]	Rem/R conversion factor (dose equivalent)[3]	Dose Equivalent (H*10), µRem(µSv)
A1	36	10	Ø	2.5	0.72	Ø
A2	36	10	Ø	2.5	0.72	Ø
A3	36	10	Ø.1	2.5	0.72	0.18
A4	36	10	Ø	2.5	0.72	Ø

2. TABLE 2: Incorrect presentation of data in Column 3 for Measured Exposure. Indicated value is .1 uRem. The correct value should be 1 uRem.

3. TABLE 2: Incorrect presentation of data in Column 6 for Dose Equivalent. Indicated value is .18 uRem. The correct value should be 1.8 uRem.
