Rapiscan Systems	Secure 1000 Radiation Emission Measurement	FORM R-XXXX-DV

Re: Rapiscan AIT System Radiation Survey Reporting

Rapiscan Systems	Secure 1000 Radiation Emission Measurement	FORM R-0646-1 (Single Pose)

R-0646-1 Addendum
(Documentation Errors)

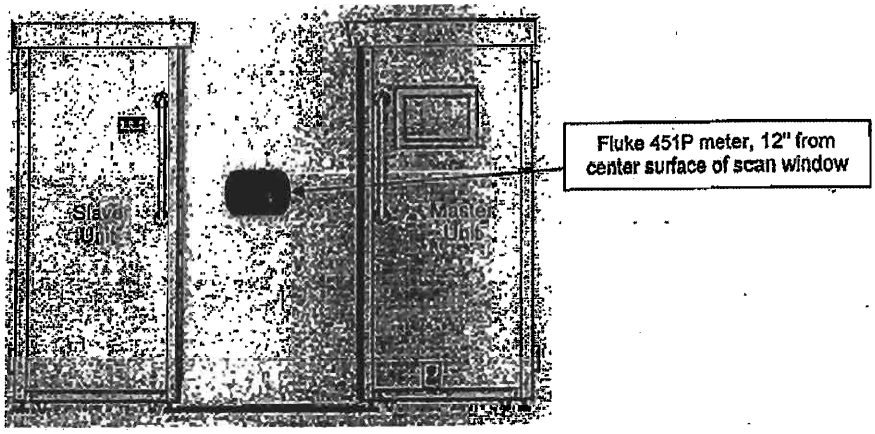
1. In Beam Dose Measurement: Survey Table. 1

Measurement Location	Measurement Height (in)	# of scan	Measured Exposure (µR) divide by 10	Fluke 451P Correction Factor[1]	Effective Dose Rem/R conversion factor (frontal)[2]	Effective Dose (µRem)
12"' from center of the scan window (Master Unit)	36	10	2.2	2.5	0.23	1.26
12"' from center of the scan window (Slave Unit)	36	10	2.2	2.5	0.23	1.26

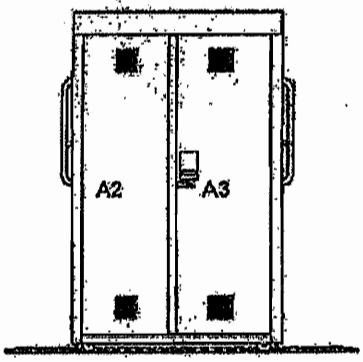
Master Unit

Measurement Location (center of the active unit external surface)	Measurement Height (in)	# of scan	Measured Exposure (µR)	Fluke 451P Correction Factor[1]	Rem/R conversion factor (dose equivalent)[3]	Dose Equivalent (H*10), (µRem)
A1	36	10	0	2.5	0.72	0
A2	36	10	0	2.5	0.72	0
A3	36	10	0	2.5	0.72	0
A4	36	10	0	2.5	0.72	0

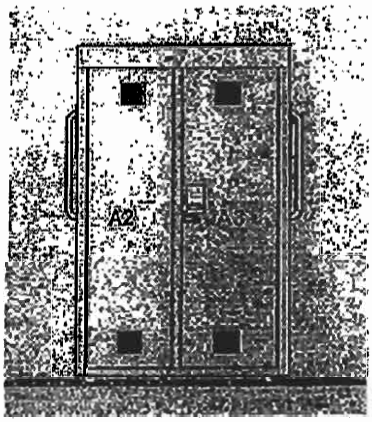
Slave Unit

Measurement Location (center of the active unit external surface)	Measurement Height (in)	# of scan	Measured Exposure (µR)	Fluke 451P Correction Factor[1]	Rem/R conversion factor (dose equivalent)[3]	Dose Equivalent (H*10), (µRem)
A1	36	10	0	2.5	0.72	0
A2	36	10	0	2.5	0.72	0
A3	36	10	0	2.5	0.72	0
A4	36	10	0	2.5	0.72	0

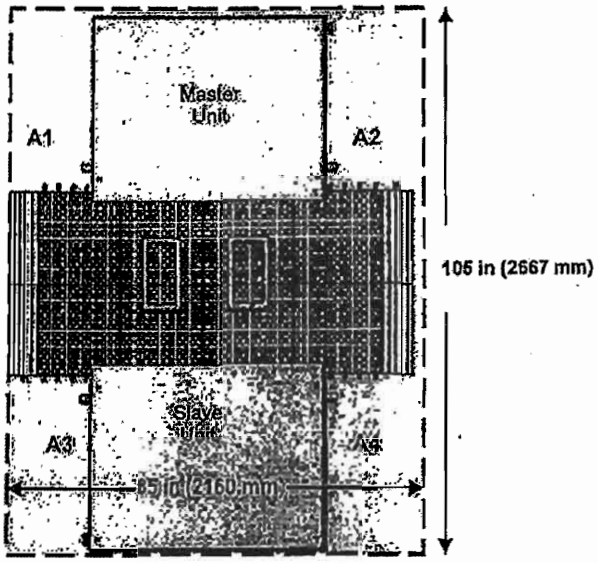
3. Inspection Zone Boundary Radiation Measurement: Survey Table. 3

Measurement Location	Measurement Height (in)	# of scan	Measured Exposure (µR)	Fluke 451P Correction Factor[1]	Rem/R conversion factor (dose equivalent)[3]	Dose Equivalent (H*10), (µRem)
A1 (12" from edge of the master unit scan window)	36	10	.1	2.5	0.72	.18
A2 (12" from edge of the master unit scan window)	36	10	0	2.5	0.72	0
A3 (12" from edge of the slave unit scan window)	36	10	0	2.5	0.72	0
A4 (12" from edge of the slave unit scan window)	36	10	0	2.5	0.72	0

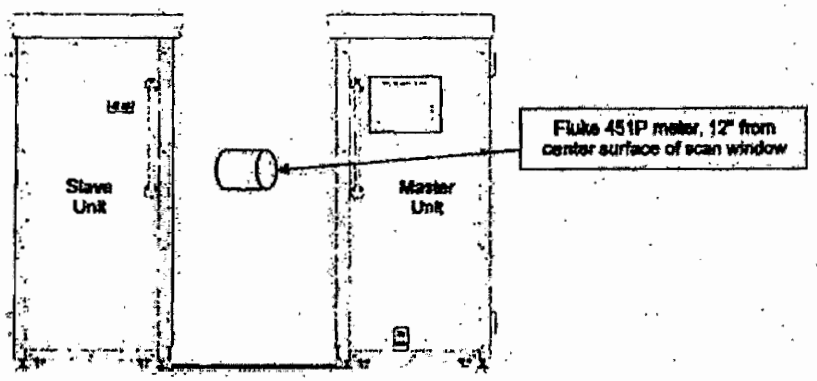
Side View

Measurement Location	Measurement Height (in)	# of scan	Measured Exposure µR (µSv) divide by 10	Fluke 451P Correction Factor[1]	Effective Dose Rem/R conversion factor (frontal)[2]	Effective Dose µRem(µSv)
12" from center of the scan window (Master Unit)	36	10	1.7	2.5	0.23	0.97
12" from center of the scan window (Slave Unit)	36	10	1.8	2.5	0.23	1.03

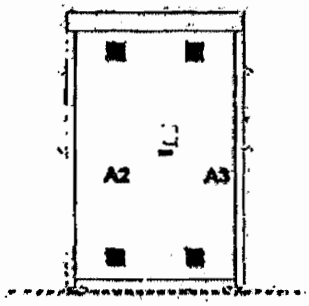
Master Unit (with monitor screen)

Measurement Location (center of the active unit external surface)	Measurement Height (in)	# of scan	Measured Exposure µR (µSv)	Fluke 451P Correction Factor[1]	Rem/R conversion factor (dose equivalent)[2]	Dose Equivalent (H*10), µRem(µSv)
A1	36	10	Ø	2.5	0.72	Ø
A2	36	10	Ø	2.5	0.72	Ø
A3	36	10	0.1	2.5	0.72	0.18
A4	36	10	Ø	2.5	0.72	Ø

1. TABLE 2: Incorrect presentation of data in Column 3 for Measured Exposure. Indicated value is .1 uRem. The correct value should be 1 uRem.

2. TABLE 2: Incorrect presentation of data in Column 6 for Dose Equivalent. Indicated value is .18 uRem. The correct value should be 1.8 uRem.

The service technician should attend refresher training.

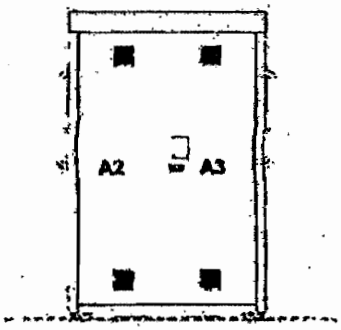
Left Side View

Measurement Location (center of the active unit external surface)	Measurement Height (in)	# of scan	Measured Exposure µR (µSv)	Fluke 451P Correction Factor[1]	Rem/R conversion factor (dose equivalent)[2]	Dose Equivalent (H*10), µRem(µSv)
A1	36	10	Ø	2.5	0.72	Ø
A2	36	10	Ø	2.5	0.72	Ø
A3	36	10	Ø	2.5	0.72	Ø
A4	36	10	Ø	2.5	0.72	Ø

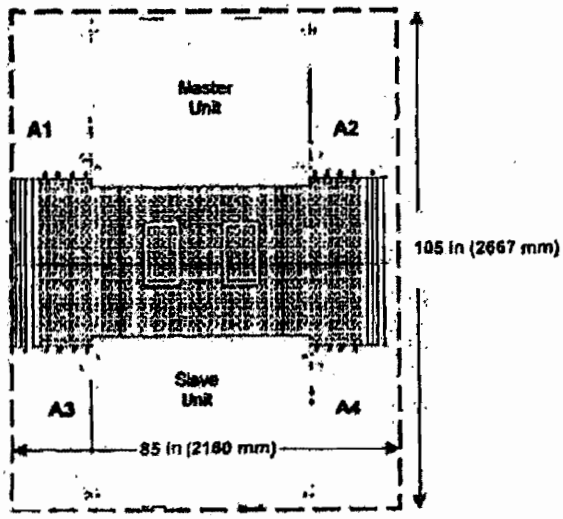
Top view

Measurement Location	Measurement Height (in)	# of scan	Measured Exposure µR (µSv)	Fluke 451P Correction Factor[1]	Rem/R conversion factor (dose equivalent)[3]	Dose Equivalent (H*10), µRem(µSv)
A1 (12" from edge of the master unit scan window)	36	10	Ø	2.5	0.72	Ø
A2 (12" from edge of the master unit scan window)	36	10	Ø	2.5	0.72	Ø
A3 (12" from edge of the slave unit scan window)	36	10	Ø	2.5	0.72	Ø
A4 (12" from edge of the slave unit scan window)	36	10	Ø	2.5	0.72	Ø
