Rapiscan systems	Secure 1000 Radiation Emission Measurement	FORM R-XXXX-DV

Re: Rapiscan AIT System Radiation Survey Reporting

R-0646-1 Addendum
(Documentation Errors)

Product Name	Secure 1000SP (Single Pose)
Serial Number	S51005005
Radiation Emission Measurement	Radiation Survey Dated: 05/25/2010
RSO Initials	[redacted]

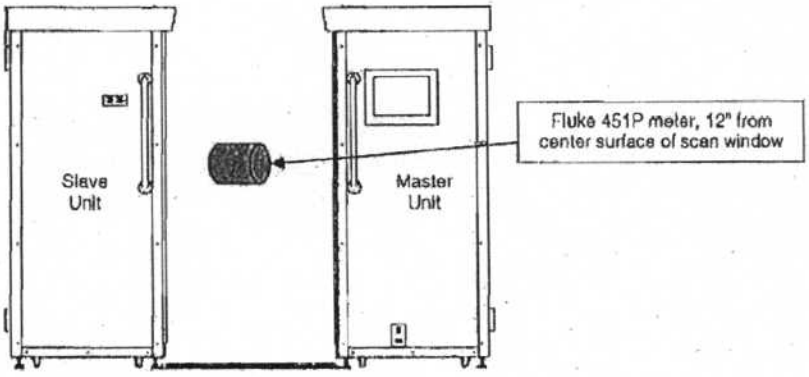
4. TABLE 1: Incorrect presentation of data in Column 3 for Measured Exposure. Indicated values are 40uR and 37uR. Corrected values are 4.0uR and 3.7uR. The values were corrected by technician when calculating Effective Dose.

The service technician should attend refresher training.

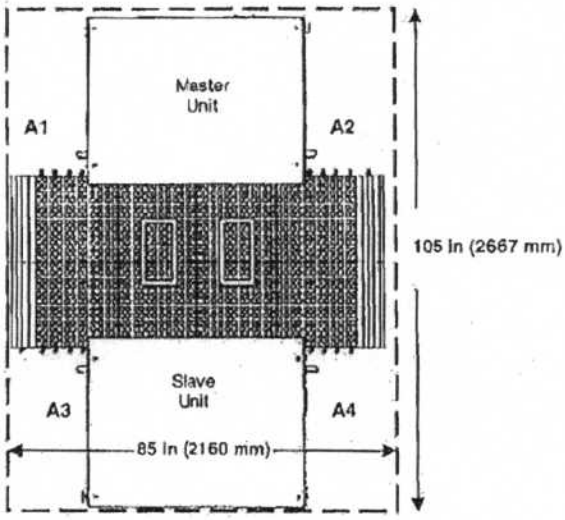
Top view

5. TABLE 3: Incorrect presentation of data in Column 6 for Dose Equivalent. Indicated value is .18 uRem. The correct value should be 1.8 uRem.
