Rapiscan systems	Secure 1000 Radiation Emission Measurement	FORM R-XXXX-DV

Re: Rapiscan AIT System Radiation Survey Reporting

Rapiscan Systems	Secure 1000 Radiation Emission Measurement	FORM R-0646-1 (Single Pose)

R-0646-1 Addendum
(Documentation Errors)

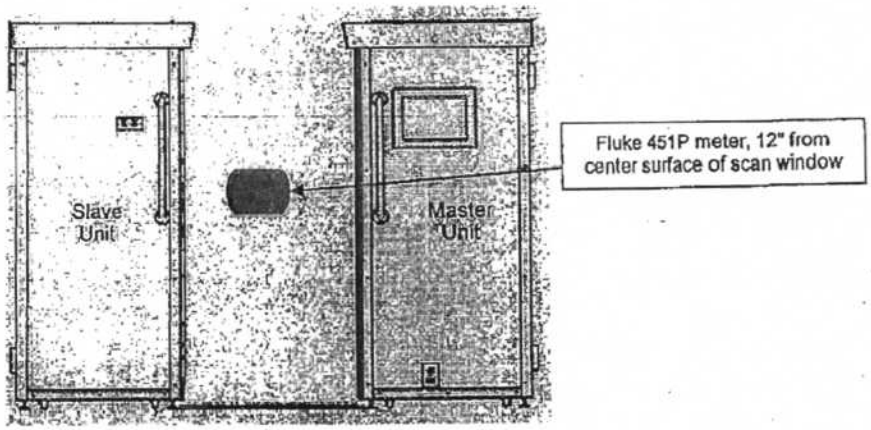
1. In Beam Dose Measurement: Survey Table. 1

Measurement Location	Measurement Height (in)	# of scan	Measured Exposure (µR) divide by 10	Fluke 451P Correction Factor[1]	Effective Dose Rem/R conversion factor (frontal)[2]	Effective Dose (µRem)
12" from center of the scan window (Master Unit)	36	10	2.4	2.5	0.23	1.38
12" from center of the scan window (Slave Unit)	36	10	2.8	2.5	0.23	1.61

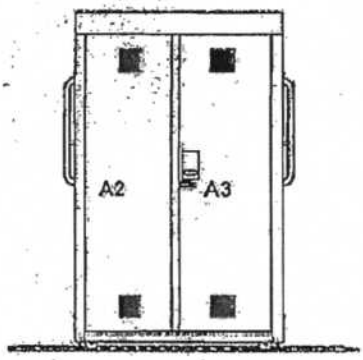
Master Unit

Measurement Location (center of the active unit external surface)	Measurement Height (in)	# of scan	Measured Exposure (µR)	Fluke 451P Correction Factor[1]	Rem/R conversion factor (dose equivalent)[3]	Dose Equivalent (H*10), (µRem)
A1	36	10	0	2.5	0.72	0
A2	36	10	0	2.5	0.72	0
A3	36	10	0	2.5	0.72	0
A4	36	10	0	2.5	0.72	0

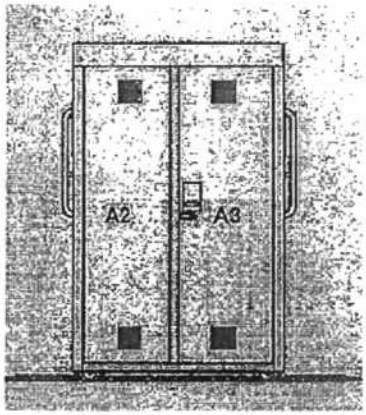
Slave Unit

Measurement Location (center of the active unit external surface)	Measurement Height (in)	# of scan	Measured Exposure (µR)	Fluke 451P Correction Factor[1]	Rem/R conversion factor (dose equivalent)[3]	Dose Equivalent (H*10), (µRem)
A1	36	10	0	2.5	0.72	0
A2	36	10	0	2.5	0.72	0
A3	36	10	0	2.5	0.72	0
A4	36	10	0	2.5	0.72	0

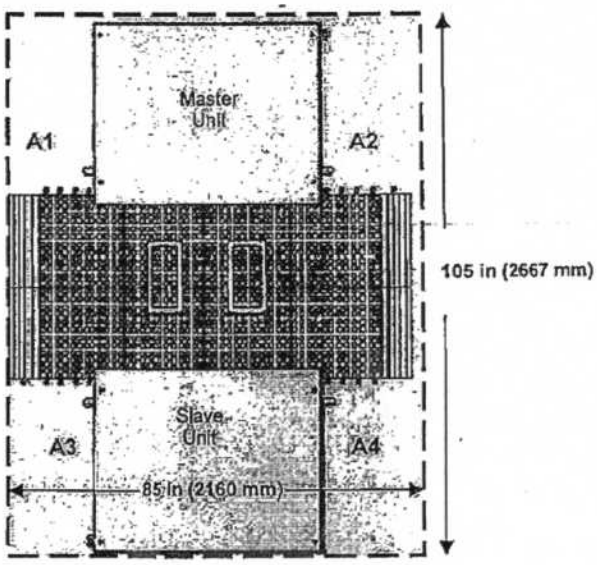
3. Inspection Zone Boundary Radiation Measurement: Survey Table. 3

Measurement Location	Measurement Height (in)	# of scan	Measured Exposure (µR)	Fluke 451P Correction Factor[1]	Rem/R conversion factor (dose equivalent)[3]	Dose Equivalent (H*10), (µRem)
A1 (12" from edge of the master unit scan window)	36	10	0	2.5	0.72	0
A2 (12" from edge of the master unit scan window)	36	10	0	2.5	0.72	0
A3 (12" from edge of the slave unit scan window)	36	10	0	2.5	0.72	0
A4 (12" from edge of the slave unit scan window)	36	10	0	2.5	0.72	0

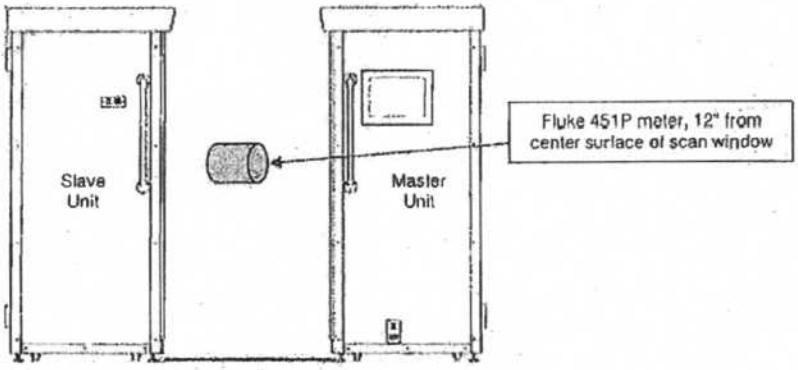
Side View

Measurement Location	Measurement Height (in)	# of scan	Measured Exposure µR (µSv) divide by 10	Fluke 451P Correction Factor[1]	Effective Dose Rem/R conversion factor (frontal)[2]	Effective Dose µRem(µSv)
12" from center of the scan window (Master Unit)	36	10	4.7	2.5	0.23	2.7
12" from center of the scan window (Slave Unit)	36	10	3.3	2.5	0.23	1.9

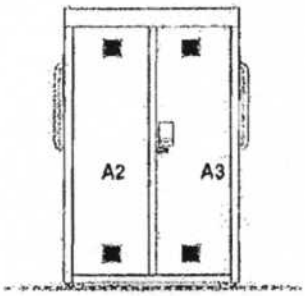
Left Side View

Measurement Location (center of the active unit external surface)	Measurement Height (in)	# of scan	Measured Exposure µR (µSv)	Fluke 451P Correction Factor[1]	Rem/R conversion factor (dose equivalent)[3]	Dose Equivalent (H*10), µRem(µSv)
A1	36	10	0	2.5	0.72	0
A2	36	10	0	2.5	0.72	0
A3	36	10	0	2.5	0.72	0
A4	36	10	1.0	2.5	0.72	1.8

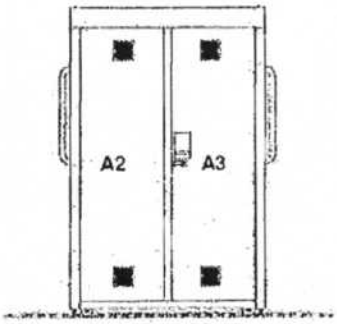
Slave Unit

Measurement Location (center of the active unit external surface)	Measurement Height (in)	# of scan	Measured Exposure µR (µSv)	Fluke 451P Correction Factor[1]	Rem/R conversion factor (dose equivalent)[3]	Dose Equivalent (H*10), µRem(µSv)
A1	36	10	0	2.5	0.72	0
A2	36	10	1.0	2.5	0.72	1.0
A3	36	10	0	2.5	0.72	0
A4	36	10	0	2.5	0.72	0

2. TABLE 2: Incorrect presentation of data in Column 6 Row 6 for Dose Equivalent. Indicated value is 1.0 uRem. The correct value should be 1.8 uRem.

The service technician should attend refresher training.

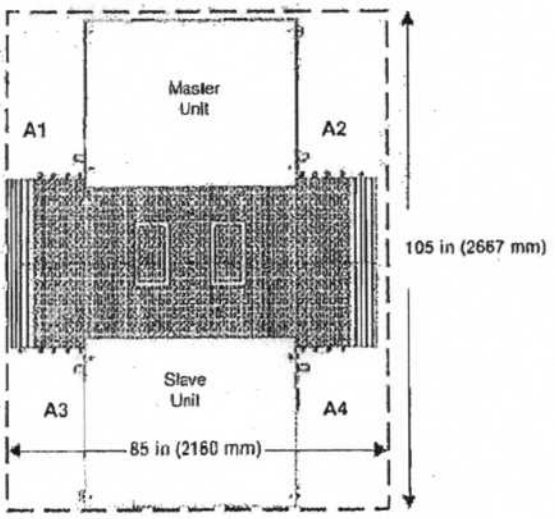
Top view

Measurement Location	Measurement Height (in)	# of scan	Measured Exposure µR (µSv)	Fluke 451P Correction Factor[1]	Rem/R conversion factor (dose equivalent)[3]	Dose Equivalent (H*10), µRem(µSv)
A1 (12" from edge of the master unit scan window)	36	10	0	2.5	0.72	0
A2 (12" from edge of the master unit scan window)	36	10	0	2.5	0.72	0
A3 (12" from edge of the slave unit scan window)	36	10	0	2.5	0.72	0
A4 (12" from edge of the slave unit scan window)	36	10	0	2.5	0.72	0
