Rapiscan Systems	Secure 1000 Radiation Emission Measurement	FORM R-XXXX-DV

Re: Rapiscan AIT System Radiation Survey Reporting

Rapiscan systems	Secure 1000 Radiation Emission Measurement	FORM R-0646-1 (Single Pose)

R-0646-1 Addendum
(Documentation Errors)

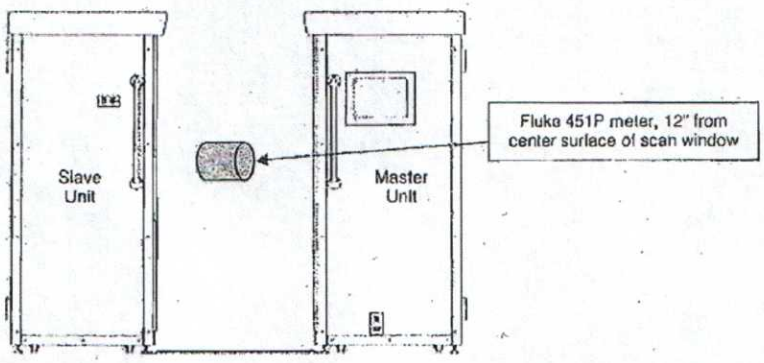
Measurement Location	Measurement Height (in)	# of scan	Measured Exposure µR (µSv) divide by 10	Fluke 451P Correction Factor[1]	Effective Dose Rem/R conversion factor (frontal)[2]	Effective Dose µRem(µSv)
12" from center of the scan window (Master Unit)	36	10	1.9	2.5	0.23	1.0
12" from center of the scan window (Slave Unit)	36	10	2.3	2.5	0.23	1.3

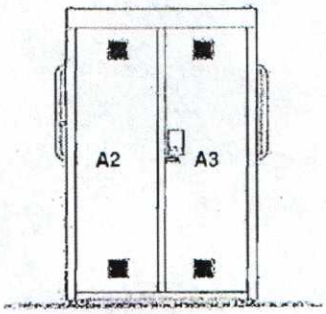
Left Side View

Measurement Location (center of the active unit external surface)	Measurement Height (in)	# of scan	Measured Exposure µR (µSv)	Fluke 451P Correction Factor[1]	Rem/R conversion factor (dose equivalent)[3]	Dose Equivalent (H*10), µRem(µSv)
A1	36	10	Ø	2.5	0.72	Ø
A2	36	10	Ø	2.5	0.72	Ø
A3	36	10	Ø	2.5	0.72	Ø
A4	36	10	1.0	2.5	0.72	1.8

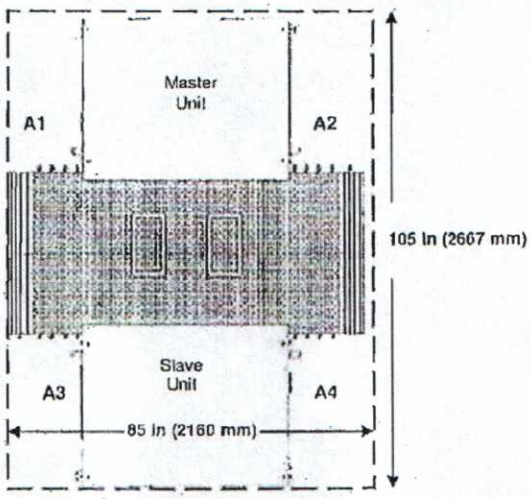
Top view

Measurement Location	Measurement Height (in)	# of scan	Measured Exposure µR (µSv)	Fluke 451P Correction Factor[1]	Rem/R conversion factor (dose equivalent)[3]	Dose Equivalent (H*10), µRem(µSv)
A1 (12" from edge of the master unit scan window)	36	10	1.0	2.5	0.72	1.8
A2 (12" from edge of the master unit scan window)	36	10	Ø	2.5	0.72	Ø
A3 (12" from edge of the slave unit scan window)	36	10	Ø	2.5	0.72	Ø
A4 (12" from edge of the slave unit scan window)	36	10	1.0	2.5	0.72	1.8
