Rapiscan Systems	Secure 1000 Radiation Emission Measurement	FORM R-0646-1 (Single Pose)

Re: Rapiscan AIT System Radiation Survey Reporting

R-0646-1 Addendum
(Documentation Errors)

Product Name	Secure 1000SP (Single Pose)
Serial Number	S51009007
Radiation Emission Measurement	Radiation Survey Dated: 06/18/2010
RSO Initials	[redacted]

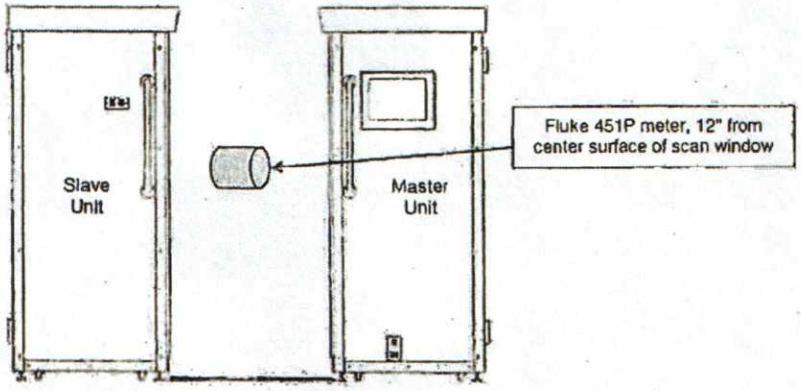
Side View

3. TABLE 1: Incorrect presentation of data in Column 3 for Measured Exposure. Indicated values are 22uR and 29uR. Corrected values are 2.2uR and 2.9uR. The values were corrected by technician when calculating Effective Dose.

The service technician should attend refresher training.

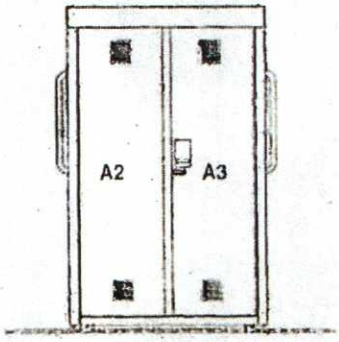
4. TABLES 2 and 3: Incorrect presentation of data in Column 6 for Dose Equivalent. Indicated values are .18 uRem. The correct value should be 1.8 uRem.
