Rapiscan	Secure 1000 Radiation Emission Measurement	FORM R-0646-1 (Single Pose)

Re: Rapiscan AIT System Radiation Survey Reporting

R-0646-1 Addendum
(Documentation Errors)

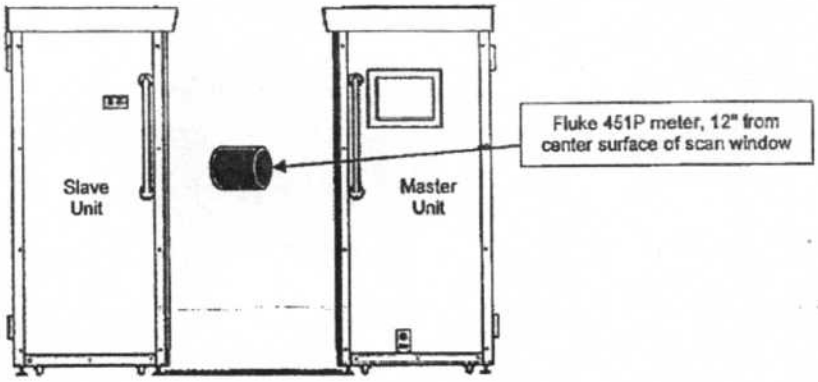
Side View

Measurement Location	Measurement Height (in)	# of scan	Measured Exposure µR (µSv) divide by 10	Fluke 451P Correction Factor[1]	Effective Dose Rem/R conversion factor (frontal)[2]	Effective Dose µRem(µSv)
12"' from center of the scan window (Master Unit)	36	10	2.4	2.5	0.23	1.38
12"' from center of the scan window (Slave Unit)	36	10	2.0	2.5	0.23	1.15

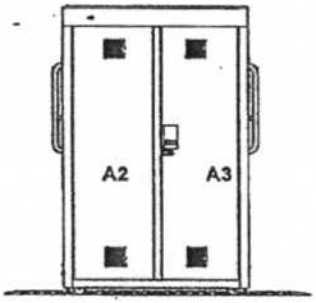
Left Side View

Measurement Location (center of the active unit external surface)	Measurement Height (in)	# of scan	Measured Exposure µR (µSv)	Fluke 451P Correction Factor[1]	Rem/R conversion factor (dose equivalent)[3]	Dose Equivalent (H*10), µRem(µSv)
A1	36	10	0	2.5	0.72	0
A2	36	10	0	2.5	0.72	0
A3	36	10	0	2.5	0.72	0
A4	36	10	0	2.5	0.72	0

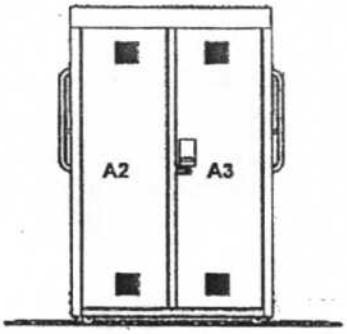
Left Side View

Measurement Location (center of the active unit external surface)	Measurement Height (in)	# of scan	Measured Exposure µR (µSv)	Fluke 451P Correction Factor[1]	Rem/R conversion factor (dose equivalent)[3]	Dose Equivalent (H*10), µRem(µSv)
A1	36	10	0	2.5	0.72	0
A2	36	10	0	2.5	0.72	0
A3	36	10	0	2.5	0.72	0
A4	36	10	0	2.5	0.72	0

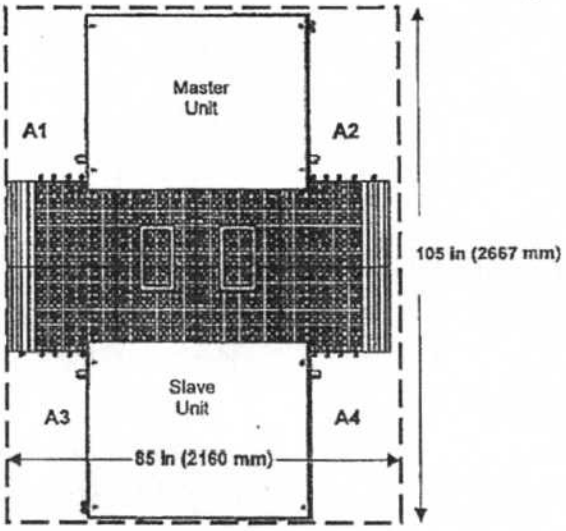
Top view

Measurement Location	Measurement Height (in)	# of scan	Measured Exposure µR (µSv)	Fluke 451P Correction Factor[1]	Rem/R conversion factor (dose equivalent)[3]	Dose Equivalent (H*10), µRem(µSv)
A1 (12" from edge of the master unit scan window)	36	10	0	2.5	0.72	0
A2 (12" from edge of the master unit scan window)	36	10	0	2.5	0.72	0
A3 (12" from edge of the slave unit scan window)	36	10	0	2.5	0.72	0
A4 (12" from edge of the slave unit scan window)	36	10	0	2.5	0.72	0

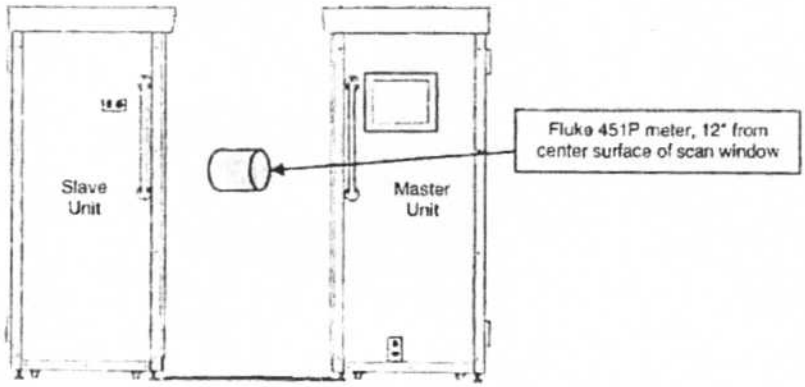
Side View

3. TABLE 1: Incorrect presentation of data in Column 3 for Measured Exposure. Indicated values are 41uR and 34uR. Corrected values are 4.1uR and 3.4uR. The values were corrected by technician when calculating Effective Dose.

The service technician should attend refresher training.

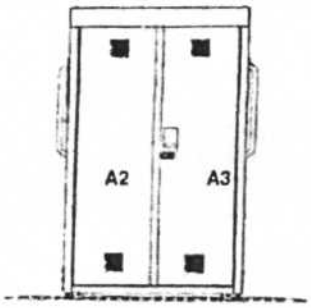
4. TABLES 2 and 3: Incorrect presentation of data in Column 6 for Dose Equivalent. Indicated values are .18 uRem. The correct value should be 1.8 uRem.
