Rapiscan Systems	Secure 1000 Radiation Emission Measurement	FORM R-0646-1 (Single Pose)

Re: Rapiscan AIT System Radiation Survey Reporting

R-0646-1 Addendum
(Documentation Errors)

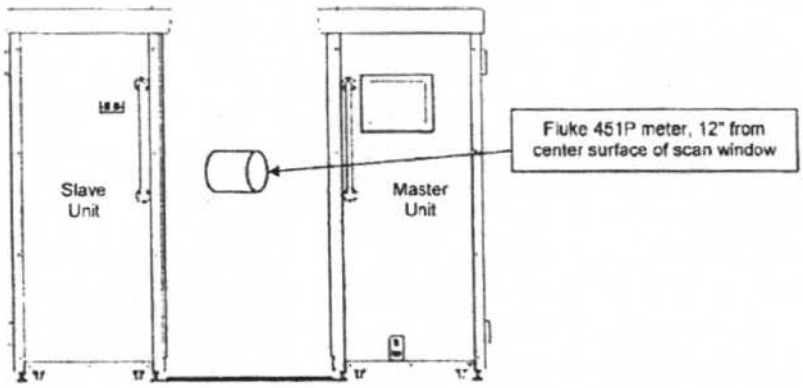
Side View

TABLE 1: Incorrect presentation of data in column 3 for Measured Exposure. Indicated values are 17uR and 13uR. Corrected values are 1.7uR and 1.3uR. The values were corrected by technician when calculating Effective Dose.

The corrected data indicates this system was operating within expected parameters. No re-survey is required for this system.

RSO will address issue with technician to ensure error is not repeated.
