Rapiscan Systems	Secure 1000 Radiation Emission Measurement	FORM R-0646-1 (Single Pose)

Re: Rapiscan AIT System Radiation Survey Reporting

R-0646-1 Addendum
(Documentation Errors)

Product Name	Secure 1000SP (Single Pose)
Serial Number	S51012004
Radiation Emission Measurement	Radiation Survey Dated: 07/16/2010
RSO Initials	[redacted]

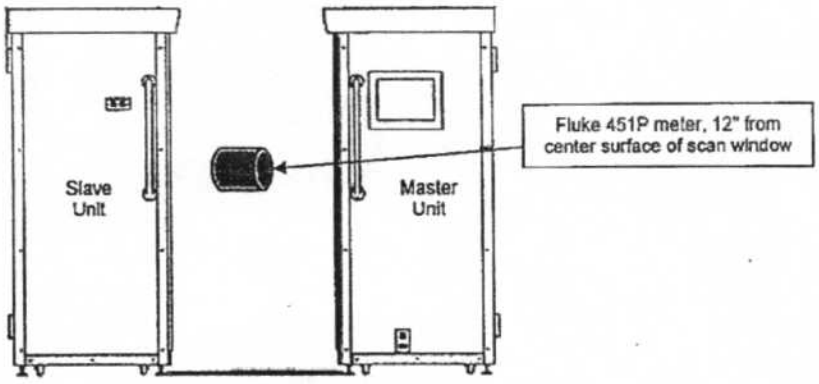
1. **In Beam Dose Measurement: Survey Table. 1**

Measurement Location	Measurement Height (in)	# of scan	Measured Exposure µR (µSv) divide by 10	Fluke 451P Correction Factor[1]	Effective Dose Rem/R conversion factor (frontal)[2]	Effective Dose µRem(µSv)
12" from center of the scan window (Master Unit)	36	10	17 1.7	2.5	0.23	.98
12" from center of the scan window (Slave Unit)	36	10	20 2.0	2.5	0.23	1.15

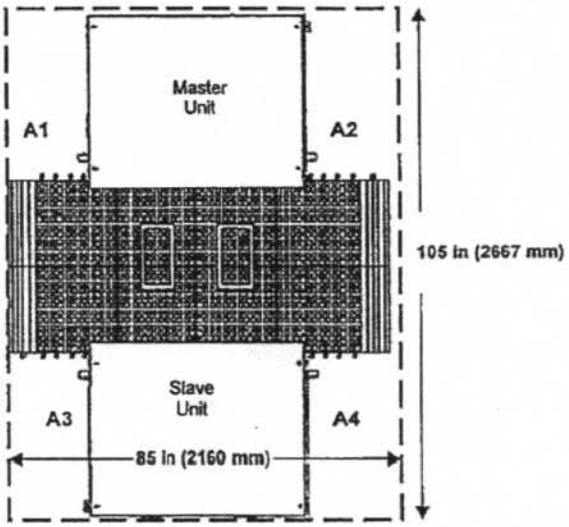
3. **Inspection Zone Boundary Radiation Measurement: Survey Table. 3**

Measurement Location	Measurement Height (in)	# of scan	Measured Exposure µR (µSv)	Fluke 451P Correction Factor[1]	Rem/R conversion factor (dose equivalent)[3]	Dose Equivalent (H*10), µRem(µSv)
A1 (12" from edge of the master unit scan window)	36	10	0	2.5	0.72	0
A2 (12" from edge of the master unit scan window)	36	10	0	2.5	0.72	0
A3 (12" from edge of the slave unit scan window)	36	10	0	2.5	0.72	0
A4 (12" from edge of the slave unit scan window)	36	10	0	2.5	0.72	0
