Rapiscan	Secure 1000 Radiation Emission Measurement	FORM R-0646-1 (Single Pose)

Re: Rapiscan AIT System Radiation Survey Reporting

R-0646-1 Addendum
(Documentation Errors)

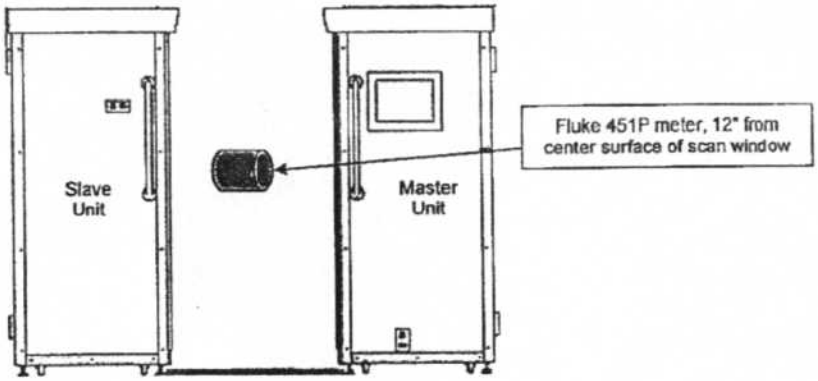
Side View

Measurement Location	Measurement Height (in)	# of scan	Measured Exposure µR (µSv) divide by 10	Fluke 451P Correction Factor[1]	Effective Dose Rem/R conversion factor (frontal)[2]	Effective Dose µRem(µSv)
12"' from center of the scan window (Master Unit)	36	10	18 1.8	2.5	0.23	1.04
12"' from center of the scan window (Slave Unit)	36	10	14 1.4	2.5	0.23	.81

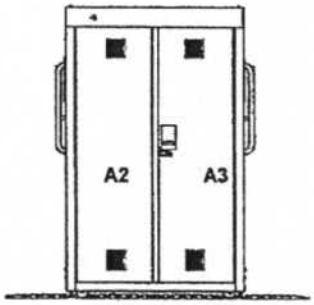
Left Side View

Measurement Location (center of the active unit external surface)	Measurement Height (in)	# of scan	Measured Exposure µR (µSv)	Fluke 451P Correction Factor[1]	Rem/R conversion factor (dose equivalent)[3]	Dose Equivalent (H*10), µRem(µSv)
A1	36	10	0	2.5	0.72	0
A2	36	10	0	2.5	0.72	0
A3	36	10	0	2.5	0.72	0
A4	36	10	0	2.5	0.72	0

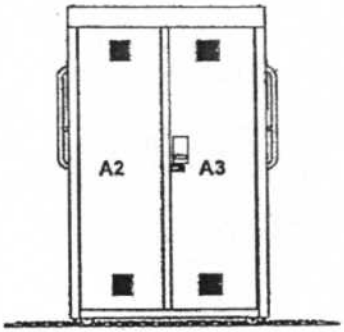
Left Side View

Measurement Location (center of the active unit external surface)	Measurement Height (in)	# of scan	Measured Exposure µR (µSv)	Fluke 451P Correction Factor[1]	Rem/R conversion factor (dose equivalent)[3]	Dose Equivalent (H*10), µRem(µSv)
A1	36	10	0	2.5	0.72	0
A2	36	10	0	2.5	0.72	0
A3	36	10	0	2.5	0.72	0
A4	36	10	0	2.5	0.72	0

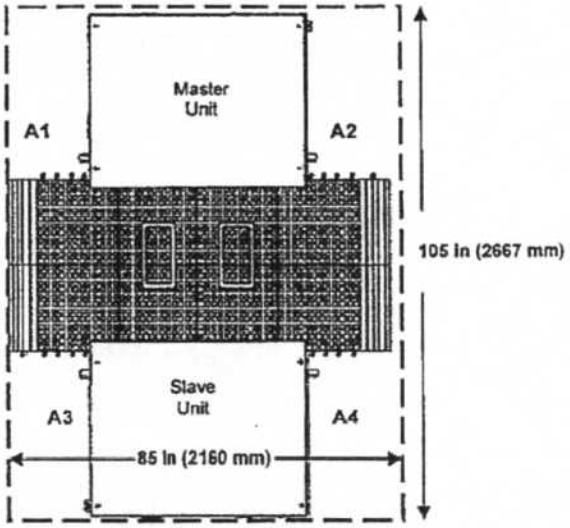
Top view

Measurement Location	Measurement Height (in)	# of scan	Measured Exposure µR (µSv)	Fluke 451P Correction Factor[1]	Rem/R conversion factor (dose equivalent)[2]	Dose Equivalent (H*10), µRem(µSv)
A1 (12" from edge of the master unit scan window)	36	10	0	2.5	0.72	0
A2 (12" from edge of the master unit scan window)	36	10	0	2.5	0.72	0
A3 (12" from edge of the slave unit scan window)	36	10	0	2.5	0.72	0
A4 (12" from edge of the slave unit scan window)	36	10	0	2.5	0.72	0

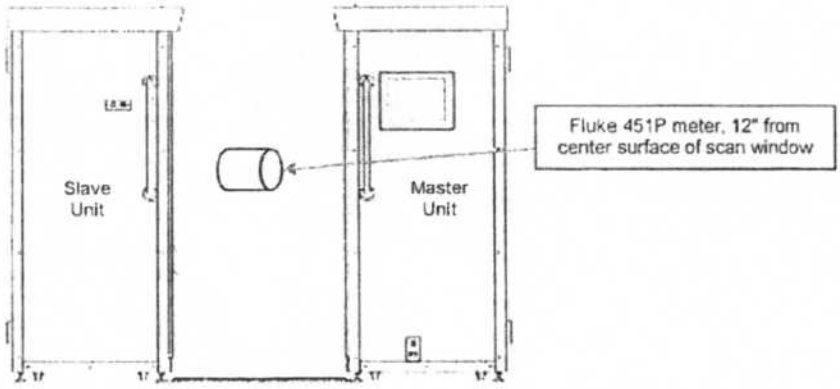
Side View

Measurement Location	Measurement Height (in)	# of scan	Measured Exposure µR (µSv) divide by 10	Fluke 451P Correction Factor[1]	Effective Dose Rem/R conversion factor (frontal)[2]	Effective Dose µRem(µSv)
12" from center of the scan window (Master Unit)	36	10	1.7	2.5	0.23	0.9775
12" from center of the scan window (Slave Unit)	36	10	1.6	2.5	0.23	0.92

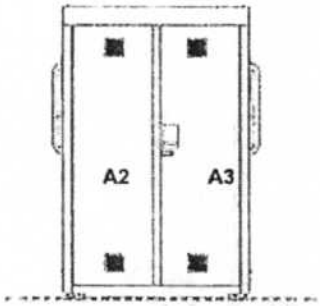
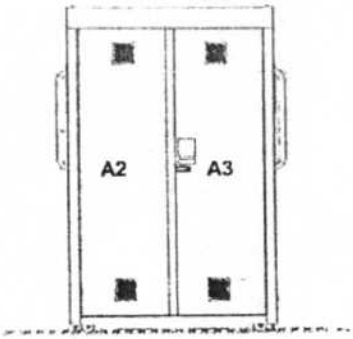
2. Radiation Leakage Measurement: Survey Table. 2

Measurement Location (center of the active unit external surface)	Measurement Height (in)	# of scan	Measured Exposure µR (µSv)	Fluke 451P Correction Factor[1]	Rem/R conversion factor (dose equivalent)[3]	Dose Equivalent (H*10), µRem(µSv)
A1	36	10	0.0	2.5	0.72	0.0
A2	36	10	0.0	2.5	0.72	0.0
A3	36	10	1.0	2.5	0.72	1.85
A4	36	10	0.0	2.5	0.72	0.0

Measurement Location (center of the active unit external surface)	Measurement Height (in)	# of scan	Measured Exposure µR (µSv)	Fluke 451P Correction Factor[1]	Rem/R conversion factor (dose equivalent)[3]	Dose Equivalent (H*10), µRem(µSv)
A1	36	10	0.0	2.5	0.72	0.0
A2	36	10	0.0	2.5	0.72	0.0
A3	36	10	0.0	2.5	0.72	0.0
A4	36	10	1.0	2.5	0.72	1.85

5. TABLE 2: Incorrect presentation of data in Column 6 for Dose Equivalent. Indicated value is 1.85 uRem. The correct value should be 1.8 uRem.

The service technician should attend refresher training.

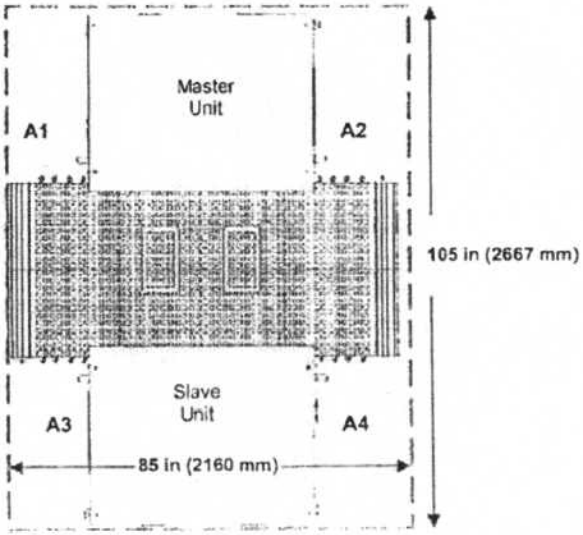
Top view

Measurement Location	Measurement Height (in)	# of scan	Measured Exposure µR (µSv)	Fluke 451P Correction Factor[1]	Rem/R conversion factor (dose equivalent)[3]	Dose Equivalent (H*10), µRem(µSv)
A1 (12" from edge of the master unit scan window)	36	10	0-0	2.5	0.72	0-0
A2 (12" from edge of the master unit scan window)	36	10	0-0	2.5	0.72	0-0
A3 (12" from edge of the slave unit scan window)	36	10	0-0.	2.5	0.72	0-0
A4 (12" from edge of the slave unit scan window)	36	10	0-0	2.5	0.72	0-0
