Rapiscan Systems	Secure 1000 Radiation Emission Measurement	FORM R-0646-1 (Single Pose)

Re: Rapiscan AIT System Radiation Survey Reporting

R-0646-1 Addendum
(Documentation Errors)

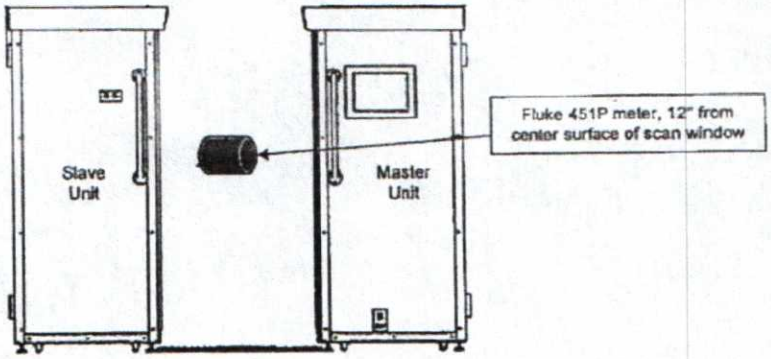
Side View

Measurement Location	Measurement Height (in)	# of scan	Measured Exposure µR (µSv) divide by 10	Fluke 451P Correction Factor[1]	Effective Dose Rem/R conversion factor (frontal)[2]	Effective Dose µRem(µSv)
12"" from center of the scan window (Master Unit)	36	10	1.5	2.5	0.23	.86
12"" from center of the scan window (Slave Unit)	36	10	2.1	2.5	0.23	1.21

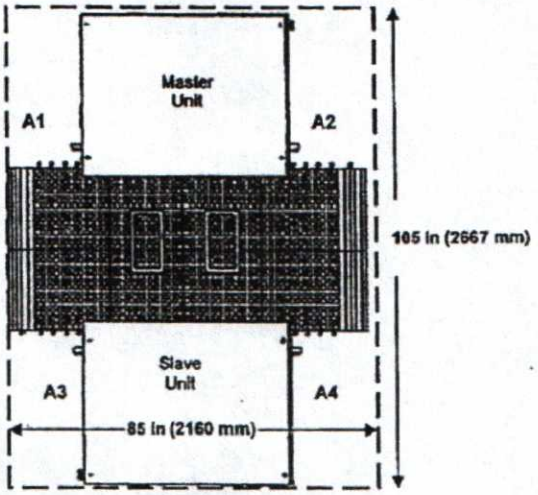
Top view

Measurement Location	Measurement Height (in)	# of scan	Measured Exposure µR (µSv)	Fluke 451P Correction Factor[1]	Rem/R conversion factor (dose equivalent)[2]	Dose Equivalent (H*10), µRem(µSv)
A1 (12" from edge of the master unit scan window)	36	10	0	2.5	0.72	0
A2 (12" from edge of the master unit scan window)	36	10	0	2.5	0.72	0
A3 (12" from edge of the slave unit scan window)	36	10	0	2.5	0.72	0
A4 (12" from edge of the slave unit scan window)	36	10	0	2.5	0.72	0

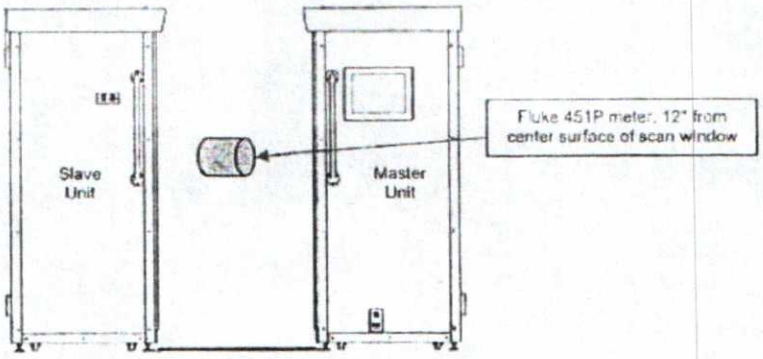
Side View

Measurement Location	Measurement Height (in)	# of scan	Measured Exposure µR (µSv) divide by 10	Fluke 451P Correction Factor'	Effective Dose Rem/R conversion factor (frontal)²	Effective Dose µRem(µSv)
12" from center of the scan window (Master Unit)	36	10	2.5	2.5	0.23	1.43
12" from center of the scan window (Slave Unit)	36	10	4.1	2.5	0.23	2.35

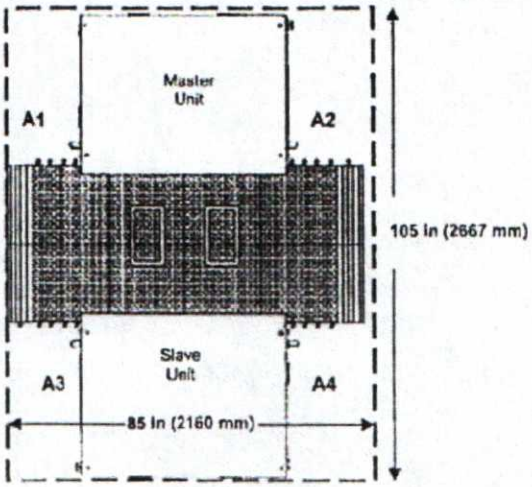
Top view

Measurement Location	Measurement Height (in)	# of scan	Measured Exposure µR (µSv)	Fluke 451P Correction Factor[1]	Rem/R conversion factor (dose equivalent)[2]	Dose Equivalent (H*10), µRem(µSv)
A1 (12" from edge of the master unit scan window)	36	10	0	2.5	0.72	0
A2 (12" from edge of the master unit scan window)	36	10	0	2.5	0.72	0
A3 (12" from edge of the slave unit scan window)	36	10	0	2.5	0.72	0
A4 (12" from edge of the slave unit scan window)	36	10	0	2.5	0.72	0
