Rapiscan systems	Secure 1000 Radiation Emission Measurement	FORM R-0646-1 (Single Pose)

Re: Rapiscan AIT System Radiation Survey Reporting

R-0646-1 Addendum
(Documentation Errors)

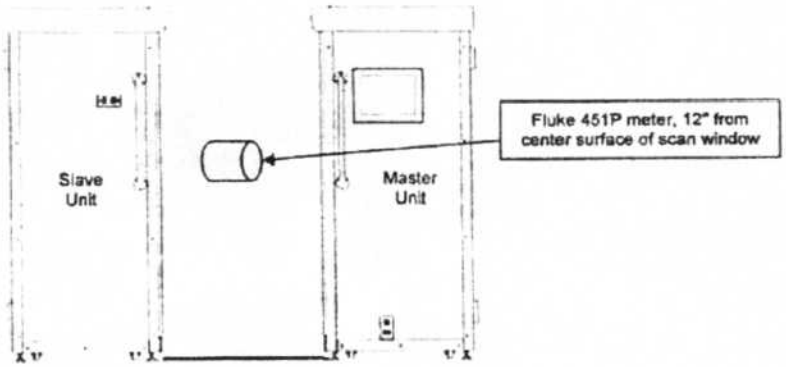
Side View

Measurement Location	Measurement Height (in)	# of scan	Measured Exposure µR (µSv) divide by 10	Fluke 451P Correction Factor[1]	Effective Dose Rem/R conversion factor (frontal)[2]	Effective Dose µRem(µSv)	
12" from center of the scan window (Master Unit)	36	10	1.7	2.5	0.23	0.68	0.97
12" from center of the scan window (Slave Unit)	36	10	2.4	2.5	0.23	0.96	1.38

3. TABLE 1: Incorrect presentation of data in Column 3 for Measured Exposure. Indicated values are 17uR and 24uR. Corrected values are 1.7uR and 2.4uR

4. TABLE 1: Incorrect presentation of data in Column 6 for Effective Dose. Indicated values are .68 uRem and .96 uRem. Corrected values, per RSO corrections, are .977 uRem and 1.38 uRem.

The service technician should attend refresher training.
