Rapiscan systems	Secure 1000 Radiation Emission Measurement	FORM R-0646-1 (Single Pose)

Re: Rapiscan AIT System Radiation Survey Reporting

R-0646-1 Addendum
(Documentation Errors)

Product Name	Secure 1000SP (Single Pose)
Serial Number	S51017013
Radiation Emission Measurement	Radiation Survey Dated: 10/06/2010
RSO Initials	[redacted]

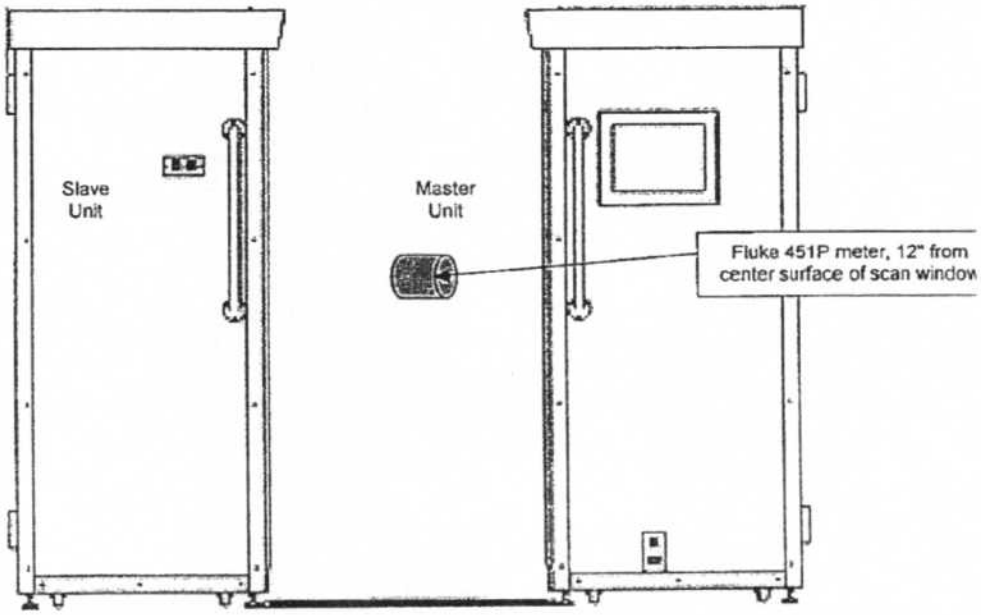
Side View

COLUMN NUMBERS					
1	2	3	4	5	6	7
Measurement Location	Measurement Height (in)	# of scan	Measured Exposure µR (µSv) divide by 10	Fluke 451P Correction Factor[1]	Effective Dose Rem/R conversion factor (frontal)[2]	Effective Dose µRem(µSv)
12"' from center of the scan window (Master Unit)	36	10	1.9	2.5	0.23	1.09
12"' from center of the scan window (Slave Unit)	36	10	2.0	2.5	0.23	1.15

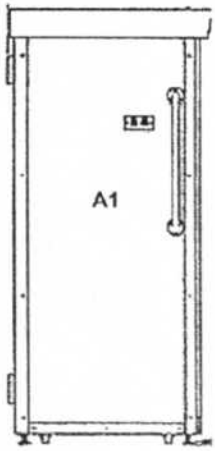
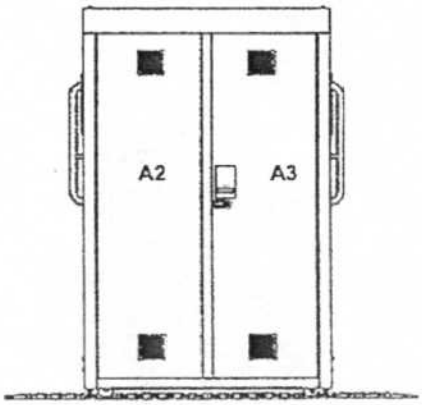
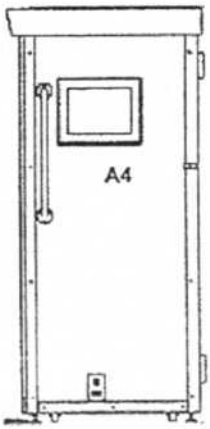
COLUMN NUMBERS					
1	2	3	4	5	6	7
Measurement Location (center of the active unit external surface)	Measurement Height (in)	# of scan	Measured Exposure µR (µSv)	Fluke 451P Correction Factor[1]	Rem/R conversion factor (dose equivalent)[3]	Dose Equivalent (H*10), µRem(µSv)
A1	36	10	0	2.5	0.72	0
A2	36	10	0	2.5	0.72	0
A3	36	10	0	2.5	0.72	0
A4	36	10	0	2.5	0.72	0

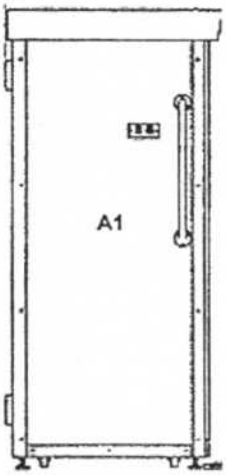
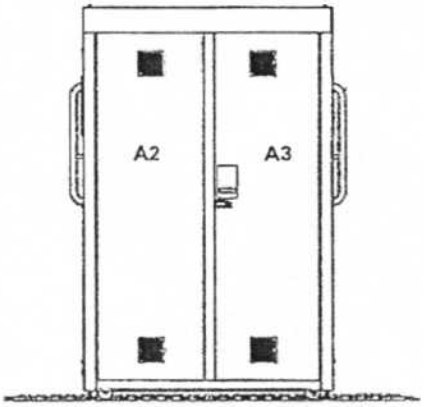
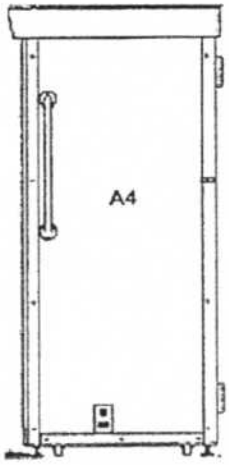
COLUMN NUMBERS					
1	2	3	4	5	6	7
Measurement Location (center of the active unit external surface)	Measurement Height (in)	# of scan	Measured Exposure µR (µSv)	Fluke 451P Correction Factor[1]	Rem/R conversion factor (dose equivalent)[3]	Dose Equivalent (H*10), µRem(µSv)
A1	36	10	0	2.5	0.72	0
A2	36	10	0	2.5	0.72	0
A3	36	10	0	2.5	0.72	0
A4	36	10	0	2.5	0.72	0

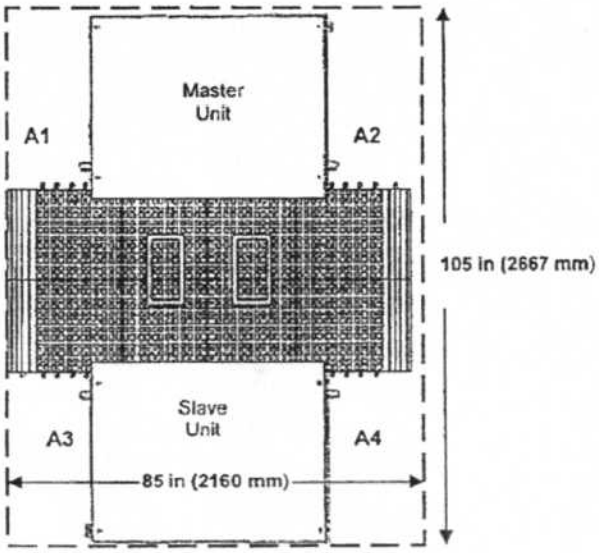
Top view

COLUMN NUMBERS					
1	2	3	4	5	6	7
Measurement Location	Measurement Height (in)	# of scan	Measured Exposure µR (µSv)	Fluke 451P Correction Factor[1]	Rem/R conversion factor (dose equivalent)[3]	Dose Equivalent (H*10), µRem(µSv)
A1 (12" from edge of the master unit scan window)	36	10	0	2.5	0.72	0
A2 (12" from edge of the master unit scan window)	36	10	0	2.5	0.72	0
A3 (12" from edge of the slave unit scan window)	36	10	0	2.5	0.72	0
A4 (12" from edge of the slave unit scan window)	36	10	0	2.5	0.72	0

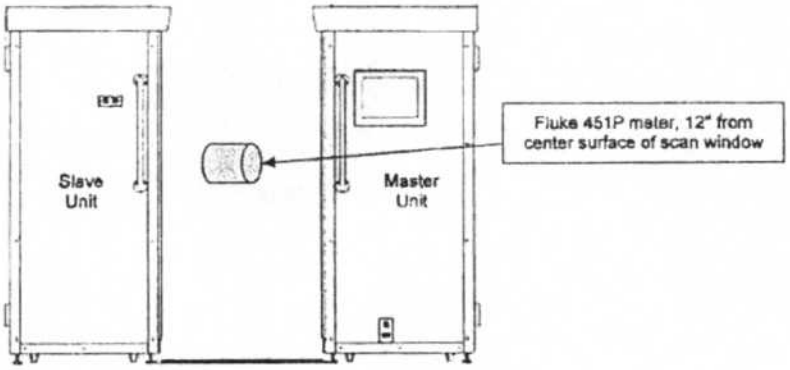
Side View

Measurement Location	Measurement Height (In)	# of scan	Measured Exposure µR (µSv) divide by 10	Fluke 451P Correction Factor[1]	Effective Dose Rem/R conversion factor (frontal)[2]	Effective Dose µRem(µSv)
12" from center of the scan window (Master Unit)	36	10	0.160	2.5	0.23	.92
12" from center of the scan window (Slave Unit)	36	10	1.4	2.5	0.23	.805

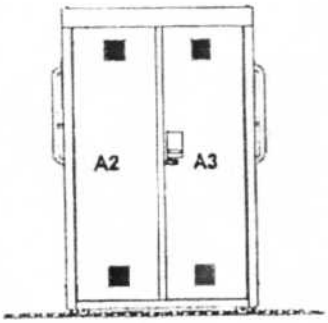
Back View

Measurement Location (center of the active unit external surface)	Measurement Height (in)	# of scan	Measured Exposure µR (µSv)	Fluke 451P Correction Factor[1]	Rem/R conversion factor (dose equivalent)[2]	Dose Equivalent (H*10), µRem(µSv)
A1	36	10	0	2.5	0.72	0
A2	36	10	0	2.5	0.72	0
A3	36	10	0	2.5	0.72	0
A4	38	10	0	2.5	0.72	0

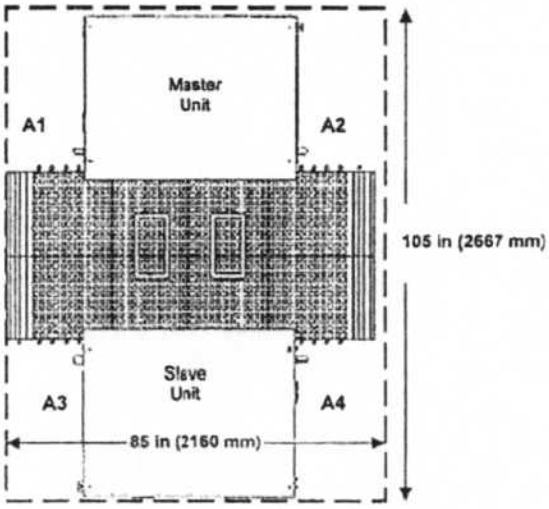
Top view

Measurement Location	Measurement Height (in)	# of scan	Measured Exposure µR (µSv)	Fluke 451P Correction Factor[1]	Rem/R conversion factor (dose equivalent)[3]	Dose Equivalent (H*10), µRem(µSv)
A1 (12" from edge of the master unit scan window)	36	10	0	2.5	0.72	0
A2 (12" from edge of the master unit scan window)	36	10	0	2.5	0.72	0
A3 (12" from edge of the slave unit scan window)	36	10	0	2.5	0.72	0
A4 (12" from edge of the slave unit scan window)	36	10	0	2.5	0.72	0
