Rapiscan systems	Secure 1000 Radiation Emission Measurement	FORM R-0646-1 (Single Pose)

Re: Rapiscan AIT System Radiation Survey Reporting

R-0646-1 Addendum
(Documentation Errors)

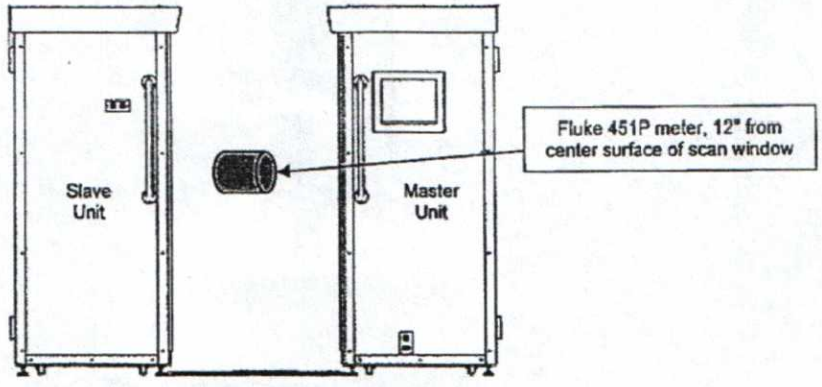
Side View

Measurement Location	Measurement Height (in)	# of scan	Measured Exposure µR (µSv) divide by 10	Fluke 451P Correction Factor[1]	Effective Dose Rem/R conversion factor (frontal)[2]	Effective Dose µRem(µSv)
12"' from center of the scan window (Master Unit)	36	10	2.4	2.5	0.23	1.38
12"' from center of the scan window (Slave Unit)	36	10	2.0	2.5	0.23	1.15

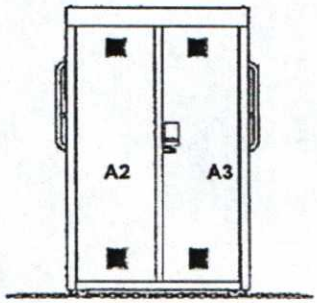
Left Side View

Measurement Location (center of the active unit external surface)	Measurement Height (in)	# of scan	Measured Exposure µR (µSv)	Fluke 451P Correction Factor[1]	Rem/R conversion factor (dose equivalent)[3]	Dose Equivalent (H*10), µRem(µSv)
A1	36	10	0	2.5	0.72	0
A2	36	10	0	2.5	0.72	0
A3	36	10	0	2.5	0.72	0
A4	36	10	0	2.5	0.72	0

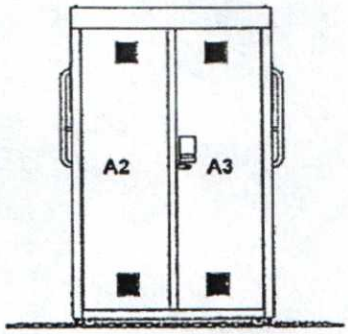
Left Side View

Measurement Location (center of the active unit external surface)	Measurement Height (in)	# of scan	Measured Exposure µR (µSv)	Fluke 451P Correction Factor[1]	Rem/R conversion factor (dose equivalent)[3]	Dose Equivalent (H*10), µRem(µSv)
A1	36	10	0	2.5	0.72	0
A2	36	10	0	2.5	0.72	0
A3	36	10	0	2.5	0.72	0
A4	36	10	0	2.5	0.72	0

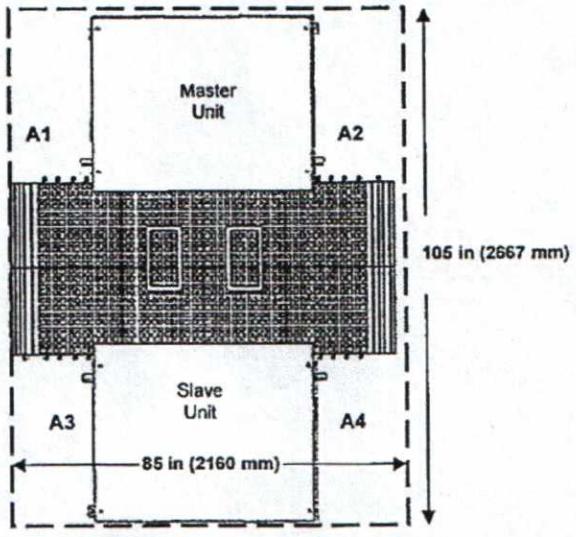
Top view

Measurement Location	Measurement Height (in)	# of scan	Measured Exposure µR (µSv)	Fluke 451P Correction Factor[1]	Rem/R conversion factor (dose equivalent)[3]	Dose Equivalent (H*10), µRem(µSv)
A1 (12" from edge of the master unit scan window)	36	10	0	2.5	0.72	0
A2 (12" from edge of the master unit scan window)	36	10	0	2.5	0.72	0
A3 (12" from edge of the slave unit scan window)	36	10	0	2.5	0.72	0
A4 (12" from edge of the slave unit scan window)	36	10	0	2.5	0.72	0

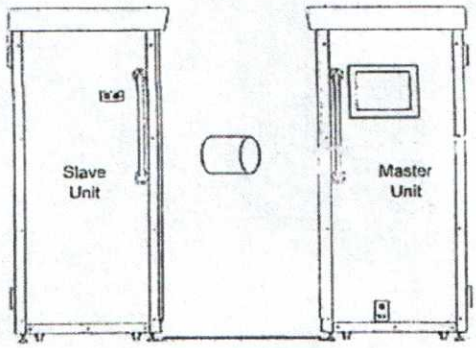
Side View

Fluke 451P meter, 12" from center surface of scan window

2. TABLE 1: Incorrect presentation of data in Column 3 for Measured Exposure. Indicated values are 25uR and 25uR. Corrected values are 2.5uR and 2.5uR

3. TABLE 1: Incorrect presentation of data in Column 6 for Effective Dose. Indicated values are 14 uRem and 14 uRem. Corrected values, per RSO corrections, are 1.4 uRem and 1.4 uRem.

The service technician should attend refresher training.

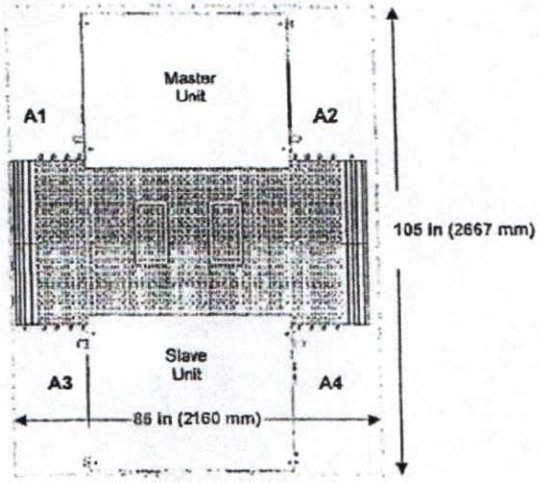
Top view

Measurement Location	Measurement Height (in)	# of scan	Measured Exposure µR (µSv)	Fluke 451P Correction Factor[1]	Rem/R conversion factor (dose equivalent)[3]	Dose Equivalent (H*10), µRem(µSv)
A1 (12" from edge of the master unit scan window)	36	10	0	2.5	0.72	0
A2 (12" from edge of the master unit scan window)	36	10	0	2.5	0.72	0
A3 (12" from edge of the slave unit scan window)	36	10	0	2.5	0.72	0
A4 (12" from edge of the slave unit scan window)	36	10	0	2.5	0.72	0
