Rapiscan Systems	Secure 1000 Radiation Emission Measurement	FORM R-0646-1 (Single Pose)

Re: Rapiscan AIT System Radiation Survey Reporting

R-0646-1 Addendum
(Documentation Errors)

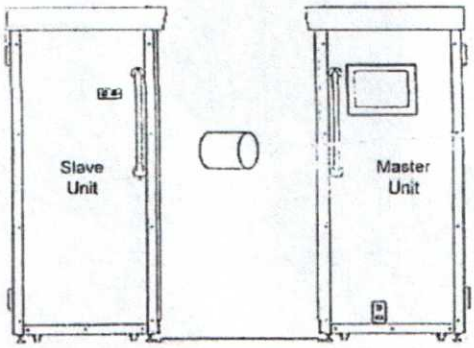
Side View

Fluke 451P meter, 12" from center surface of scan window

2. TABLE 1: Incorrect presentation of data in Column 3 for Measured Exposure. Indicated values are 28uR and 27uR. Corrected values are 2.8uR and 2.7uR

3. TABLE 1: Incorrect presentation of data in Column 6 for Effective Dose. Indicated values are 16 uRem and 15 uRem. Corrected values are 1.6 uRem and 1.5 uRem.

The service technician should attend refresher training.
