Rapiscan Systems	Secure 1000 Radiation Emission Measurement	FORM R-0646-1 (Single Pose)

Re: Rapiscan AIT System Radiation Survey Reporting

R-0646-1 Addendum
(Documentation Errors)

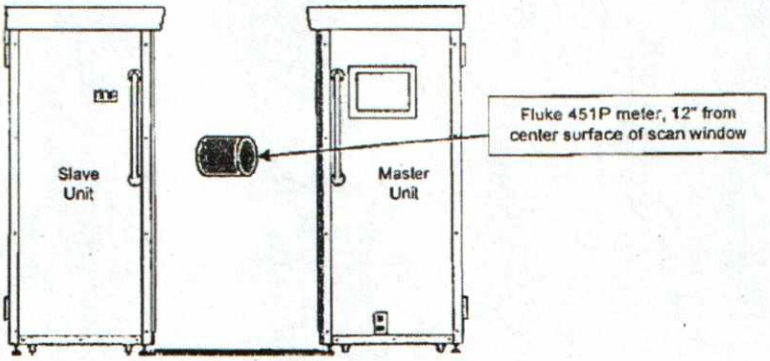
Side View

Measurement Location	Measurement Height (in)	# of scan	Measured Exposure µR (µSv) divide by 10	Fluke 451P Correction Factor[1]	Effective Dose Rem/R conversion factor (frontal)[2]	Effective Dose µRem(µSv)
12" from center of the scan window (Master Unit)	36	10	1.6	2.5	0.23	.92
12" from center of the scan window (Slave Unit)	36	10	1.8	2.5	0.23	1.04

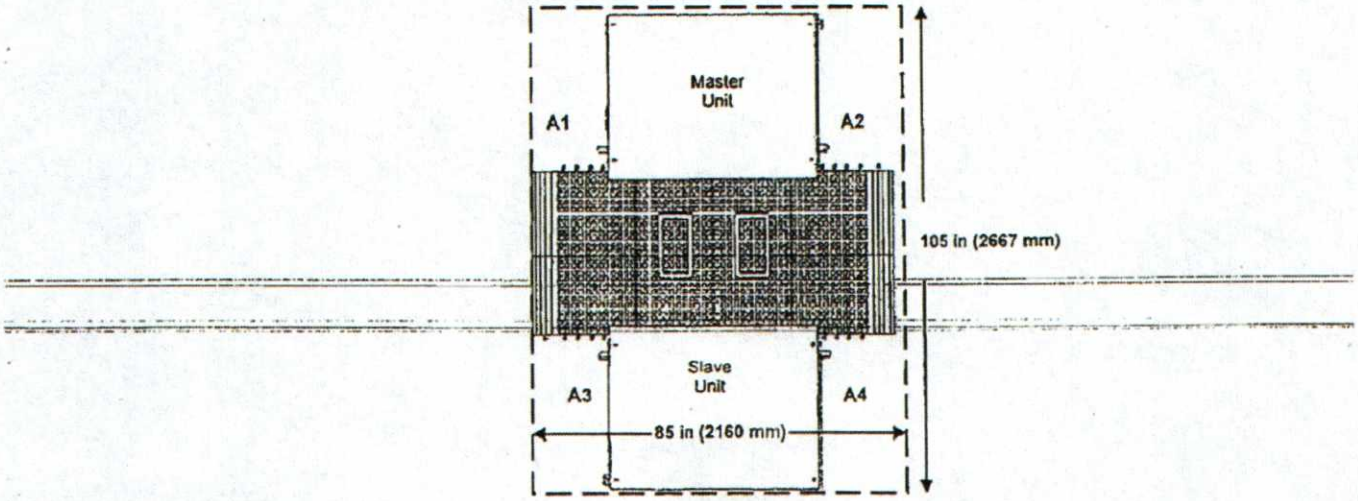
Top view

Measurement Location	Measurement Height (in)	# of scan	Measured Exposure µR (µSv)	Fluke 451P Correction Factor[1]	Rem/R conversion factor (dose equivalent)[3]	Dose Equivalent (H*10), µRem(µSv)
A1 (12" from edge of the master unit scan window)	36	10	0	2.5	0.72	0
A2 (12" from edge of the master unit scan window)	36	10	0	2.5	0.72	0
A3 (12" from edge of the slave unit scan window)	36	10	0	2.5	0.72	0
A4 (12" from edge of the slave unit scan window)	36	10	0	2.5	0.72	0

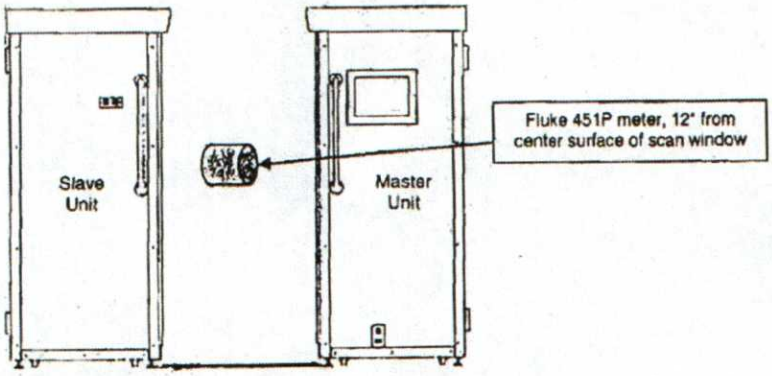
Side View

2. TABLE 1: Incorrect presentation of data in Column 3 for Measured Exposure. Indicated values are 12uR and 11uR. Corrected values are 1.2uR and 1.1uR. The values were corrected by technician when calculating Effective Dose.

The service technician should attend refresher training.

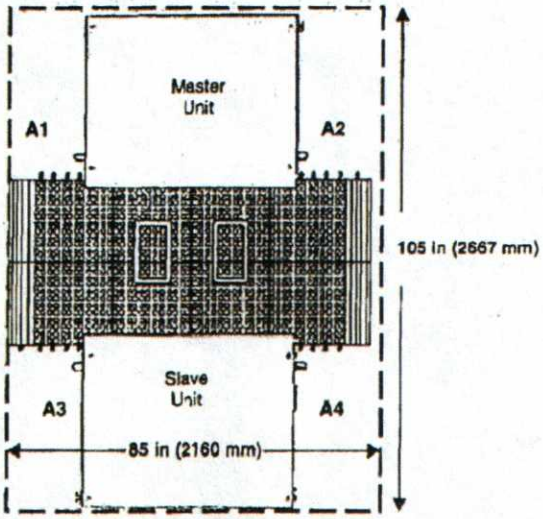
Top view

Measurement Location	Measurement Height (in)	# of scan	Measured Exposure µR (µSv)	Fluke 451P Correction Factor[1]	Rem/R conversion factor (dose equivalent)[3]	Dose Equivalent (H*10), µRem(µSv)
A1 (12" from edge of the master unit scan window)	36	10	0	2.5	0.72	0
A2 (12" from edge of the master unit scan window)	36	10	0	2.5	0.72	0
A3 (12" from edge of the slave unit scan window)	36	10	0	2.5	0.72	0
A4 (12" from edge of the slave unit scan window)	36	10	0	2.5	0.72	0
