Rapiscan systems	Secure 1000 Radiation Emission Measurement	FORM R-0646-1 (Single Pose)

Re: Rapiscan AIT System Radiation Survey Reporting

R-0646-1 Addendum
(Documentation Errors)

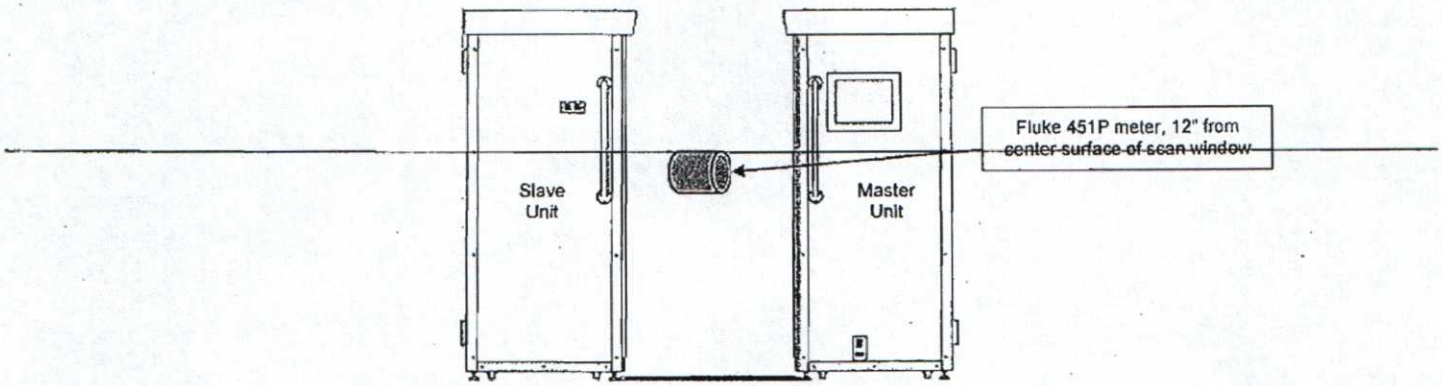
Side View

Measurement Location	Measurement Height (in)	# of scan	Measured Exposure µR (µSv) divide by 10	Fluke 451P Correction Factor[1]	Effective Dose Rem/R conversion factor (frontal)[2]	Effective Dose µRem(µSv)
12"' from center of the scan window (Master Unit)	36	10	2.0	2.5	0.23	1.15
12"' from center of the scan window (Slave Unit)	36	10	2.0	2.5	0.23	1.15

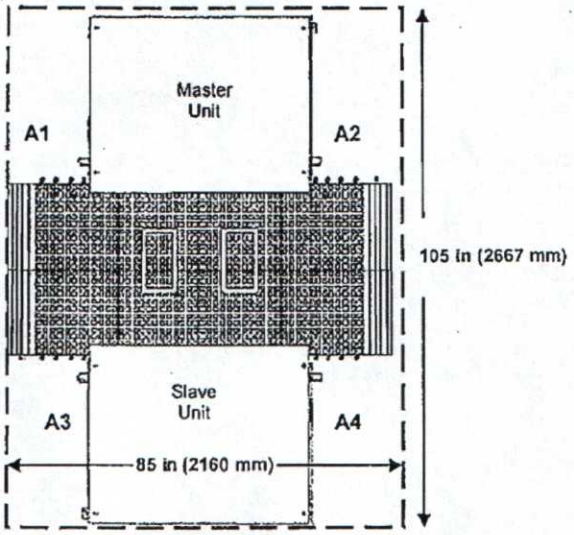
Top view

Measurement Location	Measurement Height (in)	# of scan	Measured Exposure µR (µSv)	Fluke 451P Correction Factor[1]	Rem/R conversion factor (dose equivalent)[3]	Dose Equivalent (H*10), µRem(µSv)
A1 (12" from edge of the master unit scan window)	36	10	0	2.5	0.72	0
A2 (12" from edge of the master unit scan window)	36	10	0	2.5	0.72	0
A3 (12" from edge of the slave unit scan window)	36	10	0	2.5	0.72	0
A4 (12" from edge of the slave unit scan window)	36	10	0	2.5	0.72	0

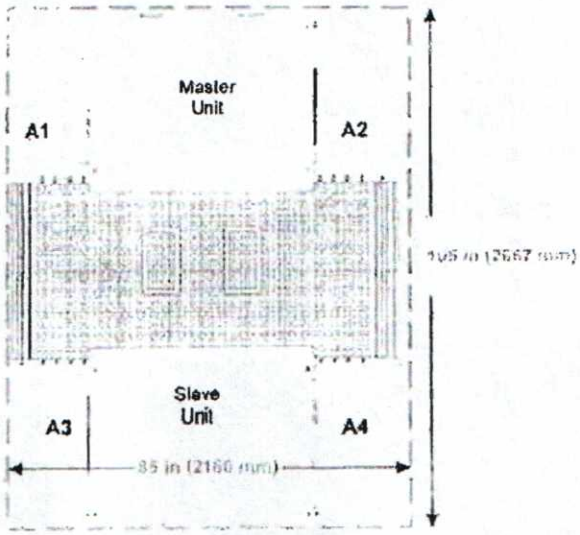
Top view

Measurement Location	Measurement Height (in)	# of scan	Measured Exposure µR (µSv)	Fluke 451P Correction Factor[4]	Rem/R conversion factor (dose equivalent)[5]	Dose Equivalent (H*10), µRem(µSv)
A1 (12" from edge of the master unit scan window)	36	10	Ø	2.5	0.72	Ø
A2 (12" from edge of the master unit scan window)	36	10	Ø	2.5	0.72	Ø
A3 (12" from edge of the slave unit scan window)	36	10	Ø	2.5	0.72	Ø
A4 (12" from edge of the slave unit scan window)	36	10	Ø	2.5	0.72	Ø
