Rapiscan systems	Secure 1000 Radiation Emission Measurement	FORM R-0646-1 (Single Pose)

Rapiscan Secure 1000

Re: Rapiscan AIT System Radiation Survey Reporting

R-0646-1 Addendum
(Documentation Errors)

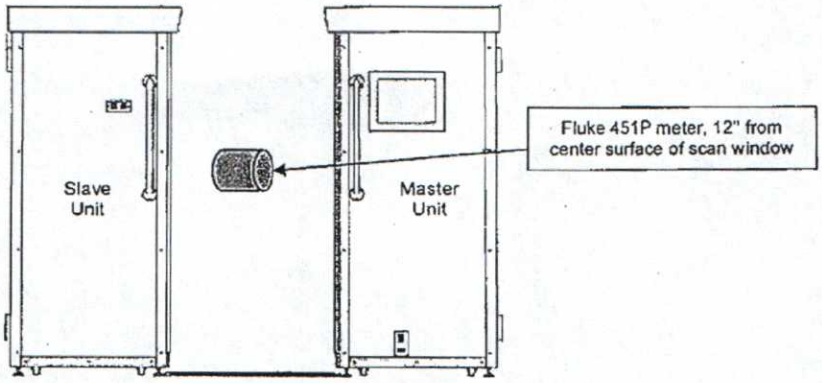
Side View

Measurement Location	Measurement Height (in)	# of scan	Measured Exposure µR (µSv) divide by 10	Fluke 451P Correction Factor[1]	Effective Dose Rem/R conversion factor (frontal)[2]	Effective Dose µRem(µSv)
12" from center of the scan window (Master Unit)	36	10	2.3	2.5	0.23	1.32
12" from center of the scan window (Slave Unit)	36	10	1.8	2.5	0.23	1.04

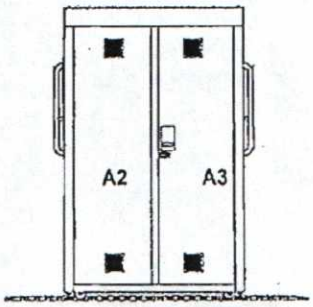
Left Side View

Measurement Location (center of the active unit external surface)	Measurement Height (in)	# of scan	Measured Exposure µR (µSv)	Fluke 451P Correction Factor[1]	Rem/R conversion factor (dose equivalent)[3]	Dose Equivalent (H*10), µRem(µSv)
A1	36	10	0	2.5	0.72	0
A2	36	10	0	2.5	0.72	0
A3	36	10	0	2.5	0.72	0
A4	36	10	0	2.5	0.72	0

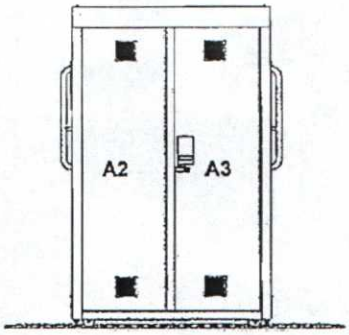
Left Side View

Measurement Location (center of the active unit external surface)	Measurement Height (in)	# of scan	Measured Exposure µR (µSv)	Fluke 451P Correction Factor[1]	Rem/R conversion factor (dose equivalent)[3]	Dose Equivalent (H*10), µRem(µSv)
A1	36	10	0	2.5	0.72	0
A2	36	10	0	2.5	0.72	0
A3	36	10	0	2.5	0.72	0
A4	36	10	0	2.5	0.72	0

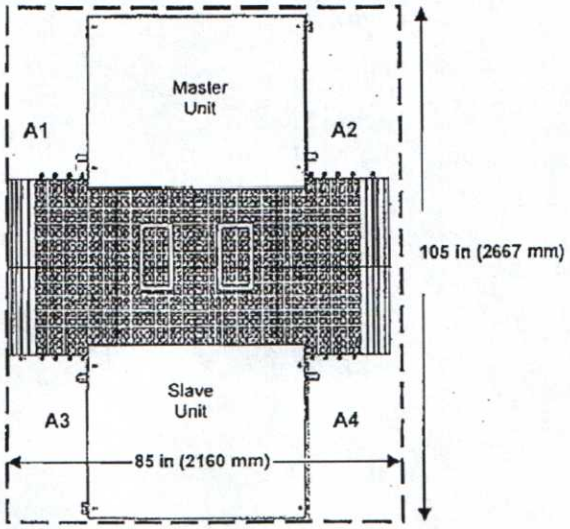
Top view

Measurement Location	Measurement Height (in)	# of scan	Measured Exposure µR (µSv)	Fluke 451P Correction Factor[1]	Rem/R conversion factor (dose equivalent)[2]	Dose Equivalent (H*10), µRem(µSv)
A1 (12" from edge of the master unit scan window)	36	10	0	2.5	0.72	0
A2 (12" from edge of the master unit scan window)	36	10	0	2.5	0.72	0
A3 (12" from edge of the slave unit scan window)	36	10	0	2.5	0.72	0
A4 (12" from edge of the slave unit scan window)	36	10	0	2.5	0.72	0

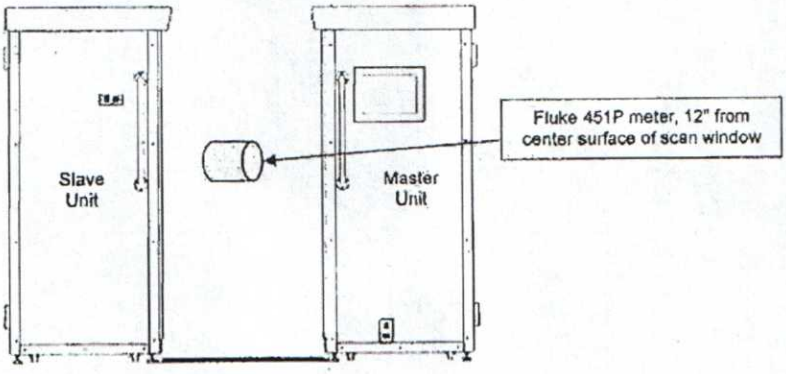
Side View

2. TABLE 1: Incorrect presentation of data in Column 3 for Measured Exposure. Indicated values are 17uR and 19uR. Corrected values are 1.7uR and 1.9uR.

3. TABLE 1: Incorrect presentation of data in Column 6 for Effective Dose. Indicated values are 9.7 uRem and 10.9 uRem. Corrected values are .97 uRem and 1.09 uRem.

The service technician should attend refresher training.

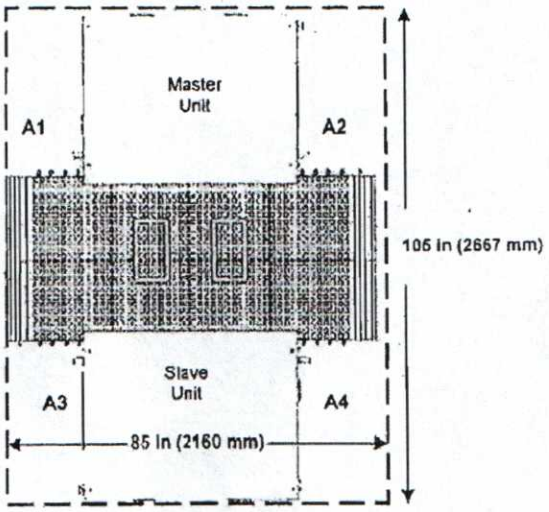
Top view

Measurement Location	Measurement Height (in)	# of scan	Measured Exposure µR (µSv)	Fluke 451P Correction Factor[1]	Rem/R conversion factor (dose equivalent)[3]	Dose Equivalent (H*10), µRem(µSv)
A1 (12" from edge of the master unit scan window)	36	10	Ø	2.5	0.72	Ø
A2 (12" from edge of the master unit scan window)	36	10	Ø	2.5	0.72	Ø
A3 (12" from edge of the slave unit scan window)	36	10	Ø	2.5	0.72	Ø
A4 (12" from edge of the slave unit scan window)	36	10	Ø	2.5	0.72	Ø
