| Rapiscan Systems | Secure 1000 Radiation Emission Measurement | FORM R-0646-1 (Single Pose) |

**Re: Rapiscan AIT System Radiation Survey Reporting**

# R-0646-1 Addendum
# (Documentation Errors)

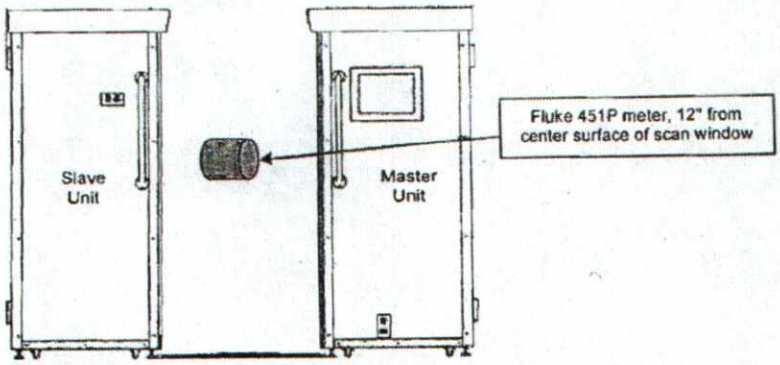
**Side View**

| Measurement Location | Measurement Height (in) | # of scan | Measured Exposure µR (µSv) divide by 10 | Fluke 451P Correction Factor[1] | Effective Dose Rem/R conversion factor (frontal)[2] | Effective Dose µRem( µSv) |
|---|---|---|---|---|---|---|
| 12" from center of the scan window (Master Unit) | 36 | 10 | 2.1 | 2.5 | 0.23 | 1.21 |
| 12" from center of the scan window (Slave Unit) | 36 | 10 | 1.8 | 2.5 | 0.23 | 1.04 |

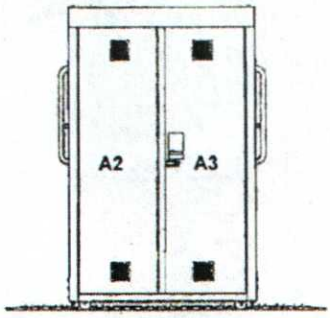
| Measurement Location (center of the active unit external surface) | Measurement Height (in) | # of scan | Measured Exposure µR (µSv) | Fluke 451P Correction Factor[1] | Rem/R conversion factor (dose equivalent)[3] | Dose Equivalent (H*10), µRem( µSv) |
|---|---|---|---|---|---|---|
| A1 | 36 | 10 | 0 | 2.5 | 0.72 | 0 |
| A2 | 36 | 10 | 0 | 2.5 | 0.72 | 0 |
| A3 | 36 | 10 | 0 | 2.5 | 0.72 | 0 |
| A4 | 36 | 10 | 0 | 2.5 | 0.72 | 0 |

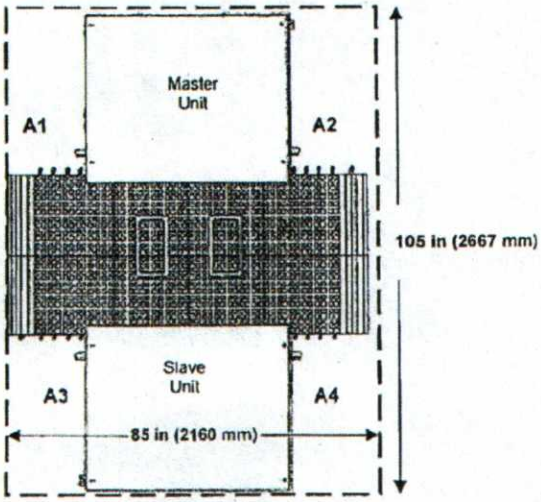
**Top view**

| Measurement Location | Measurement Height (in) | # of scan | Measured Exposure µR (µSv) | Fluke 451P Correction Factor[1] | Rem/R conversion factor (dose equivalent)[2] | Dose Equivalent (H*10), µRem( µSv) |
|---|---|---|---|---|---|---|
| A1 (12" from edge of the master unit scan window) | 36 | 10 | 0 | 2.5 | 0.72 | 0 |
| A2 (12" from edge of the master unit scan window) | 36 | 10 | 0 | 2.5 | 0.72 | 0 |
| A3 (12" from edge of the slave unit scan window) | 36 | 10 | 0 | 2.5 | 0.72 | 0 |
| A4 (12" from edge of the slave unit scan window) | 36 | 10 | 0 | 2.5 | 0.72 | 0 |

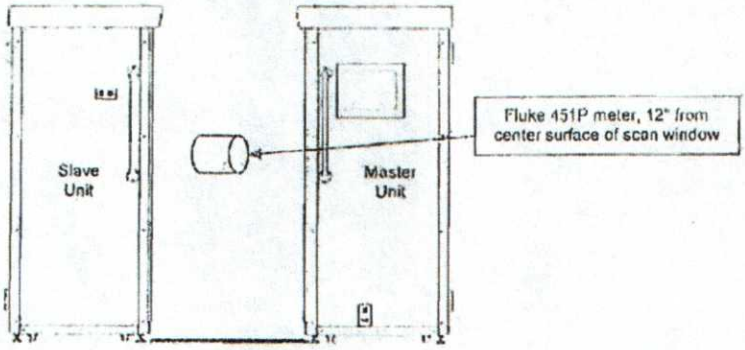
Side View

1. TABLE 1: Incorrect presentation of data in Column 3 for Measured Exposure. Indicated values are 21uR and 19uR. Corrected values are 2.0uR and 1.9uR.

2. TABLE 1: Incorrect presentation of data in Column 6 for Effective Dose. Indicated values are .12 uRem and .10 uRem. Corrected values, per RSO calculations, are 1.2 uRem and 1 uRem.

The service technician should attend refresher training.

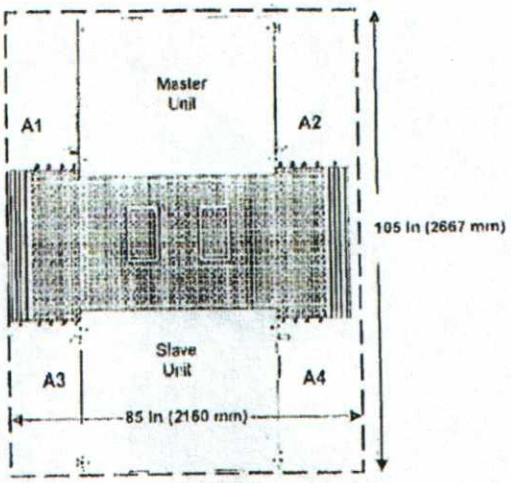
Top view

| Measurement Location | Measurement Height (in) | # of scan | Measured Exposure µR (µSv) | Fluke 451P Correction Factor[1] | Rem/R conversion factor (dose equivalent)[3] | Dose Equivalent (H*10), µRem( µSv) |
|---|---|---|---|---|---|---|
| A3 (12" from edge of the slave unit scan window) | 36 | 10 | 0 | 2.5 | 0.72 | 0 |
| A4 (12" from edge of the slave unit scan window) | 36 | 10 | 0 | 2.5 | 0.72 | 0 |
