Rapiscan Systems	Secure 1000 Radiation Emission Measurement	FORM R-0646-1 (Single Pose)

Re: Rapiscan AIT System Radiation Survey Reporting

R-0646-1 Addendum
(Documentation Errors)

Product Name	Secure 1000SP (Single Pose)
Serial Number	S51039007
Radiation Emission Measurement	Radiation Survey Dated: 11/19/2010
RSO Initials	[redacted]

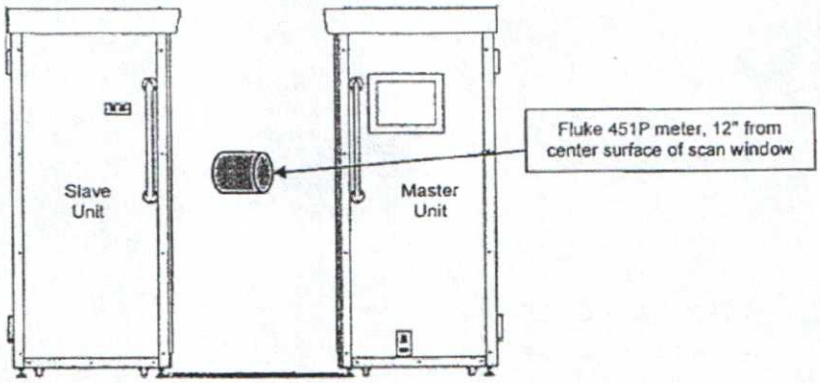
Side View

Measurement Location	Measurement Height (in)	# of scan	Measured Exposure µR (µSv) divide by 10	Fluke 451P Correction Factor[1]	Effective Dose Rem/R conversion factor (frontal)[2]	Effective Dose µRem(µSv)
12"' from center of the scan window (Master Unit)	36	10	2.1	2.5	0.23	1.21
12"' from center of the scan window (Slave Unit)	36	10	2.3	2.5	0.23	1.32

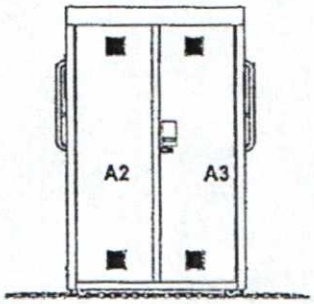
Master Unit (with monitor screen)

Measurement Location (center of the active unit external surface)	Measurement Height (in)	# of scan	Measured Exposure µR (µSv)	Fluke 451P Correction Factor[1]	Rem/R conversion factor (dose equivalent)[3]	Dose Equivalent (H*10), µRem(µSv)
A1	36	10	0	2.5	0.72	0
A2	36	10	0	2.5	0.72	0
A3	36	10	0	2.5	0.72	0
A4	36	10	0	2.5	0.72	0

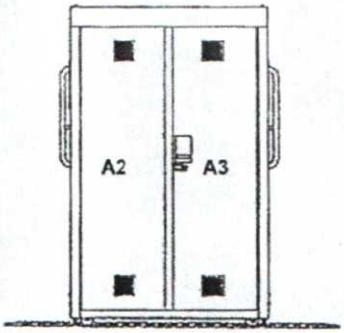
Slave Unit

Measurement Location (center of the active unit external surface)	Measurement Height (in)	# of scan	Measured Exposure µR (µSv)	Fluke 451P Correction Factor[1]	Rem/R conversion factor (dose equivalent)[3]	Dose Equivalent (H*10), µRem(µSv)
A1	36	10	0	2.5	0.72	0
A2	36	10	0	2.5	0.72	0
A3	36	10	0	2.5	0.72	0
A4	36	10	0	2.5	0.72	0

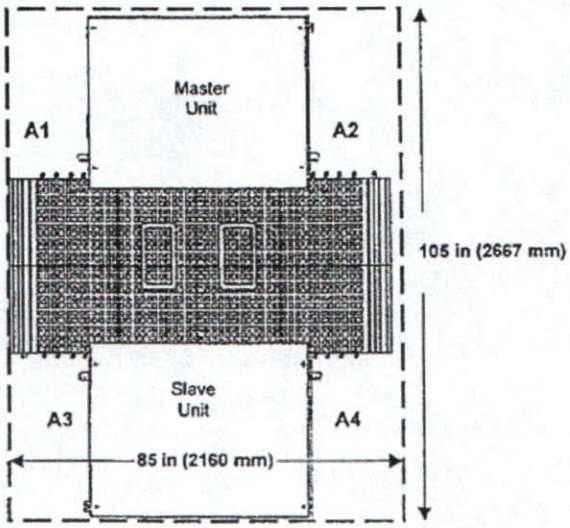
Top view

Measurement Location	Measurement Height (in)	# of scan	Measured Exposure µR (µSv)	Fluke 451P Correction Factor[1]	Rem/R conversion factor (dose equivalent)[2]	Dose Equivalent (H*10), µRem(µSv)
A1 (12" from edge of the master unit scan window)	36	10	0	2.5	0.72	0
A2 (12" from edge of the master unit scan window)	36	10	0	2.5	0.72	0
A3 (12" from edge of the slave unit scan window)	36	10	0	2.5	0.72	0
A4 (12" from edge of the slave unit scan window)	36	10	0	2.5	0.72	0
