Rapiscan systems	Secure 1000 Radiation Emission Measurement	FORM R-0646-1 (Single Pose)

Rapiscan Secure 1000

Re: Rapiscan AIT System Radiation Survey Reporting

R-0646-1 Addendum
(Documentation Errors)

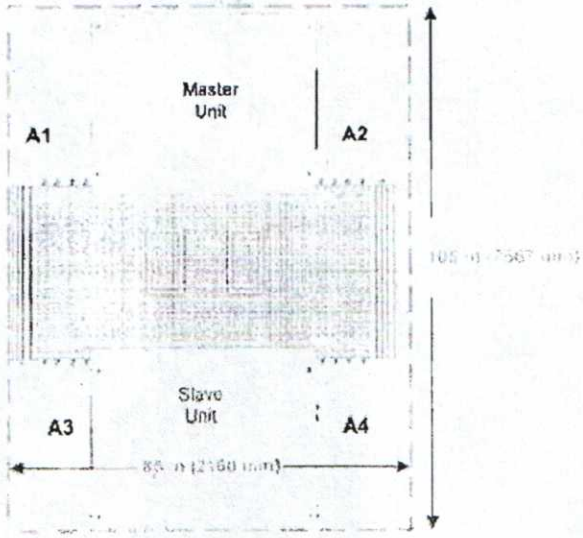
3. Inspection Zone Boundary Radiation Measurement: Survey Table. 3

Measurement Location	Measurement Height (in)	# of scan	Measured Exposure µR (µSv)	Fluke 451P Correction Factor[1]	Rem/R conversion factor (dose equivalent)[2]	Dose Equivalent (H*10), µRem(µSv)
A1 (12" from edge of the master unit scan window)	36	10	Ø	2.5	0.72	Ø
A2 (12" from edge of the master unit scan window)	36	10	Ø	2.5	0.72	Ø
A3 (12" from edge of the slave unit scan window)	36	10	0.1	2.5	0.72	0.18
A4 (12" from edge of the slave unit scan window)	36	10	0.1	2.5	0.72	0.18

3. TABLE 3: Incorrect presentation of data in Column 3 for Measured Exposure. Indicated value is .1 uRem. The correct value should be 1 uRem.

4. TABLE 3: Incorrect presentation of data in Column 6 for Dose Equivalent. Indicated value is .18 uRem. The correct value should be 1.8 uRem.

The service technician should attend refresher training.
