Rapiscan systems	Secure 1000 Radiation Emission Measurement	FORM R-0646-1 (Single Pose)

Re: Rapiscan AIT System Radiation Survey Reporting

R-0646-1 Addendum
(Documentation Errors)

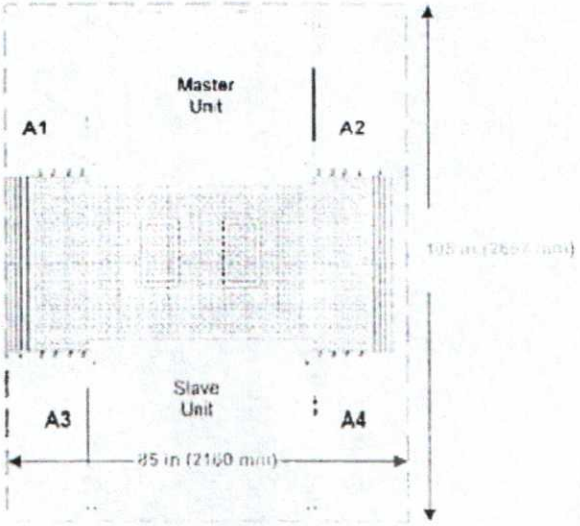
Top view

Measurement Location	Measurement Height (in)	# of scan	Measured Exposure µR (µSv)	Fluke 451P Correction Factor[1]	Rem/R conversion factor (dose equivalent)[3]	Dose Equivalent (H*10), µRem(µSv)
A1 (12" from edge of the master unit scan window)	36	10	0.1	2.5	0.72	0.18
A2 (12" from edge of the master unit scan window)	36	10	0.1	2.5	0.72	0.18
A3 (12" from edge of the slave unit scan window)	36	10	0.2	2.5	0.72	0.36
A4 (12" from edge of the slave unit scan window)	36	10	0.2	2.5	0.72	0.36

1. TABLE 3: Incorrect presentation of data in Column 3 for Measured Exposure. Indicated value is .1 uRem. The correct value should be 1 uRem.

2. TABLE 3: Incorrect presentation of data in Column 6 for Dose Equivalent. Indicated value is .18 uRem. The correct value should be 1.8 uRem.

3. TABLE 3: A probable source of error may be the Technician did not zero out the meter between surveys. Incorrect presentation of data in Column 3 for Measured Exposure. Indicated value is .2 uRem. The correct value should be 1 uRem.

4. TABLE 3: A probable source of error may be the Technician did not zero out the meter between surveys. Incorrect presentation of data in Column 6 for Dose Equivalent. Indicated value is .36 uRem. The correct value should be 1.8 uRem.

The service technician should attend refresher training.
