Rapiscan Systems	BAGGAGE/PARCEL CABINET X-RAY SYSTEM RADIATION LEAKAGE REPORT	FIELD SERVICE ENGINEERS	Form R-0598-3 9/9/99 45. RSI W.O.# 3772255 Deferred W.O.#

1. Name of Facility: HARTSFIELD JACKSON	2. Region: EAST	3. Street Address: 6000 N. TERMINAL	
4. City: ATLANTA		5. State or Province Code: GA	6. Zip Code: 30320

Rapiscan Systems	MODEL 620DV OR 500 SERIES EQUIVALENT RADIATION LEAKAGE SURVEY FORM	MODEL 620DV FSE SURVEY FORM	FORM FSE-R-0047-620DV-1

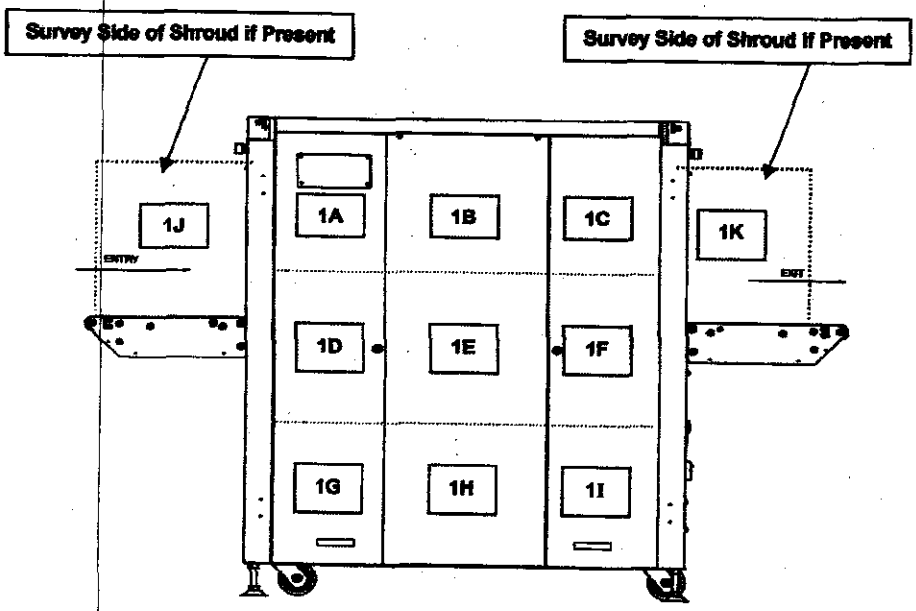
Operators Side

Location	Results NO Scatter Body	Results WITH Scatter Body
1A	20	7
1B	36	28
1C	4	10
1D	5	12
1E	29	44
1F	9	10
1G	3	13
1H	16	25
1I	3	11
1J	5	10
1K	6	7

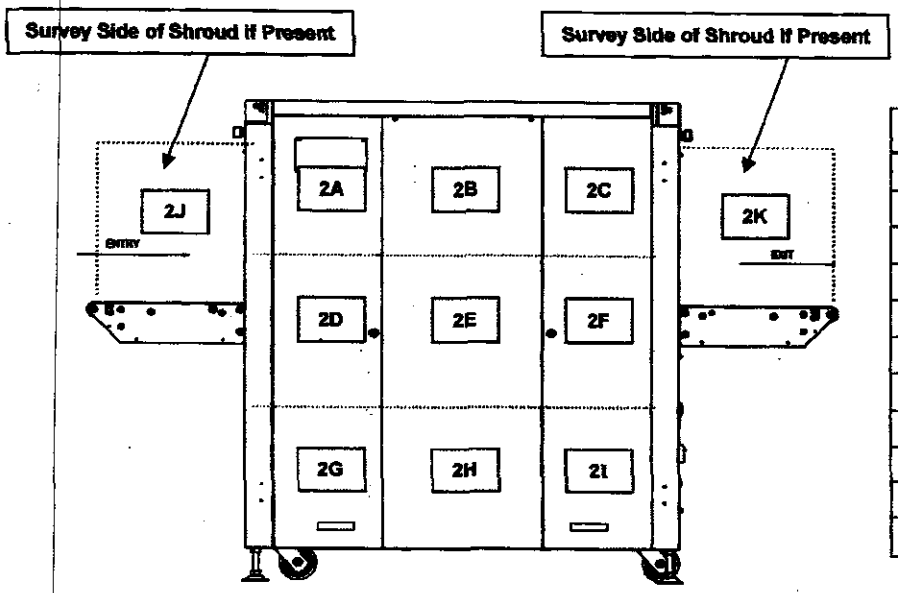
Non-Operators Side

Location	Results NO Scatter Body	Results WITH Scatter Body
2A	27	31
2B	27	2
2C	17	3
2D	5	21
2E	11	28
2F	6	4
2G	9	16
2H	23	11
2I	7	4
2J	18	200
2K	11	82

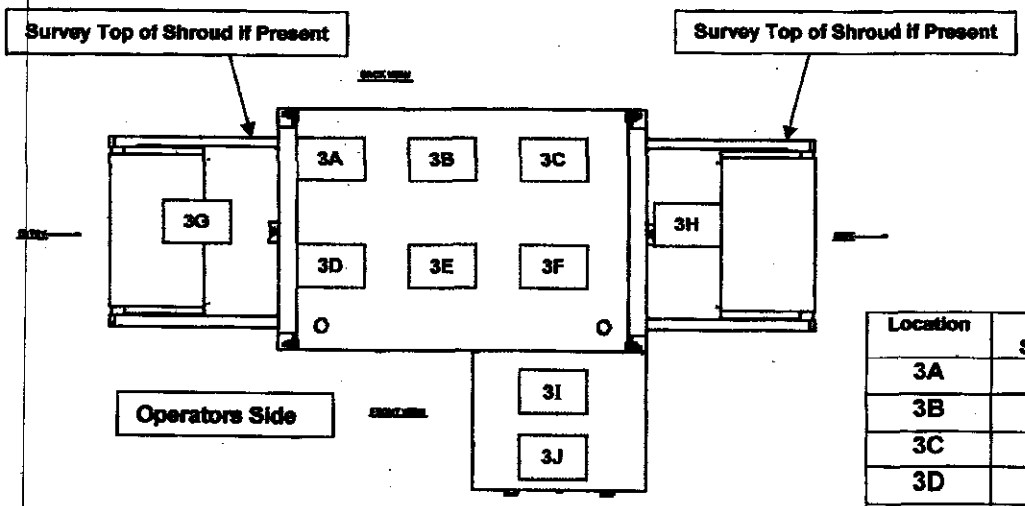
Top View

Location	Results NO Scatter Body	Results WITH Scatter Body
3A	32	70
3B	6	39
3C	5	26
3D	19	24
3E	24	18
3F	6	11
3G	20	6
3H	17	4
3I	14	3
3J	19	34

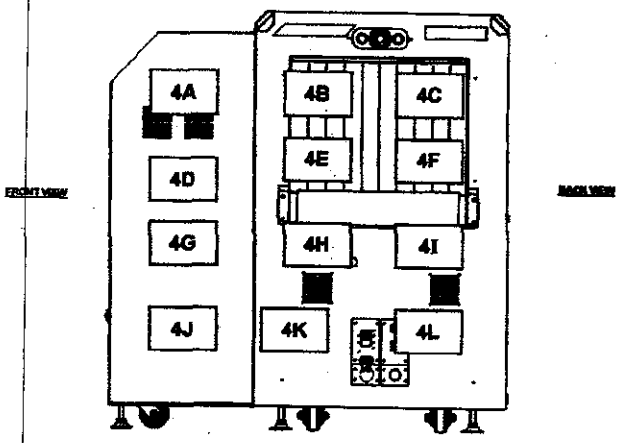
EXIT TUNNEL

Location	Results NO Scatter Body	Results WITH Scatter Body
4A	25	48
4B	9	27
4C	18	3
4D	33	47
4E	8	32
4F	22	12
4G	32	40
4H	10	27
4I	32	14
4J	49	36
4K	17	14
4L	21	6

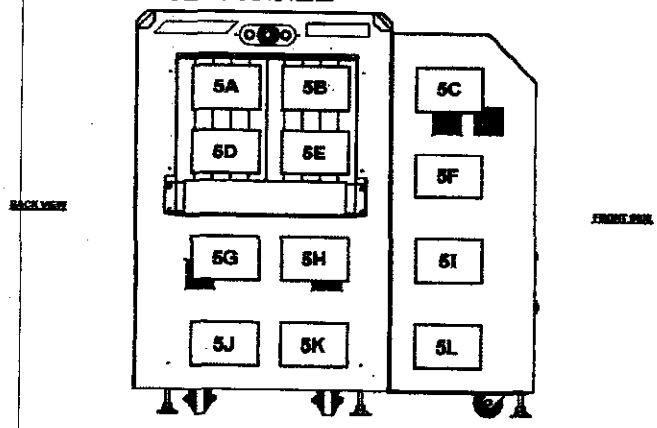
ENTRANCE TUNNEL

Location	Results NO Scatter Body	Results WITH Scatter Body
5A	6	10
5B	15	20
5C	18	28
5D	16	14
5E	9	28
5F	3	37
5G	26	21
5H	14	4
5I	6	20
5J	35	10
5K	5	12
5L	12	15
