Rapiscan Systems	BAGGAGE/PARCEL CABINET X-RAY SYSTEM RADIATION LEAKAGE REPORT	FIELD SERVICE ENGINEERS	Form R-0588-3 9/9/09 45. RSI W.O.# 3811880 Deferred W.O.#

1. Name of Facility: HARTSFIELD JACKSON	2. Region: EAST	3. Street Address: 6000 N. TERMINAL	
4. City: ATLANTA		5. State or Province Code: GA	6. Zip Code: 30320

Rapiscan Systems	MODEL 620DV OR 500 SERIES EQUIVALENT RADIATION LEAKAGE SURVEY FORM	MODEL 620DV FSE SURVEY FORM	FORM FSE-R-0047-620DV-1

FIELD SERVICE ENGINEERS RADIATION EMISSION SURVEY

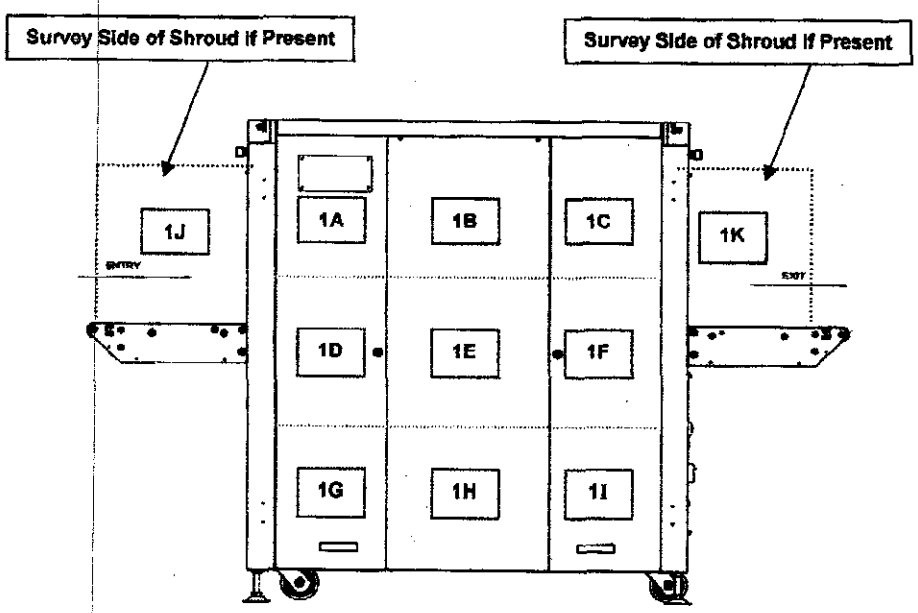
Operators Side

Location	Results NO Scatter Body	Results WITH Scatter Body
1A	47	47
1B	59	11
1C	26	4
1D	19	15
1E	23	22
1F	14	24
1G	16	24
1H	12	5
1I	15	7
1J	9	24
1K	12	45

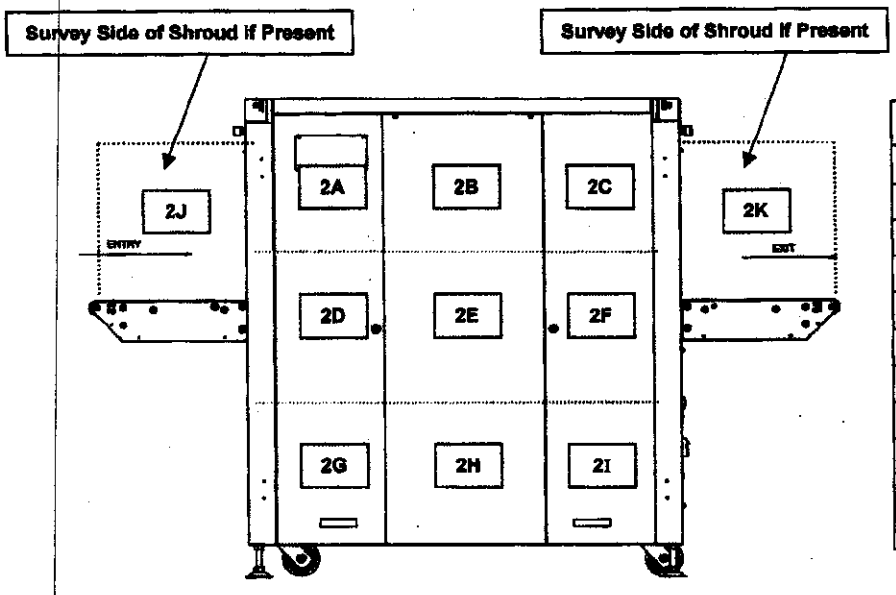
Non-Operators Side

Location	Results NO Scatter Body	Results WITH Scatter Body
2A	11	61
2B	35	63
2C	5	26
2D	6	15
2E	10	19
2F	9	12
2G	11	27
2H	10	16
2I	4	14
2J	10	4
2K	12	7

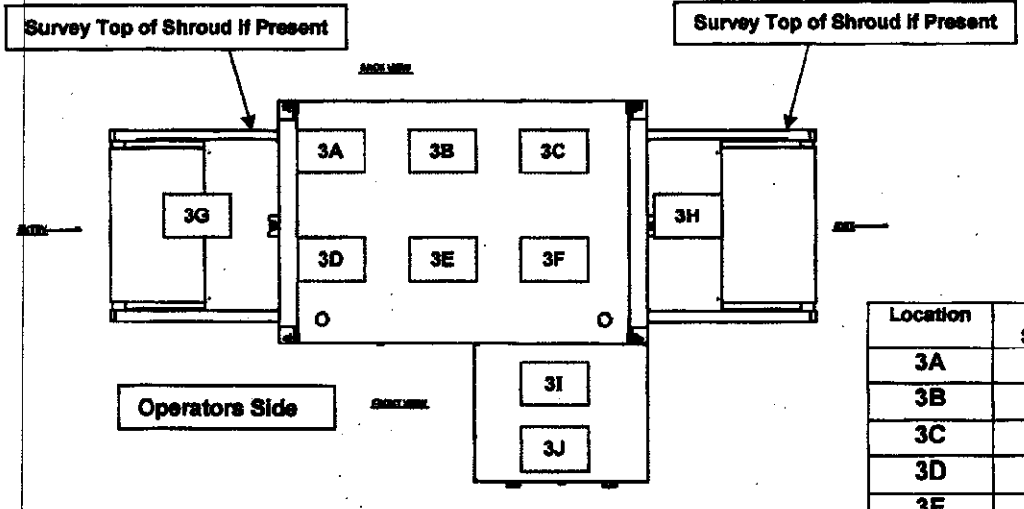
Top View

Location	Results NO Scatter Body	Results WITH Scatter Body
3A	12	70
3B	10	53
3C	24	31
3D	14	12
3E	9	11
3F	12	9
3G	11	54
3H	17	62
3I	19	17
3J	17	8

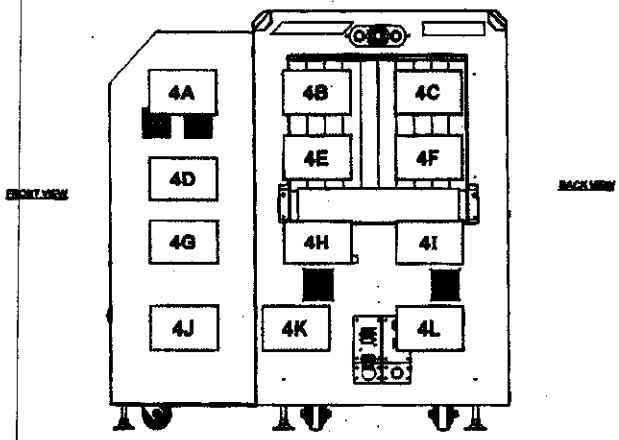
EXIT TUNNEL

Location	Results NO Scatter Body	Results WITH Scatter Body
4A	42	22
4B	6	38
4C	34	46
4D	14	25
4E	22	35
4F	19	30
4G	7	10
4H	22	9
4I	24	20
4J	12	10
4K	17	14
4L	20	18

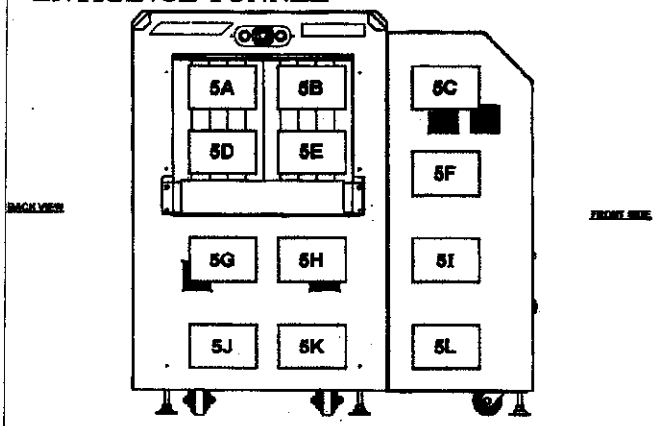
ENTRANCE TUNNEL

Location	Results NO Scatter Body	Results WITH Scatter Body
5A	41	40
5B	30	53
5C	9	33
5D	36	6
5E	21	77
5F	38	53
5G	25	46
5H	42	32
5I	16	33
5J	34	48
5K	10	21
5L	22	6
