CTX 9000 DSi Radiation Emissions Survey

A.	Manufacturer (Responsible Firm)	Morpho Detection, Inc.
B.	Manufacturer Code	Not Applicable
C.	System Model Number and/or Name	CTX 9000 DSi
D.	Unique ID	Not Applicable
E.	System Serial Number	G574
F.	Date of Manufacture (Month/Year)	Aug-05

C. Date of Radiation Emissions Survey: 1-Mar-11

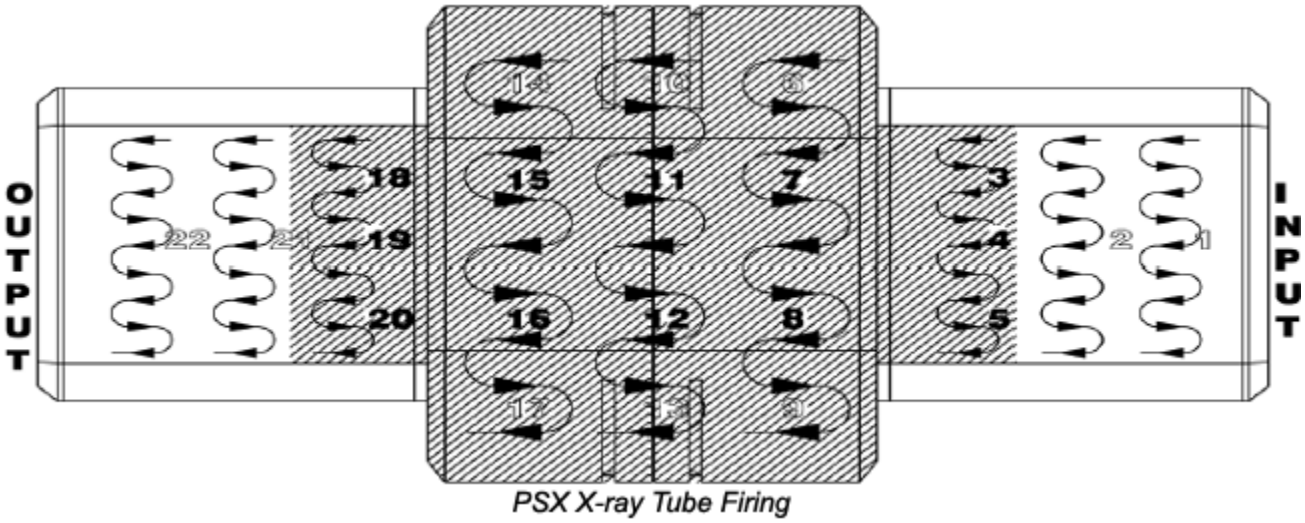
CTX 9000 DSi PSX TOP SIDE

Area #	1	2	3	4	5	6	7	8	9	10	11
Radiation value in uR/Hr	89	89	89	89	89	89	89	89	89	89	89
Area #	12	13	14	15	16	17	18	19	20	21	22
Radiation value in uR/Hr	89	89	89	89	89	89	89	89	89	89	89

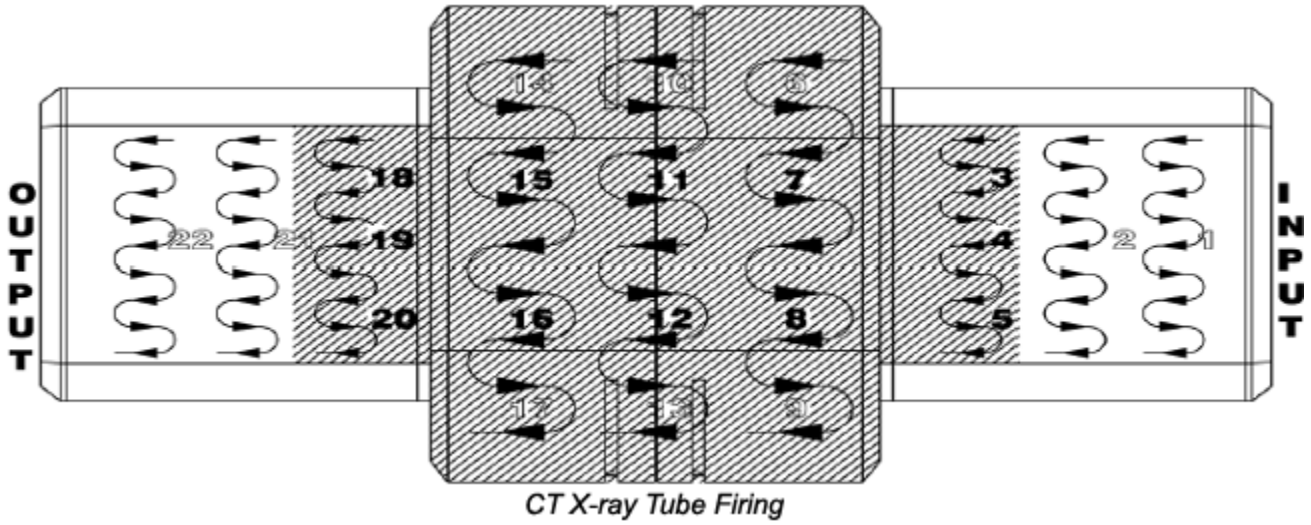
CTX 9000 DSi TOP SIDE

Area #	1	2	3	4	5	6	7	8	9	10	11
Radiation value in uR/Hr	89	89	89	89	89	89	89	89	89	89	89
Area #	12	13	14	15	16	17	18	19	20	21	22
Radiation value in uR/Hr	89	89	89	89	89	89	89	89	89	89	89
