CTX 9000 DSi Radiation Emissions Survey

A.	Manufacturer (Responsible Firm)	Morpho Detection, Inc.
B.	Manufacturer Code	Not Applicable
C.	System Model Number and/or Name	CTX 9000 DSi
D.	Unique ID	Not Applicable
E.	System Serial Number	G818
F.	Date of Manufacture (Month/Year)	Mar-09

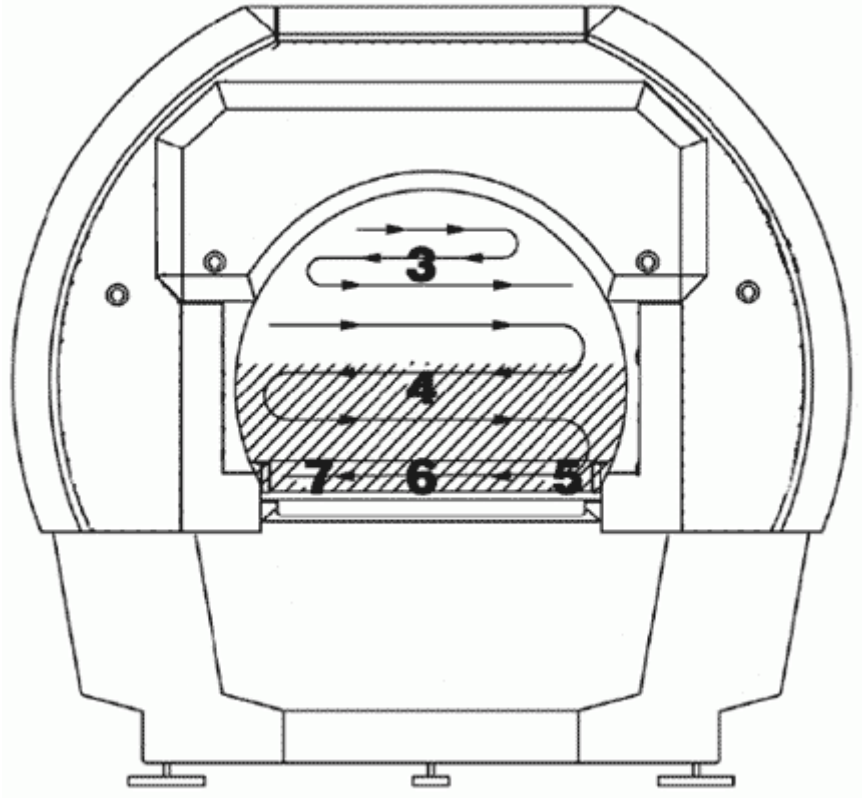
CTX 9000 DSi EXIT PORT INNER CURTAIN SURVEY

Area #	1	2	3	4	5	6	7
Radiation value in uR/Hr	N/A	N/A	34	57	48	52	43
