# CTX 9000 DSi Radiation Emissions Survey

| A. | Name of Facility | DFW |

| C. | System Model Number and/or Name | CTX 9000 DSi |
| E. | System Serial Number | G819 |

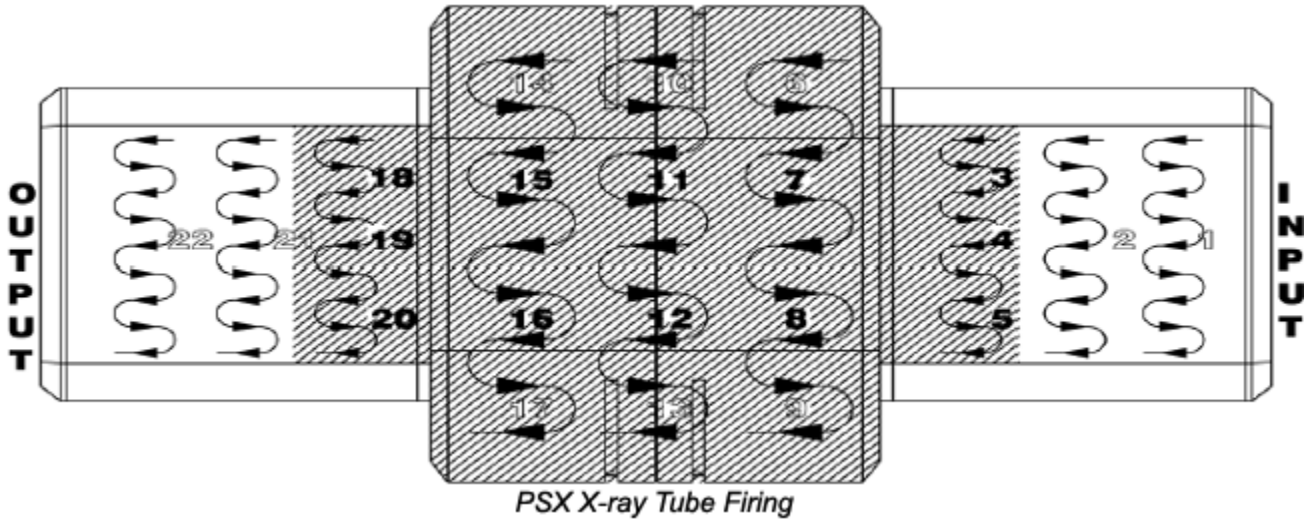
## CTX 9000 DSi PSX TOP SIDE

| Area # | 1 | 2 | 3 | 4 | 5 | 6 | 7 | 8 | 9 | 10 | 11 |
|---|---|---|---|---|---|---|---|---|---|---|---|
| Radiation value in uR/Hr | 89 | 89 | 89 | 89 | 89 | 89 | 89 | 89 | 89 | 89 | 89 |

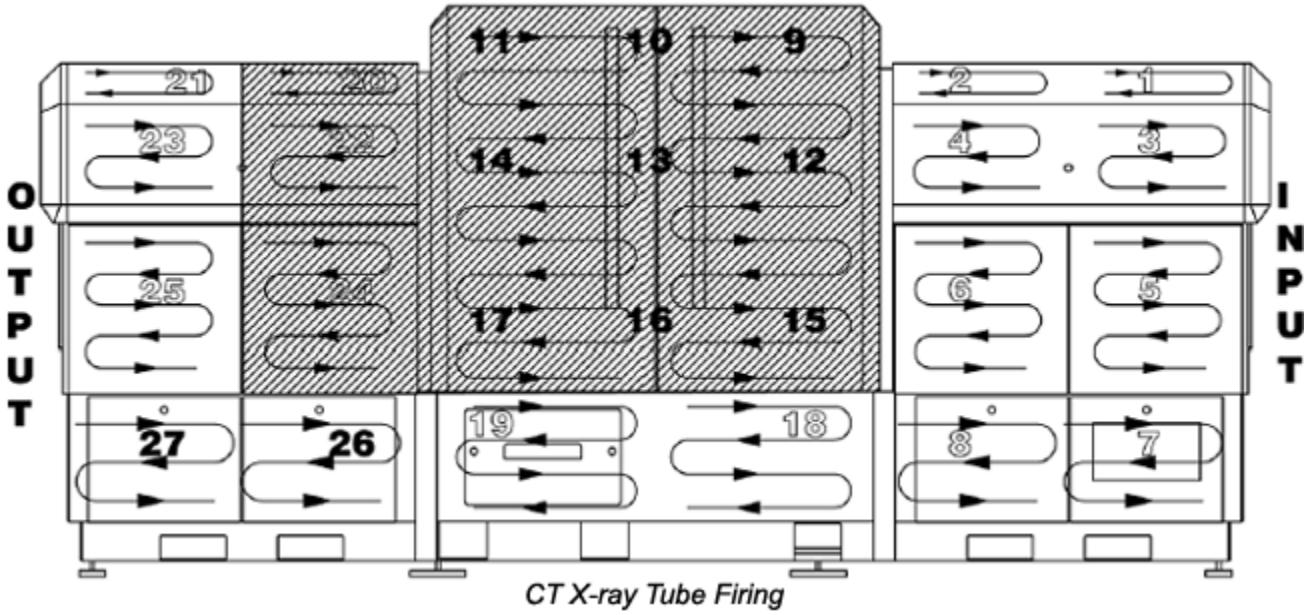
## CTX 9000 DSi LEFT SIDE

| Area # | 1 | 2 | 3 | 4 | 5 | 6 | 7 | 8 | 9 | 10 | 11 | 12 | 13 | 14 |
|---|---|---|---|---|---|---|---|---|---|---|---|---|---|---|
| Radiation value in uR/Hr | 89 | 89 | 89 | 89 | 89 | 89 | 89 | 89 | 21 | 19 | 26 | 35 | 46 | 39 |
| Radiation value in uR/Hr | 31 | 38 | 36 | 10 | 7 | 89 | 89 | 89 | 89 | 89 | 89 | 89 | 89 | |
