BAGGAGE/PARCEL CABINET X-RAY SYSTEM RADIATION LEAKAGE REPORT

1. Name of Facility: JOHN F. KENNEDY INTERNATIONAL Airport	2. Region: NEW York	3. Street Address: TERMINAL 7 CIP LN 3
4. City: JAMAICA		5. State or Province Code: NY / 6. Zip Code: 11430

Rapiscan systems	MODEL 620DV OR 500 SERIES EQUIVALENT RADIATION LEAKAGE SURVEY FORM	MODEL 620DV FSE SURVEY FORM	FORM FSE-R-0047-620DV-1

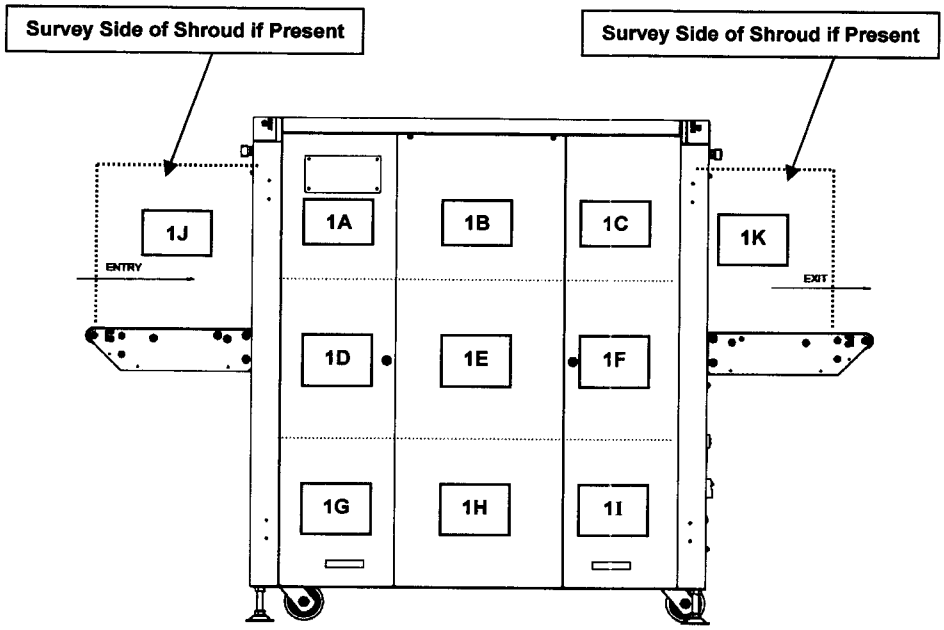
Operators Side

Location	Results NO Scatter Body	Results WITH Scatter Body
1A	19	26
1B	15	18
1C	13	9
1D	13	15
1E	18	19
1F	16	12
1G	7	10
1H	12	9
1I	10	11
1J	25	37
1K	19	16

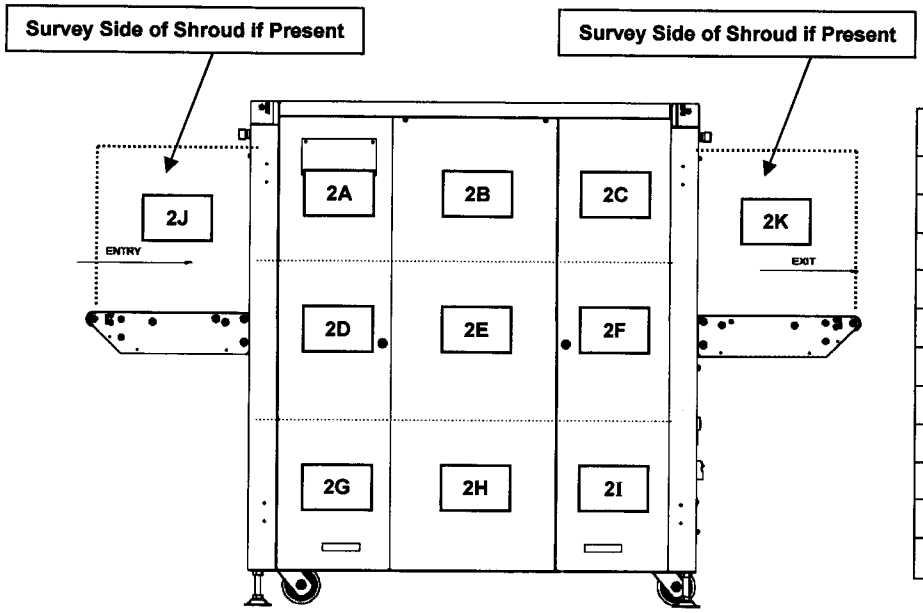
Non-Operators Side

Location	Results NO Scatter Body	Results WITH Scatter Body
2A	16	21
2B	9	19
2C	12	15
2D	15	15
2E	14	12
2F	13	18
2G	19	17
2H	12	13
2I	9	11
2J	25	32
2K	18	22

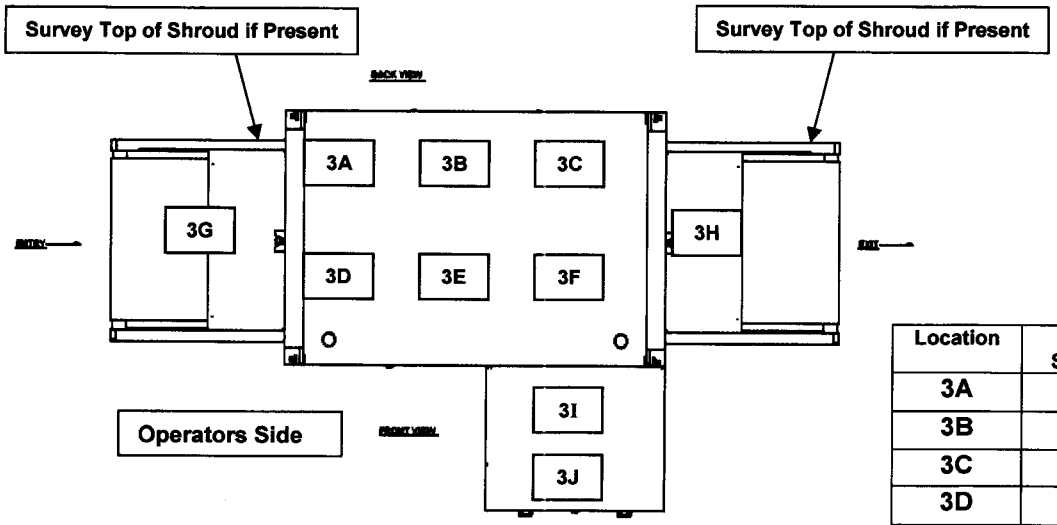
Top View

Location	Results NO Scatter Body	Results WITH Scatter Body
3A	31	32
3B	29	18
3C	30	27
3D	19	25
3E	21	22
3F	18	19
3G	25	30
3H	17	18
3I	21	20
3J	27	35

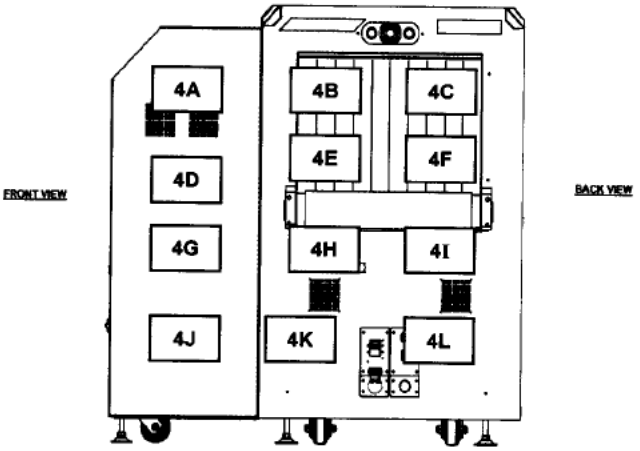
EXIT TUNNEL

Location	Results NO Scatter Body	Results WITH Scatter Body
4A	15	9
4B	30	35
4C	32	41
4D	7	16
4E	25	32
4F	26	31
4G	18	21
4H	9	7
4I	11	15
4J	16	19
4K	5	11
4L	7	6

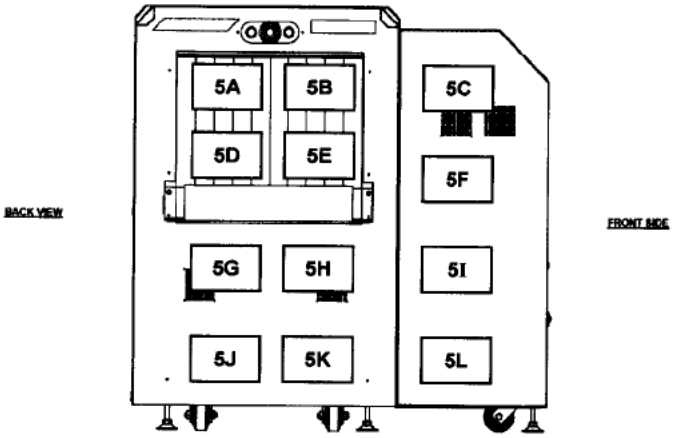
ENTRANCE TUNNEL

Location	Results NO Scatter Body	Results WITH Scatter Body
5A	27	34
5B	26	32
5C	19	19
5D	29	31
5E	31	31
5F	30	40
5G	25	18
5H	14	19
5I	11	15
5J	9	12
5K	12	11
5L	13	15
