CTX 9000 DSi Radiation Emissions Survey

A.	Manufacturer (Responsible Firm)	Morpho Detection, Inc.
B.	Manufacturer Code	Not Applicable
C.	System Model Number and/or Name	CTX 9000 DSi
D.	Unique ID	Not Applicable
E.	System Serial Number	G420
F.	Date of Manufacture (Month/Year)	May-04

C. Date of Radiation Emissions Survey: 1-Mar-11

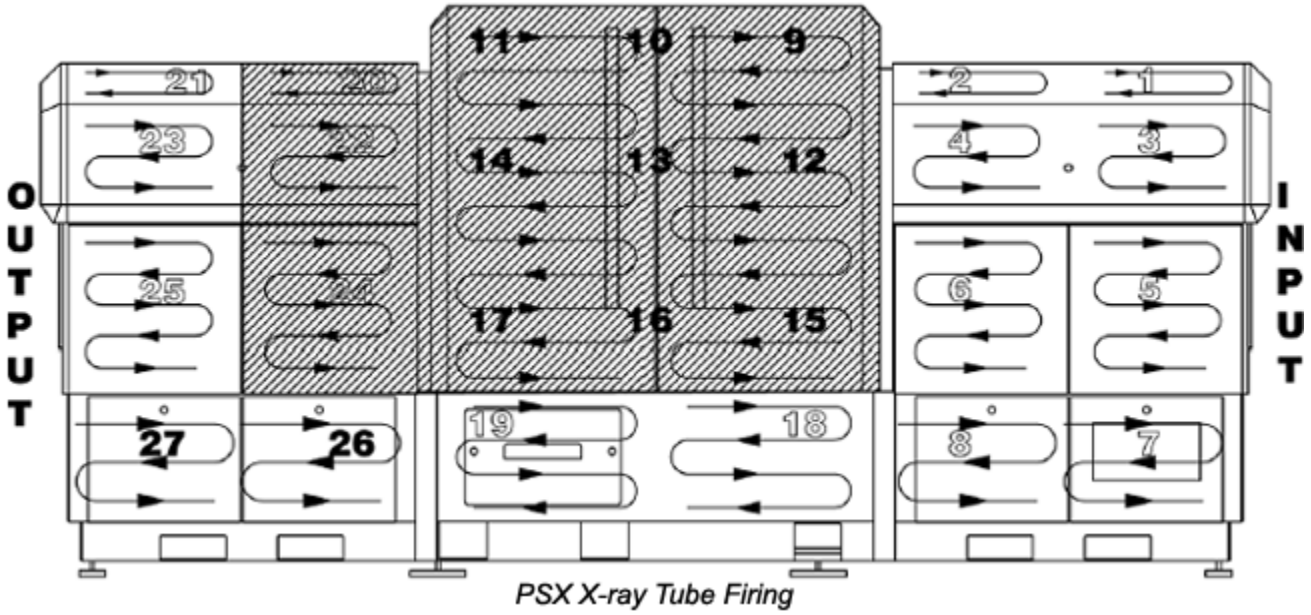
CTX 9000 DSi PSX LEFT SIDE

Area #	1	2	3	4	5	6	7	8	9	10	11	12	13	14
Radiation value in uR/Hr	89	89	89	89	89	89	89	89	89	89	89	89	89	89
Area #	15	16	17	18	19	20	21	22	23	24	25	26	27	
Radiation value in uR/Hr	89	89	89	89	89	89	89	89	89	89	89	89	89
