CTX 9000 DSi Radiation Emissions Survey

A.	Manufacturer (Responsible Firm)	Morpho Detection, Inc.
B.	Manufacturer Code	Not Applicable
C.	System Model Number and/or Name	CTX 9000 DSi
D.	Unique ID	Not Applicable
E.	System Serial Number	G562
F.	Date of Manufacture (Month/Year)	Jul-05

C. Date of Radiation Emissions Survey: 11-Mar-11

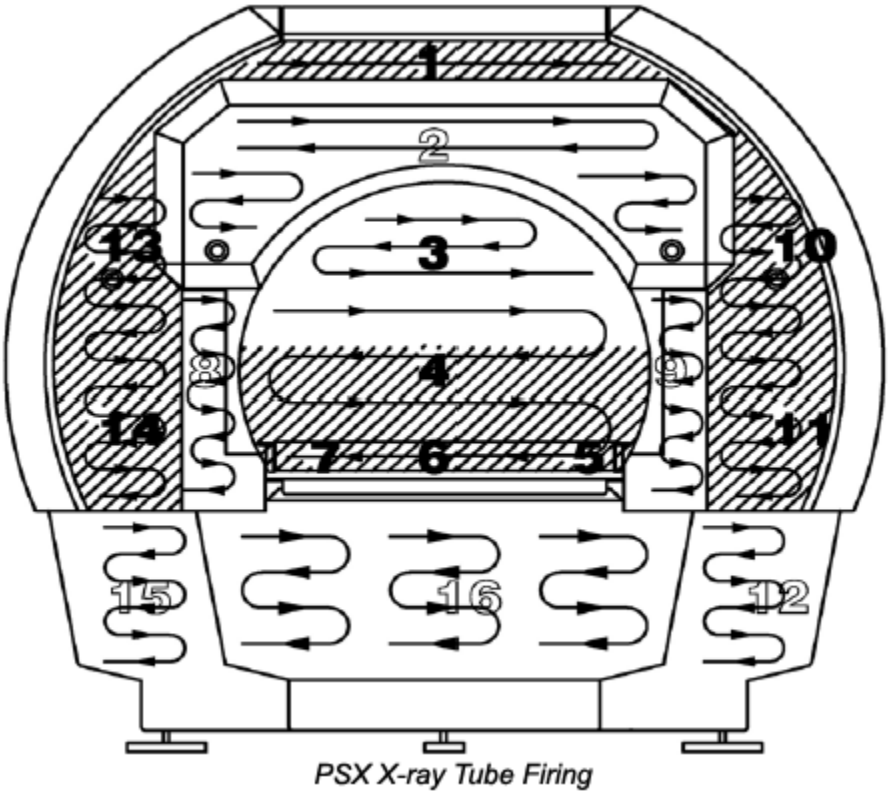
CTX 9000 DSi PSX ENTRANCE VIEW

Area #	1	2	3	4	5	6	7	8	9	10	11	12	13	14	15	16
Radiation value in uR/Hr	89	89	3	4	6	8	2	89	89	89	89	89	89	89	89	89

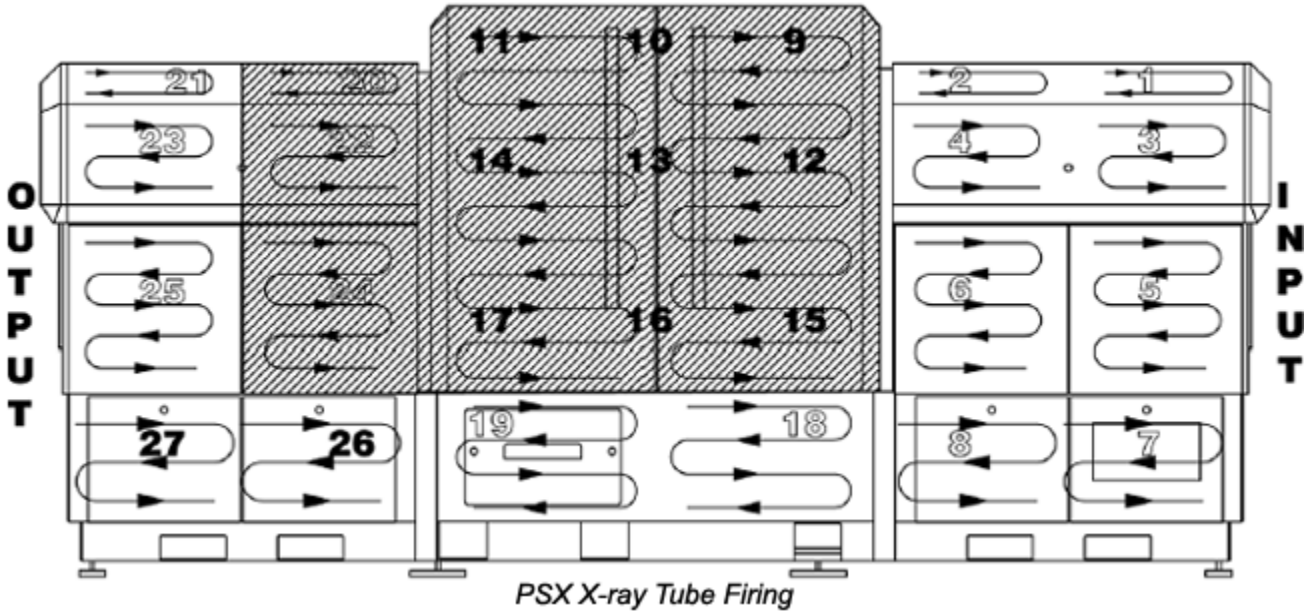
CTX 9000 DSi PSX LEFT SIDE

Area #	1	2	3	4	5	6	7	8	9	10	11	12	13	14
Radiation value in uR/Hr	89	89	89	89	89	89	89	89	89	89	89	89	89	89
Area #	15	16	17	18	19	20	21	22	23	24	25	26	27	
Radiation value in uR/Hr	89	89	89	89	89	89	89	89	89	89	89	89	89

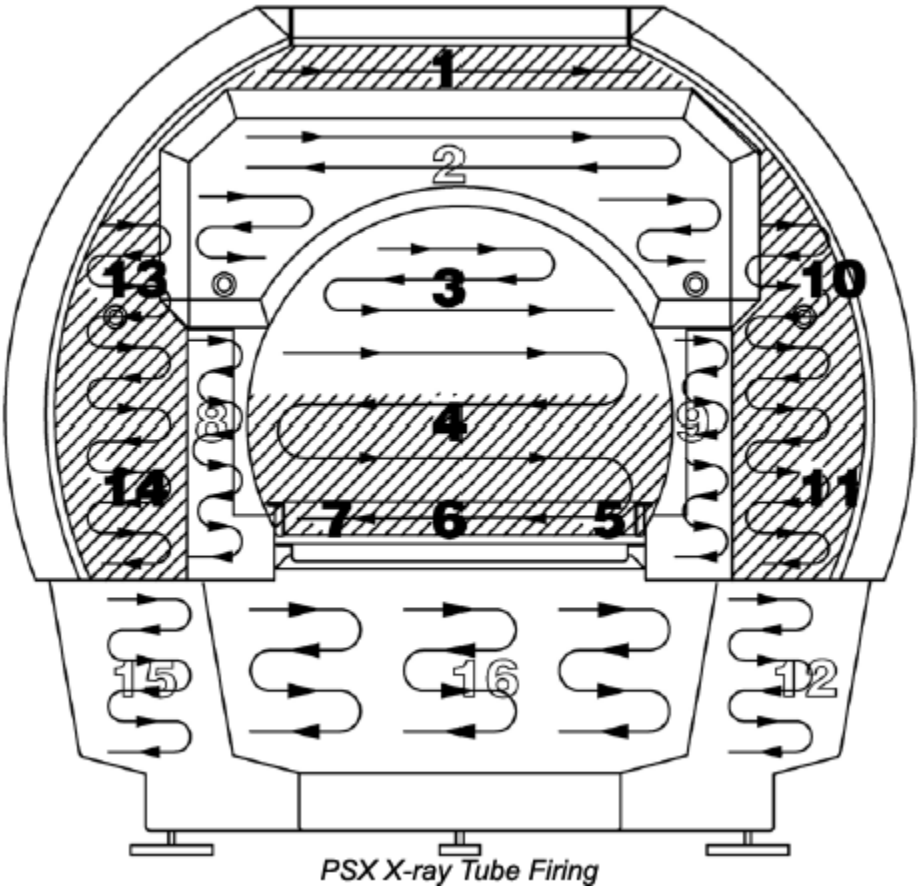
CTX 9000 DSi PSX EXIT VIEW

Area #	1	2	3	4	5	6	7	8	9	10	11	12	13	14	15	16
Radiation value in uR/Hr	89	89	3	5	6	4	5	89	89	89	89	89	89	89	89	89

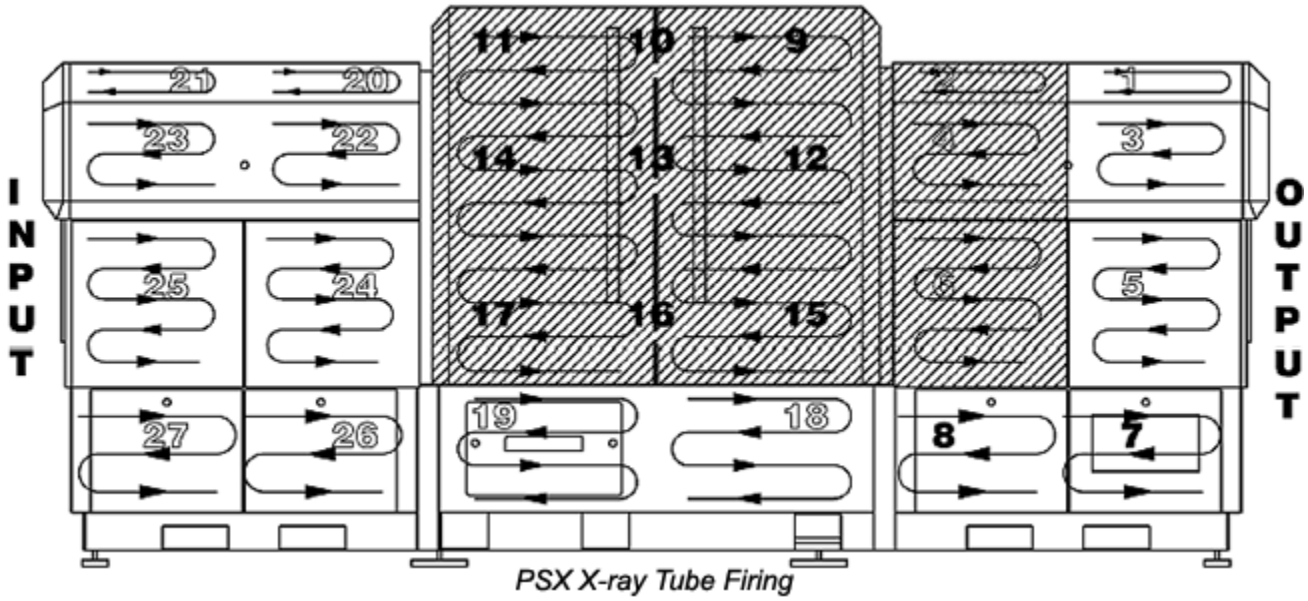
CTX 9000 DSi PSX RIGHT SIDE

Area #	1	2	3	4	5	6	7	8	9	10	11	12	13	14
Radiation value in uR/Hr	89	89	89	89	89	89	89	89	89	89	89	89	89	89
Area #	15	16	17	18	19	20	21	22	23	24	25	26	27	
Radiation value in uR/Hr	89	89	89	89	89	89	89	89	89	89	89	89	89

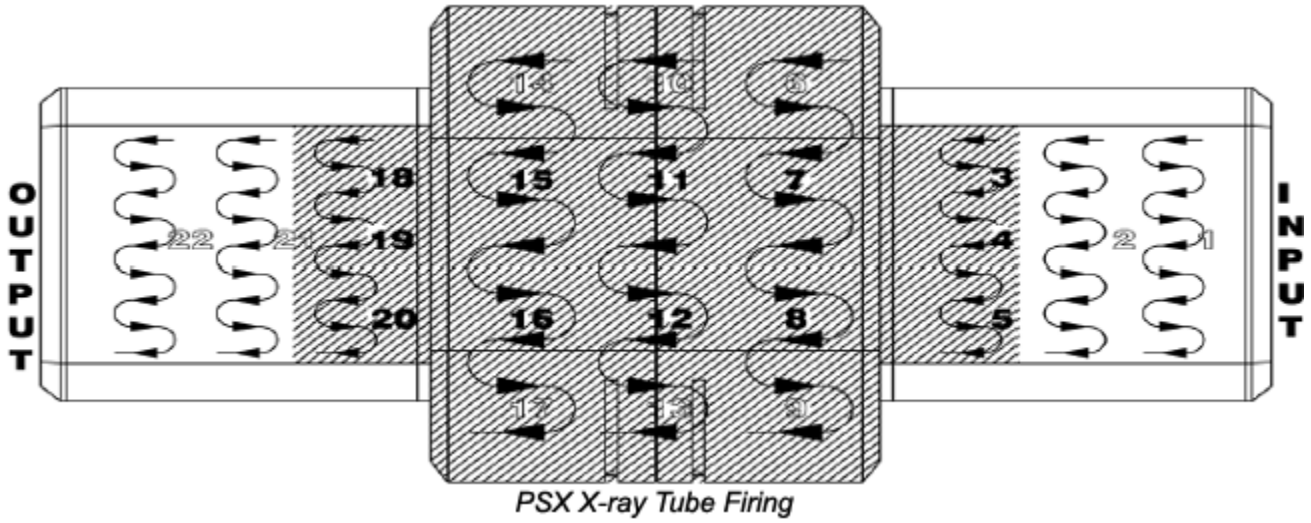
CTX 9000 DSi PSX TOP SIDE

Area #	1	2	3	4	5	6	7	8	9	10	11
Radiation value in uR/Hr	89	89	89	89	89	89	89	89	89	89	89
Area #	12	13	14	15	16	17	18	19	20	21	22
Radiation value in uR/Hr	89	89	89	89	89	89	89	89	89	89	89

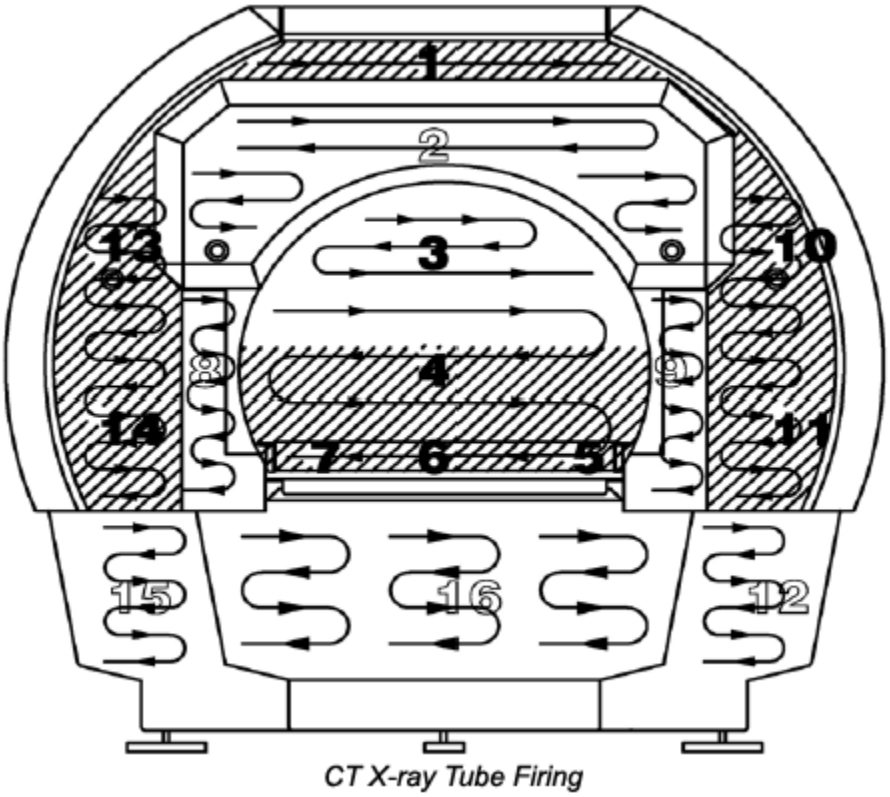
CTX 9000 DSi ENTRANCE VIEW

Area #	1	2	3	4	5	6	7	8	9	10	11	12	13	14	15	16
Radiation value in uR/Hr	89	89	6	4	6	2	5	89	89	89	89	89	89	89	89	89

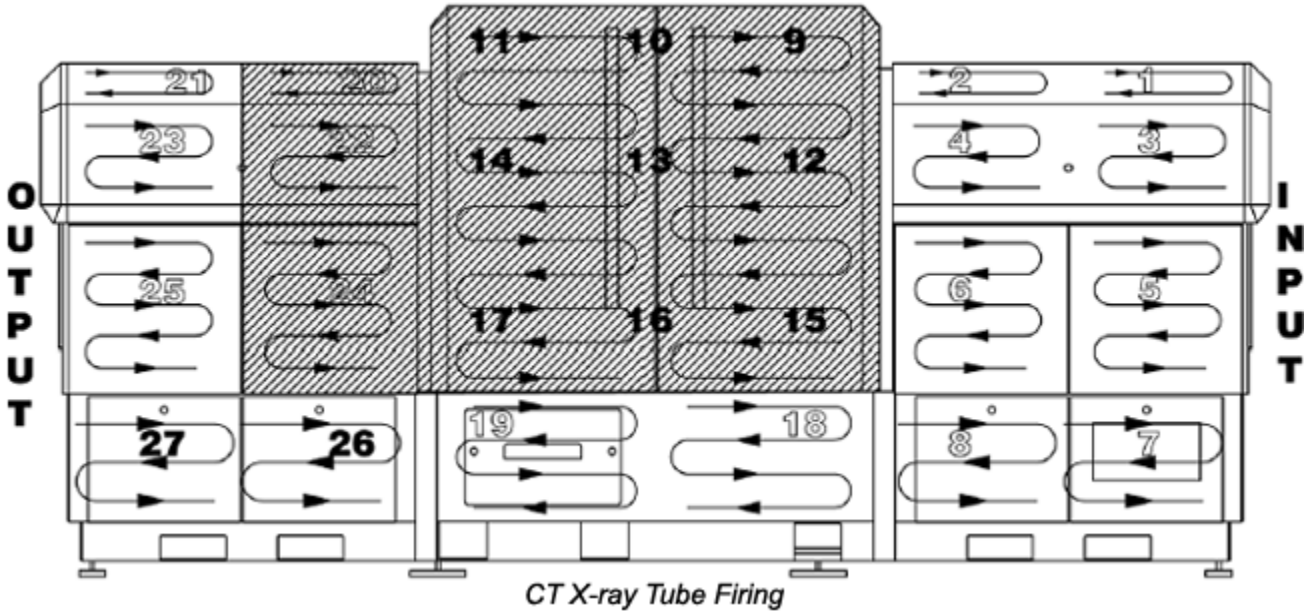
CTX 9000 DSi LEFT SIDE

Area #	1	2	3	4	5	6	7	8	9	10	11	12	13	14
Radiation value in uR/Hr	89	89	89	89	89	89	89	89	89	89	89	89	89	89
Area #	15	16	17	18	19	20	21	22	23	24	25	26	27	
Radiation value in uR/Hr	89	89	89	89	89	89	89	89	89	89	89	89	89

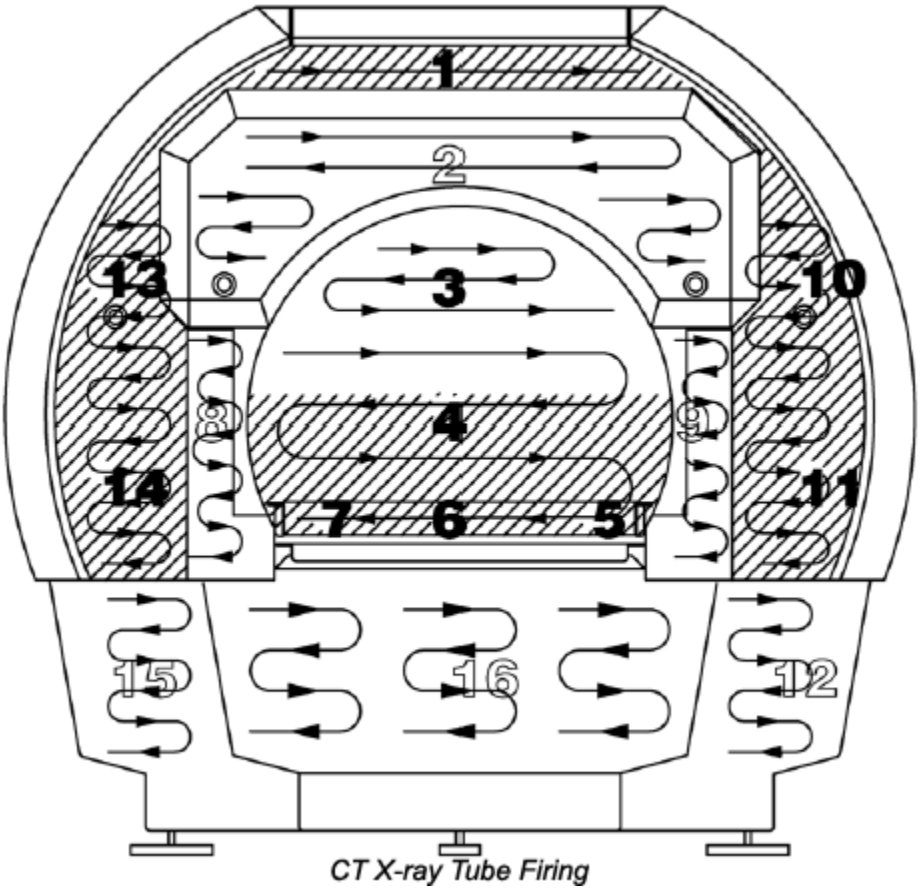
CTX 9000 DSi EXIT VIEW

Area #	1	2	3	4	5	6	7	8	9	10	11	12	13	14	15	16
Radiation value in uR/Hr	89	89	9	3	3	7	5	89	89	89	89	89	89	89	89	89

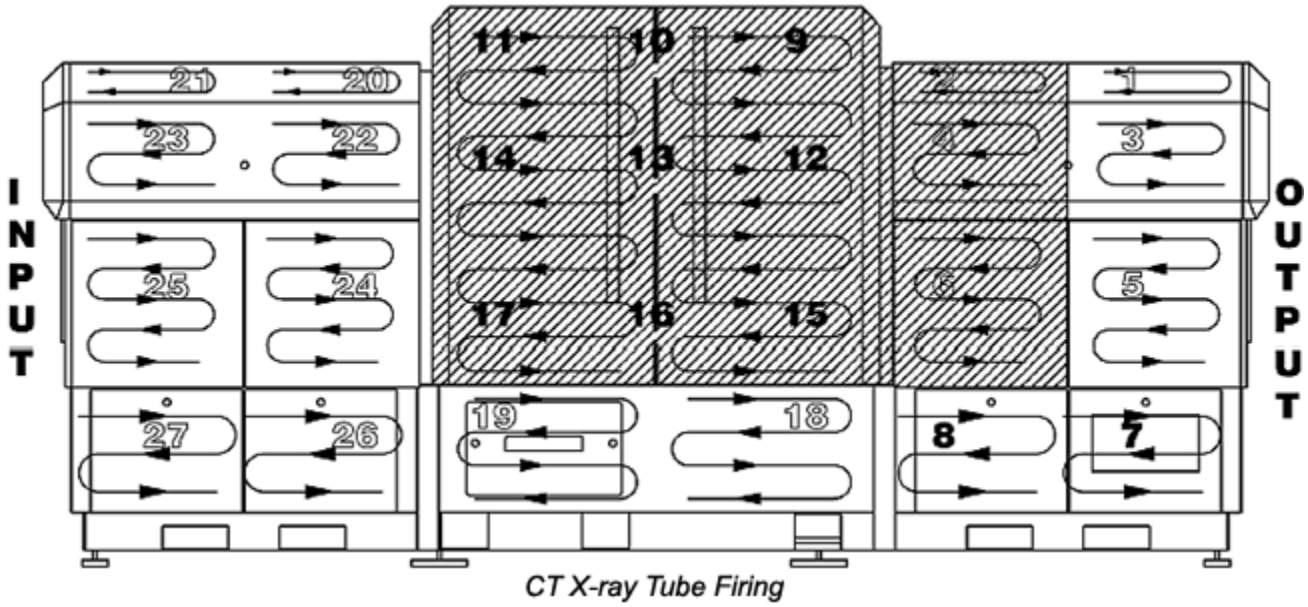
CTX 9000 DSi RIGHT SIDE

Area #	1	2	3	4	5	6	7	8	9	10	11	12	13	14
Radiation value in uR/Hr	89	89	89	89	89	89	89	89	89	89	89	89	89	89
Area #	15	16	17	18	19	20	21	22	23	24	25	26	27	
Radiation value in uR/Hr	89	89	89	89	89	89	89	89	89	89	89	89	89

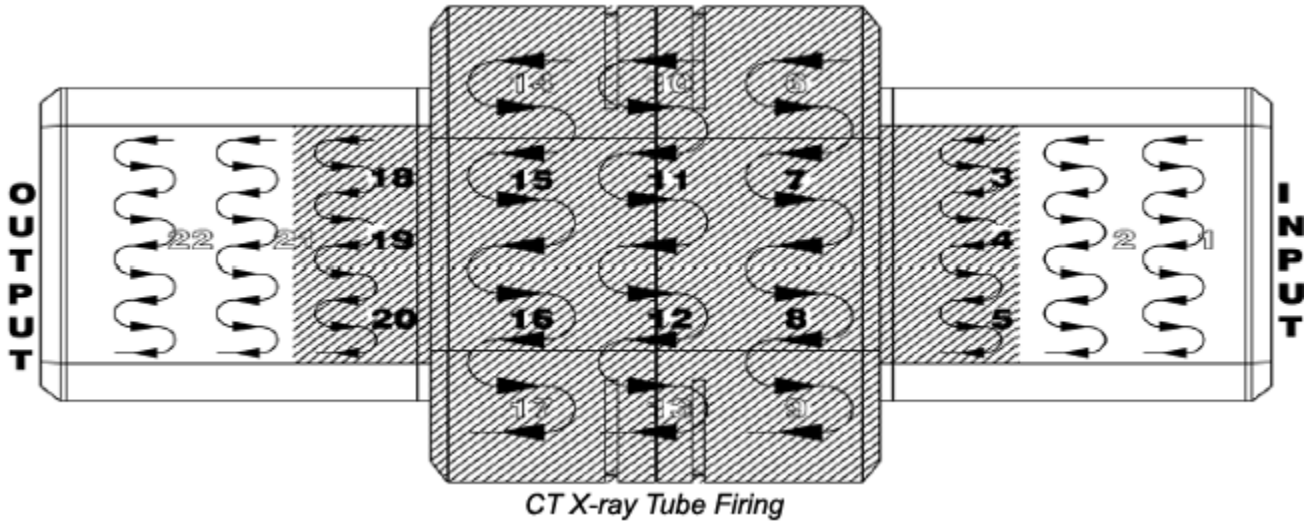
CTX 9000 DSi TOP SIDE

Area #	1	2	3	4	5	6	7	8	9	10	11
Radiation value in uR/Hr	89	89	89	89	89	89	89	89	89	89	89
Area #	12	13	14	15	16	17	18	19	20	21	22
Radiation value in uR/Hr	89	89	89	89	89	89	89	89	89	89	89

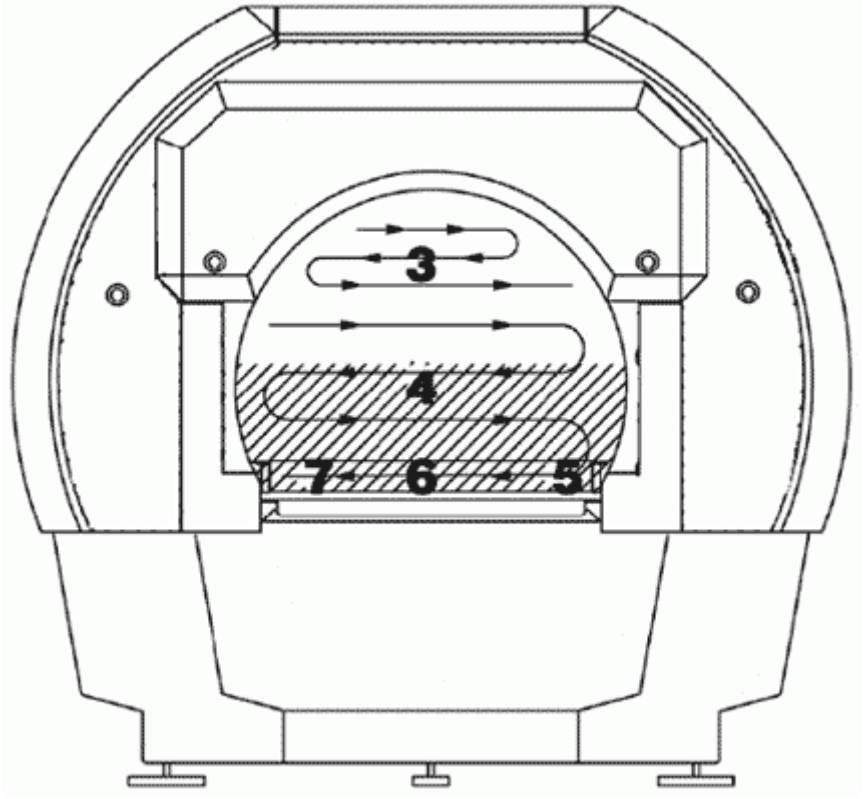
CTX 9000 DSi ENTRANCE PORT INNER CURTAIN SURVEY

Area #	1	2	3	4	5	6	7
Radiation value in uR/Hr	N/A	N/A	8	10	3	7	4

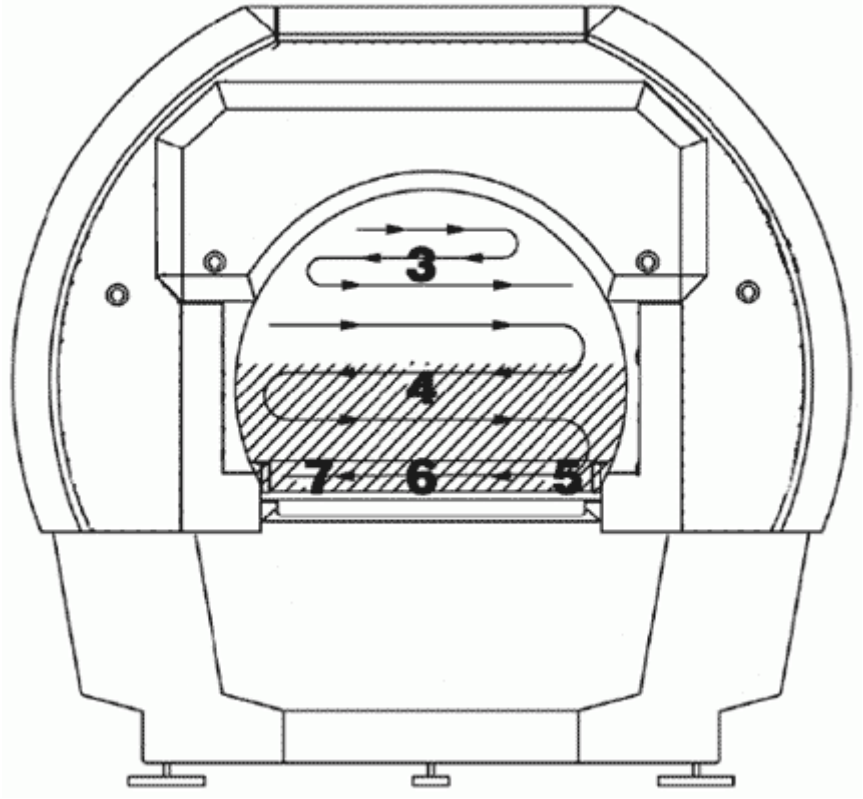
CTX 9000 DSi EXIT PORT INNER CURTAIN SURVEY

Area #	1	2	3	4	5	6	7
Radiation value in uR/Hr	N/A	N/A	20	19	15	15	18
